# Supplemental Report: 2011 Stream Restoration of the Lake Julia Outfall (Reasonover Creek) at DuPont State Forest

Compiled by Tom Gerow, Jr.  
BMP Staff Forester, Nonpoint Source Branch  
NCDA&CS - North Carolina Forest Service (NCFS)  
Raleigh, NC  
December 2011

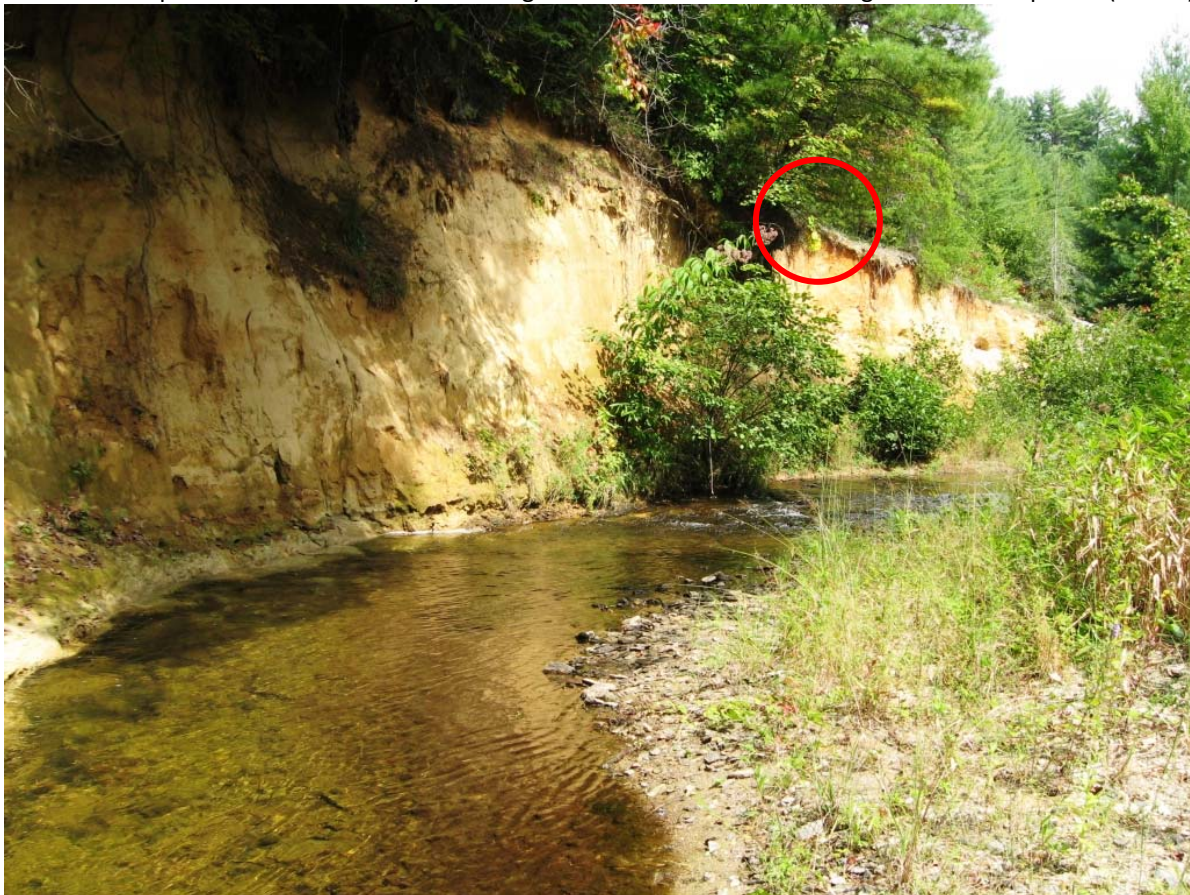
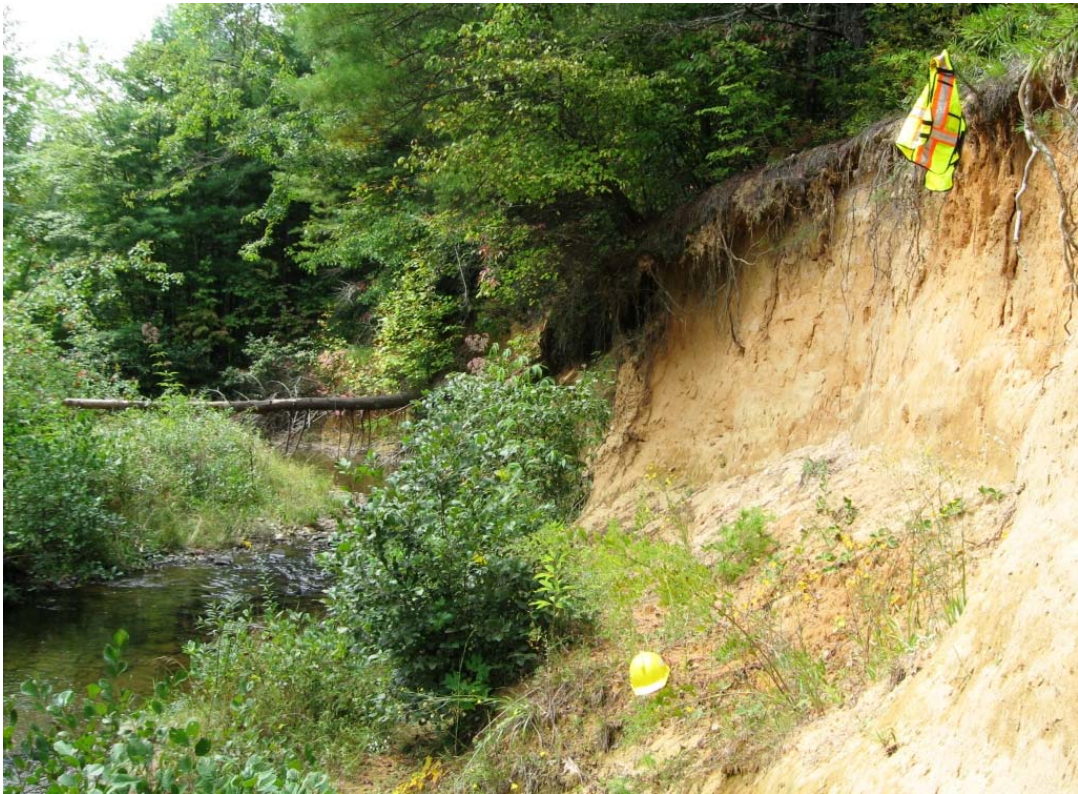
After a series of significant rainfall events in the mid-to-late 2000's, this embankment exhibited a considerable increase in the frequency of soil loss and subsequent slumping of large trees that were atop the embankment. This eroding and collapsing embankment also began migrating downstream and upstream towards the permanent bridge on Conservation Road that is a vital travel route on DuPont State Forest.

Two photos of the stream's eroding and collapsing right-bank escarpment: Above taken May 2009. Below taken Sept.2009. Note the safety vest hung on a limb to show relative height of the escarpment (circled).

A new floodplain bench was excavated along the length of the new left-bank to improve hydrologic connectivity between the new stream and the legacy floodplain. A similar bench, and a boulder sill, was established along the section of new right-bank upon backfilling of the old stream channel, against the base of the embankment escarpment.

Photo above shows the former right-bank escarpment back-filled and ground surface stabilized. The upper portion of the escarpment was left intact to sustain active nesting cavities for swallows. With the stream no longer undermining this embankment, we do not expect any significant soil loss or slumping.

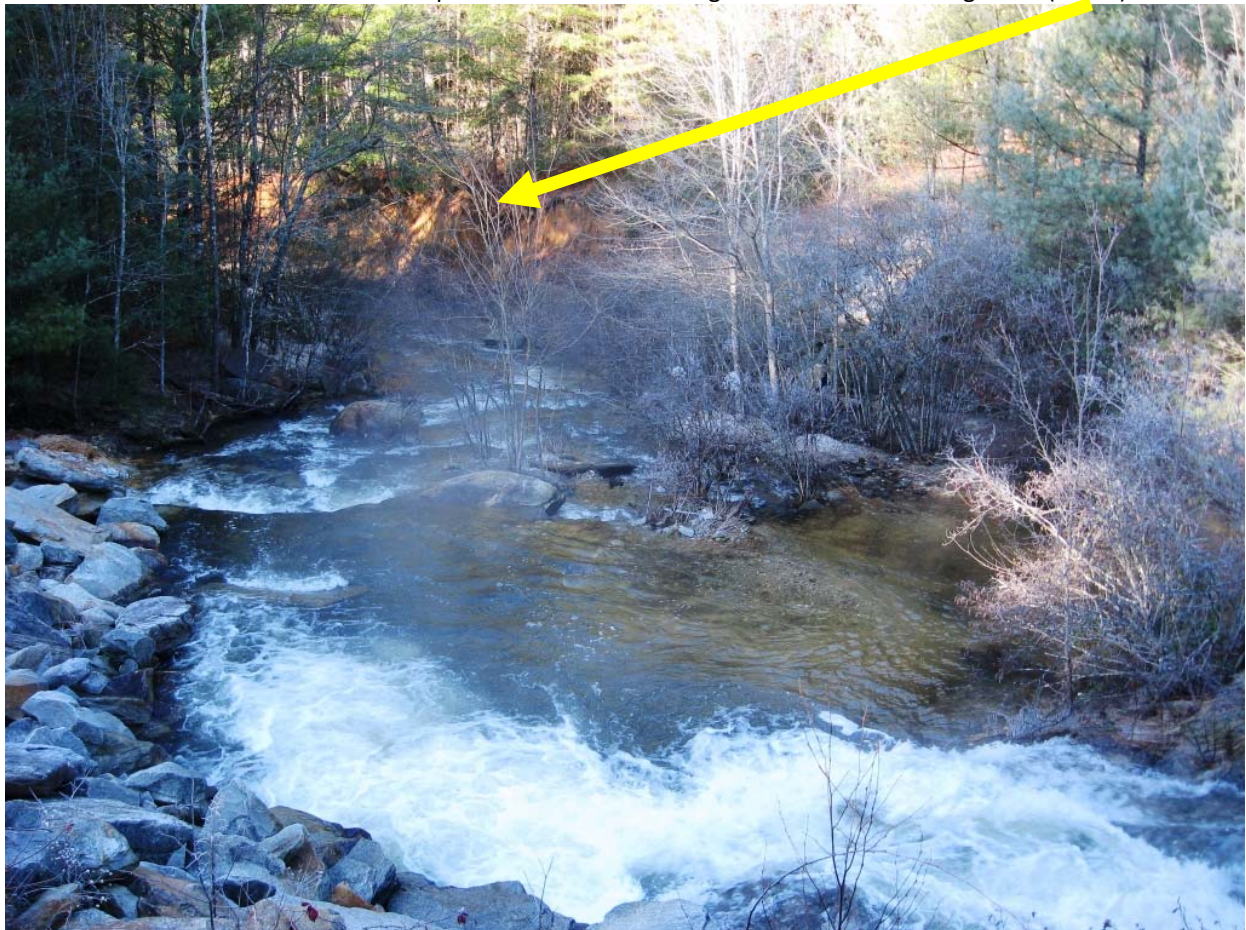
Photo above taken Sept.2009 showing close-up of escarpment. Photo below from Dec.2010, taken from the bridge on Conservation Road. The escarpment can be seen through the trees in the background (arrow).

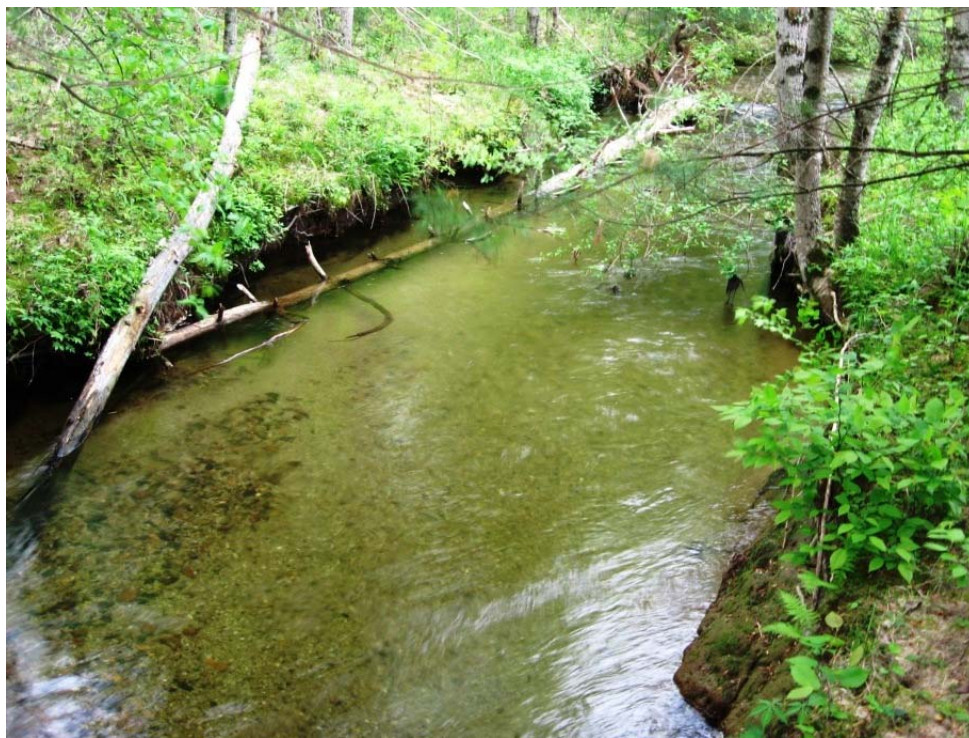
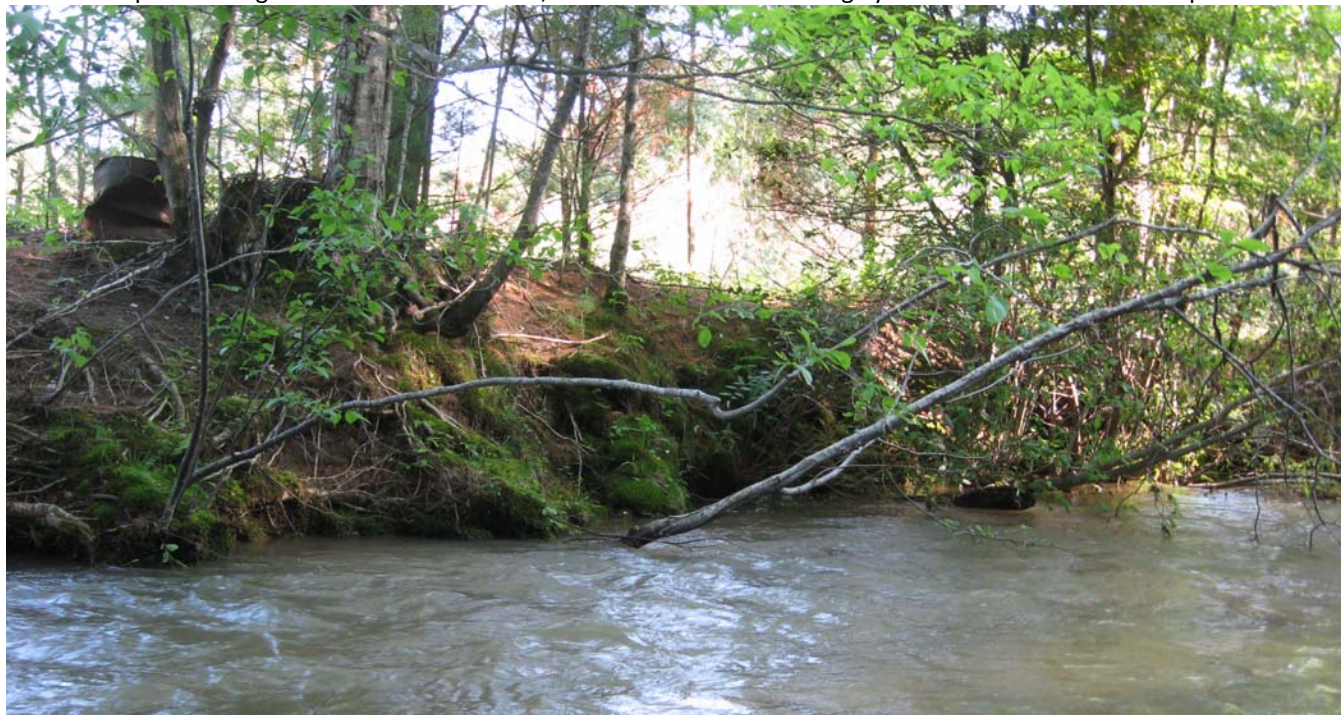
In addition to the concerns of the unstable embankment, the outfall stream had limited functionality to support aquatic organisms and fish due to a lack of in-channel woody debris, deep pools, or cobble substrate. The outfall was functioning much like a ditch, with a heavily silted substrate, incised channel banks, and was disconnected from its floodplain area.

Both photos taken May 2011. Above shows a typical pattern of the stream: somewhat incised banks, silted substrate, and lack of pools. Below shows left-bank of the stream. Sediment deposition did occur at places along both sides of this stream, but the stream was still largely disconnected from its floodplain.

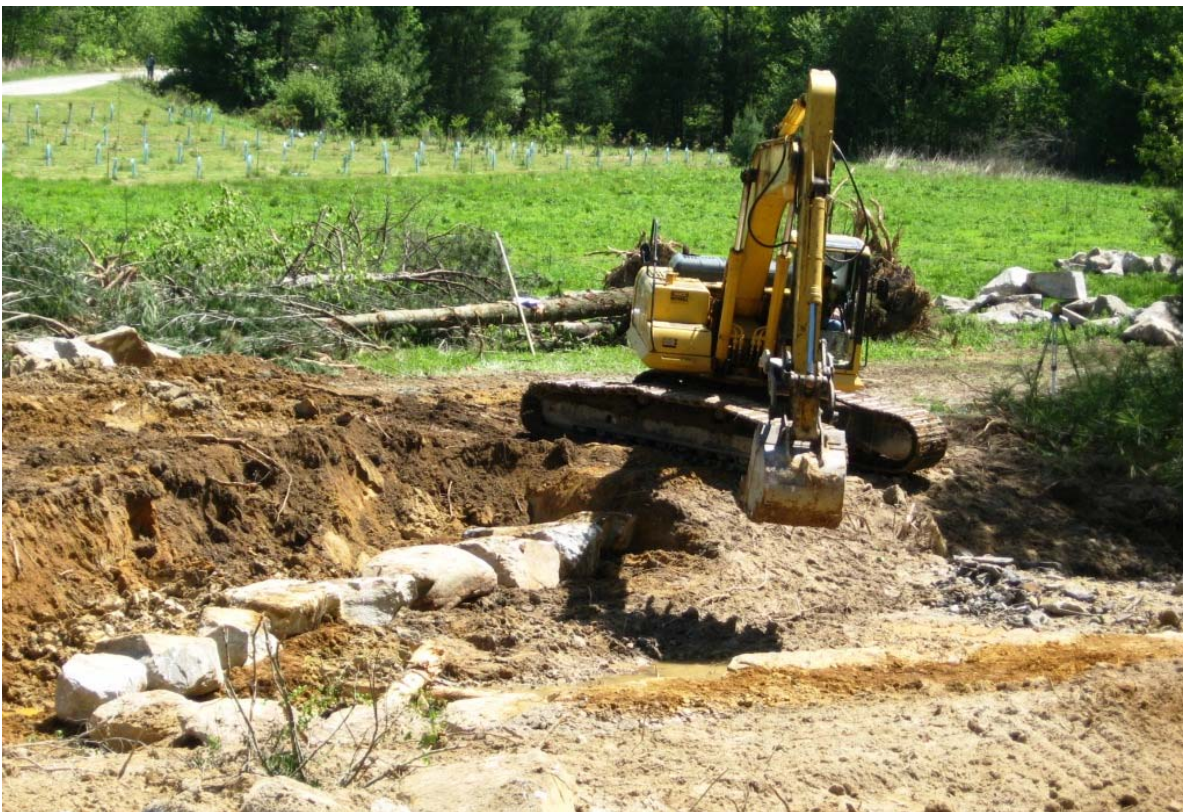
Photo above showing construction of one of the rock vanes. The new channel is situated in the legacy floodplain area.

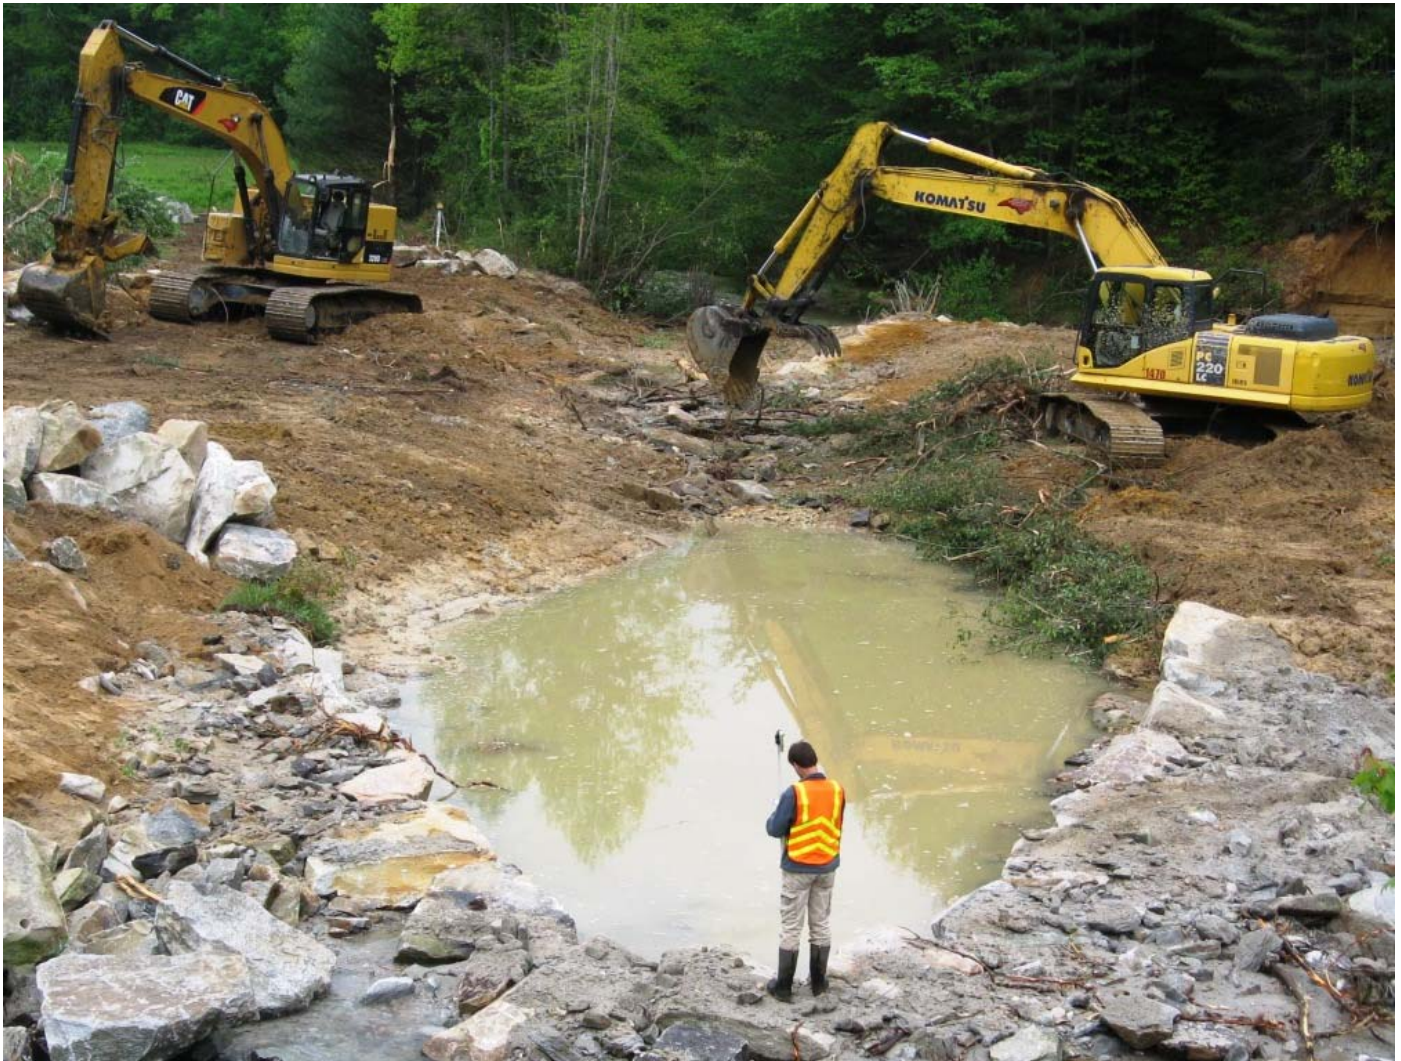
Photo above taken from the Conservation Road bridge during construction. Seen in the photo is the first large boulder vane immediately downstream from the bridge. Also note the bundles of small vegetation installed along the right bank to incorporate organic matter. The excavator on right is establishing a riffle segment.

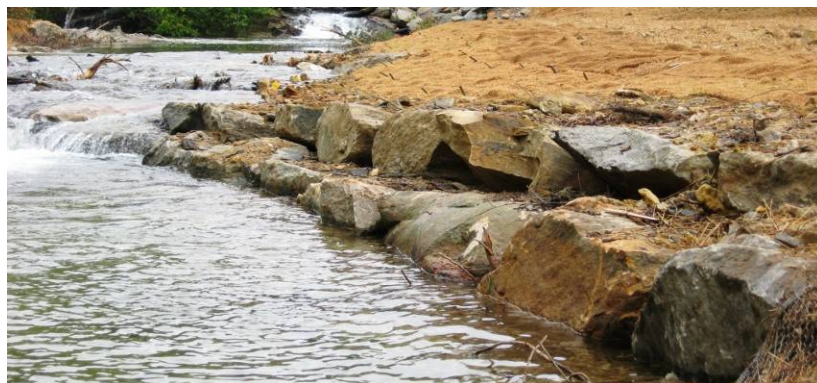
Photo above shows close-up of one rock/boulder vane arm on the new left-bank.

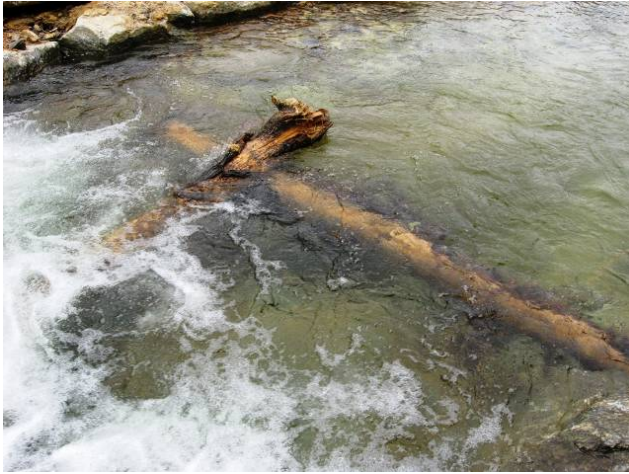
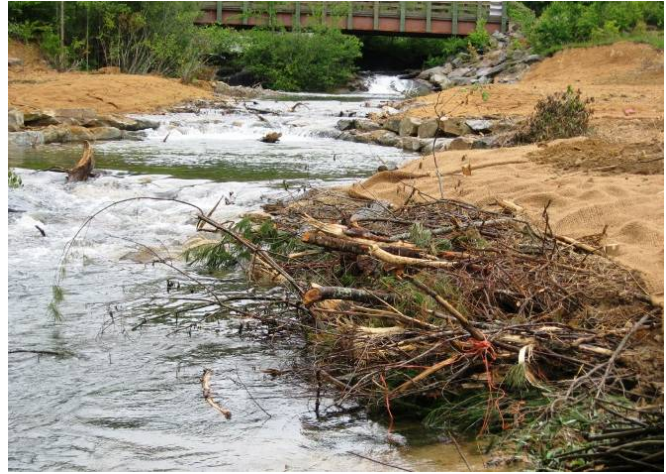
Photos above show close-up of woody material that was incorporated into the design.  
Top-Left: A log X-vane was installed within one of the pools, below a rock/boulder vane structure.  
Top-Right: Bundles of small woody material were partially buried in sections of the new streambank.

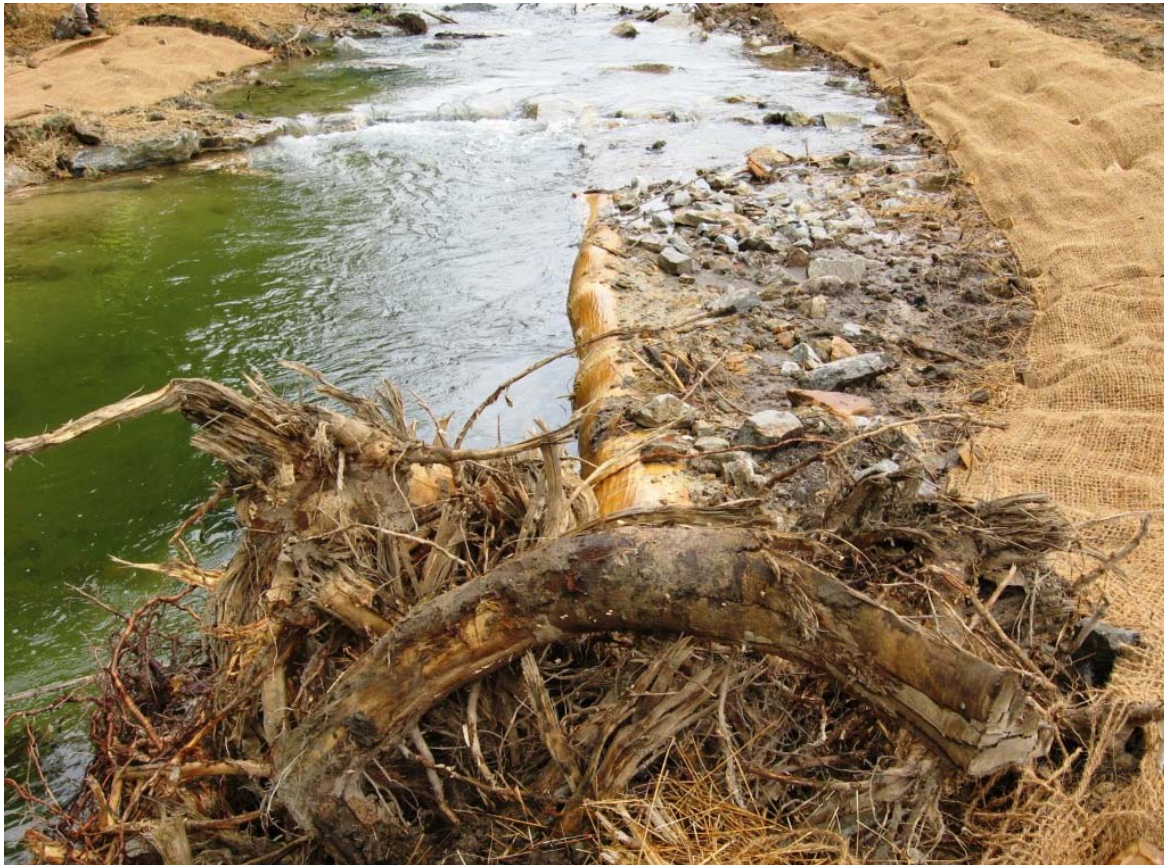
Photo above shows a log vane with attached rootwad installed along new left-bank.

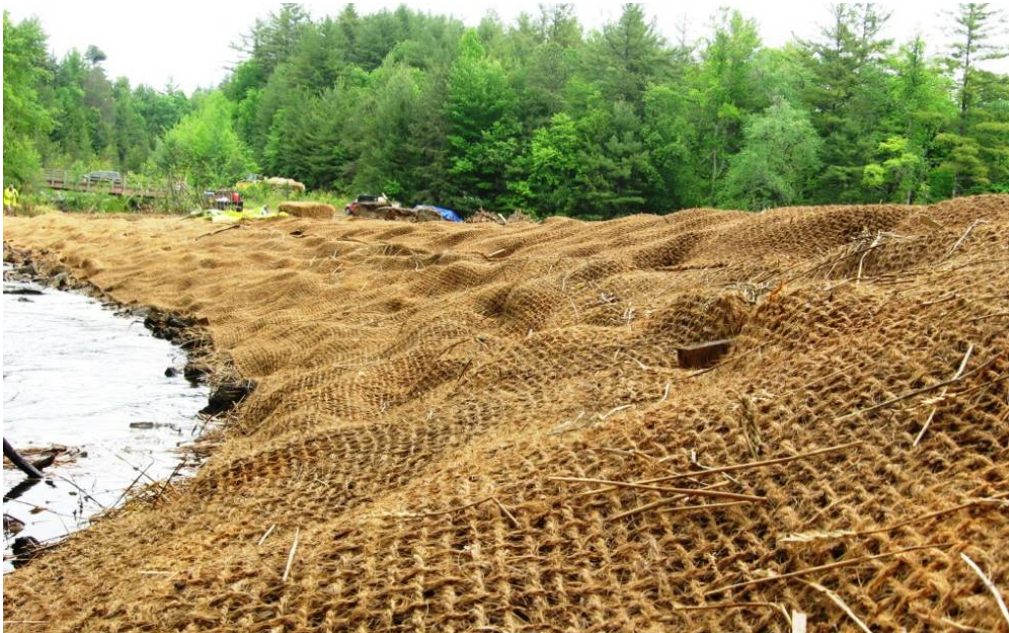
Photo above shows the new slope gradient along the left-bank, to improve the hydrologic connectivity to the floodplain.

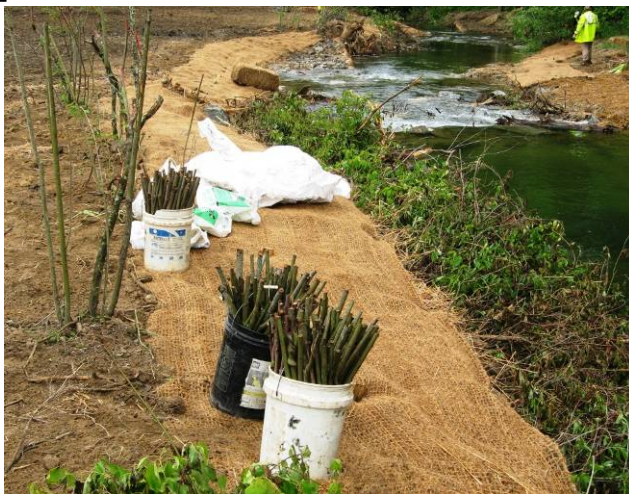
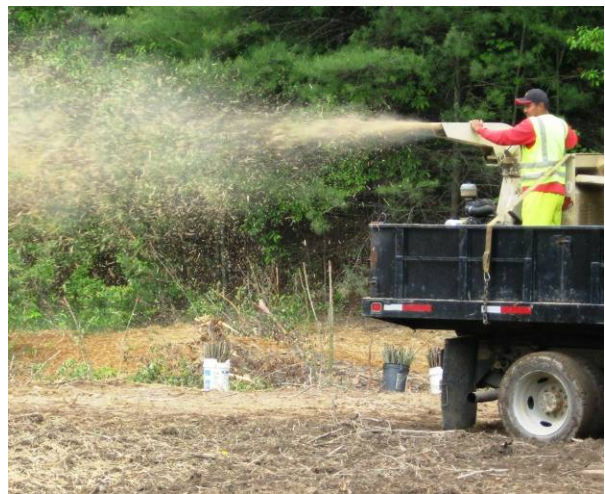
Photos above show steps taken for streambank and groundcover stabilization. Top-Left: Live stakes to be installed, and coir matting already installed. Top-Right: Straw is blown across the area after grass seed has been applied.

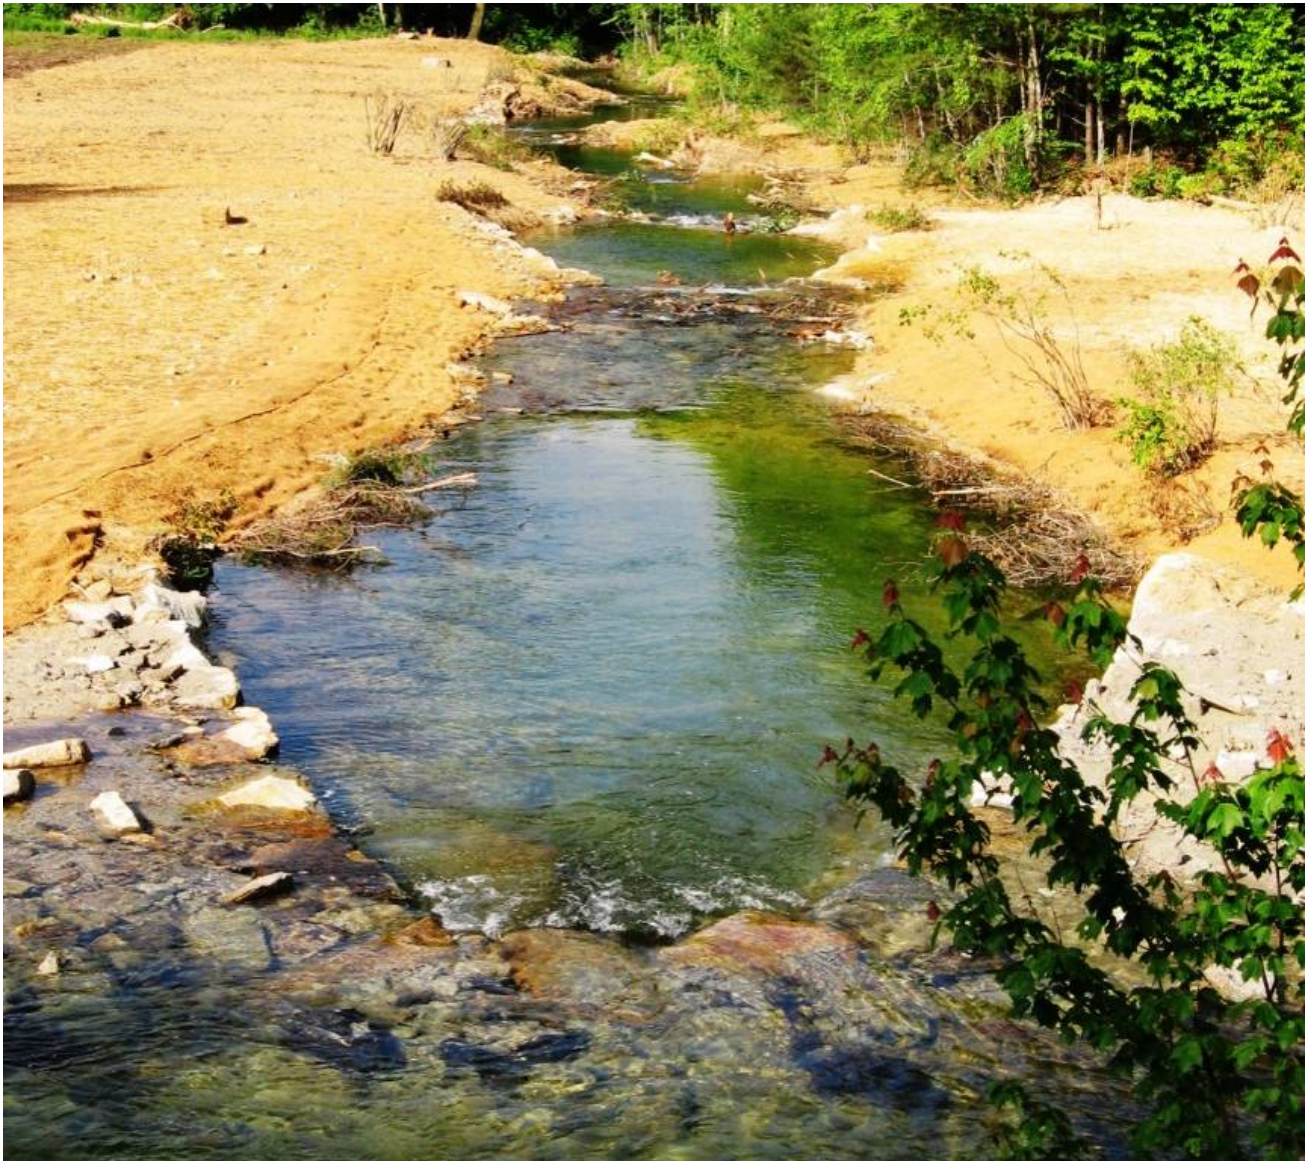
Photo above showing completed restoration work, view from the Conservation Road bridge. Soil surface on either side of the new stream channel has been covered with seed and straw.
