Stream Restoration Post-Implementation Annual Monitoring Report

Year 2: 2013

Project #10-0493:

“DuPont State Forest Lake Julia Outfall Stream Restoration”

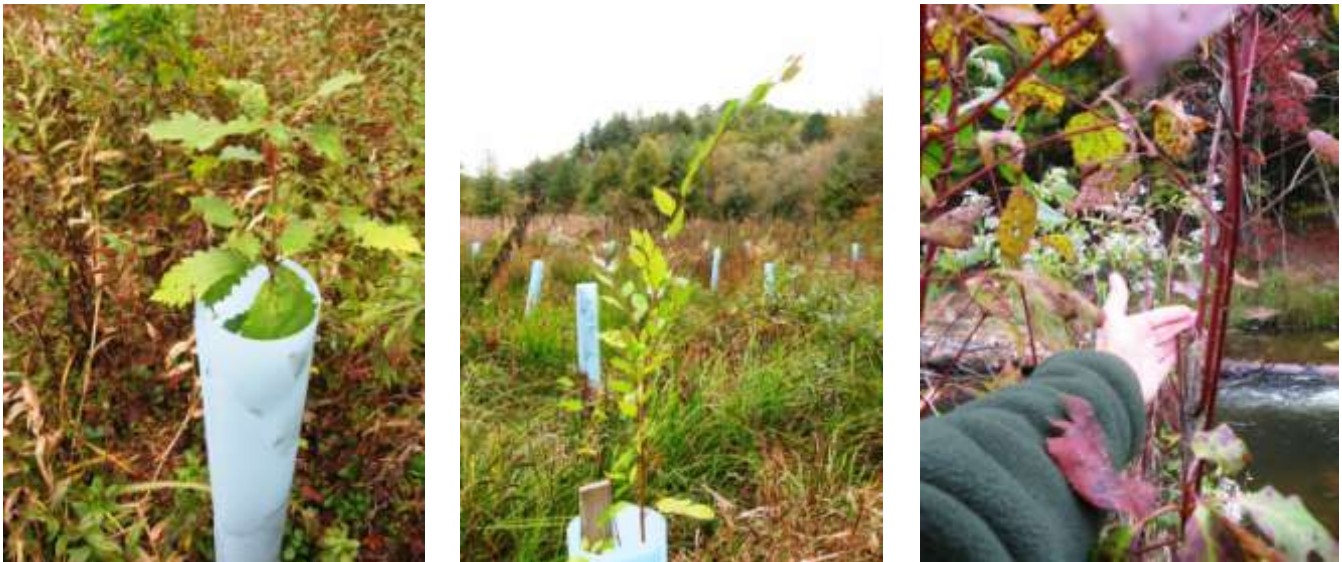
Photos above from October 2012 after one growing season.
Left, swamp chestnut oak. Center, river birch. Right, new sprouts on transplanted salvaged alder shrub.

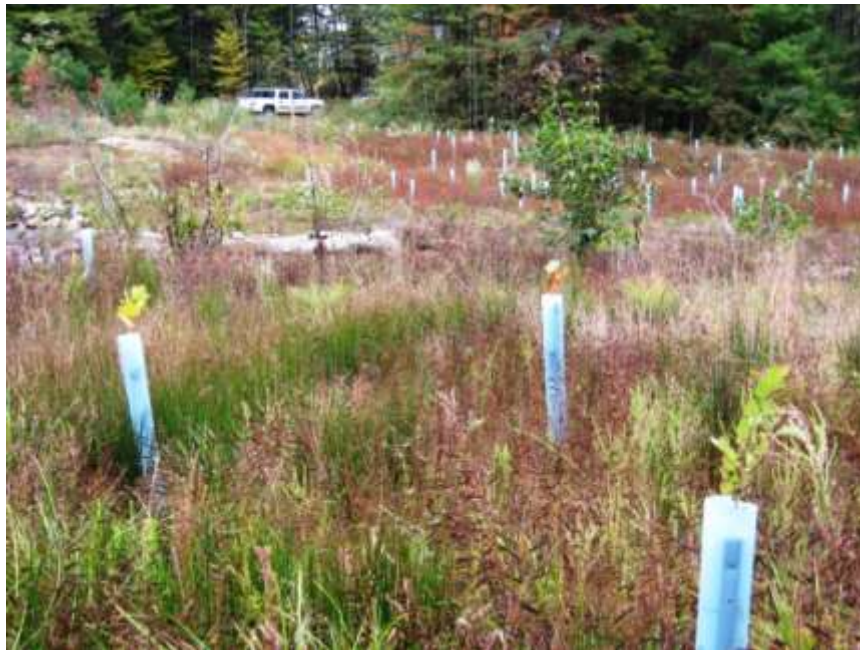
Photo from October 2012, showing colonization of the upper restored area with native vegetation, emerging growth of planted seedlings, and re-sprouting of transplanted shrubs along the stream.

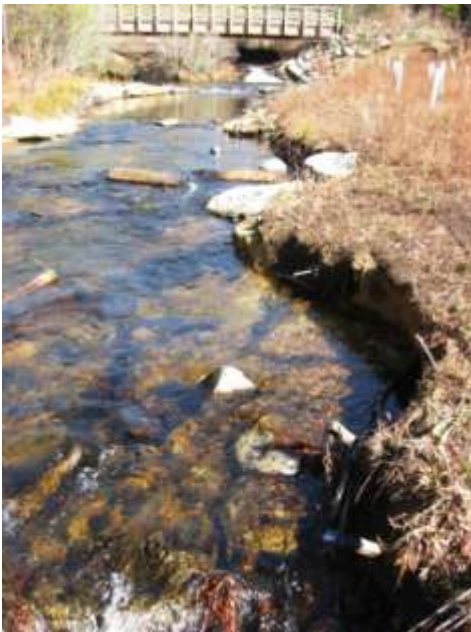
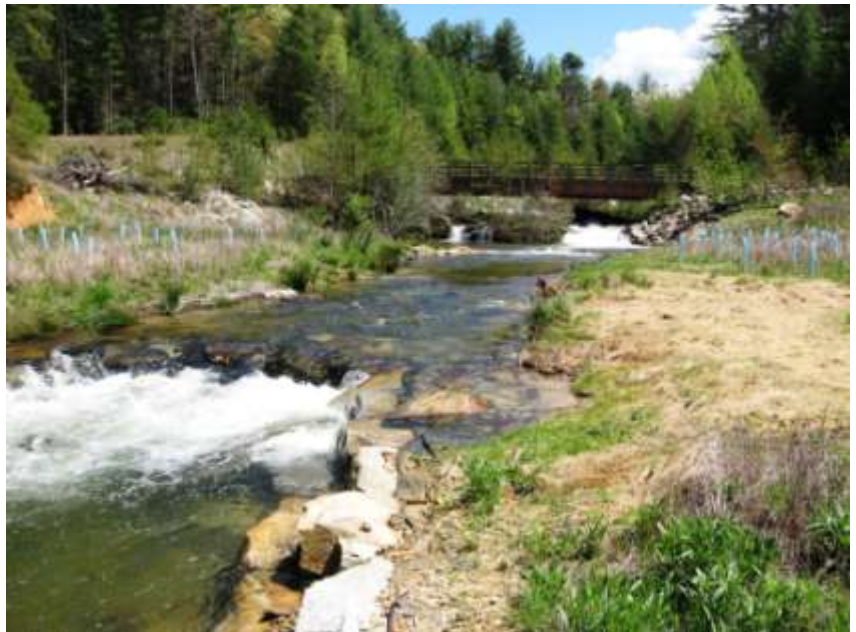
First documented in late 2012, about 50 feet of left bank had been scoured and washed away during high flow events. In April 2013, the restoration engineer and contractor both returned to the site and completed warranty repair work to restore the left bank and partially re-construct an arm of the boulder vane, while also reducing the slope angle of the embankment, thereby allowing high streamflow water to more easily connect with the adjoining riparian floodplain.

*Photo above left in November 2012 looking downstream, shows scouring of the left bank.
Photo above right in May 2013 looking upstream at the same location, after repair work was completed.*

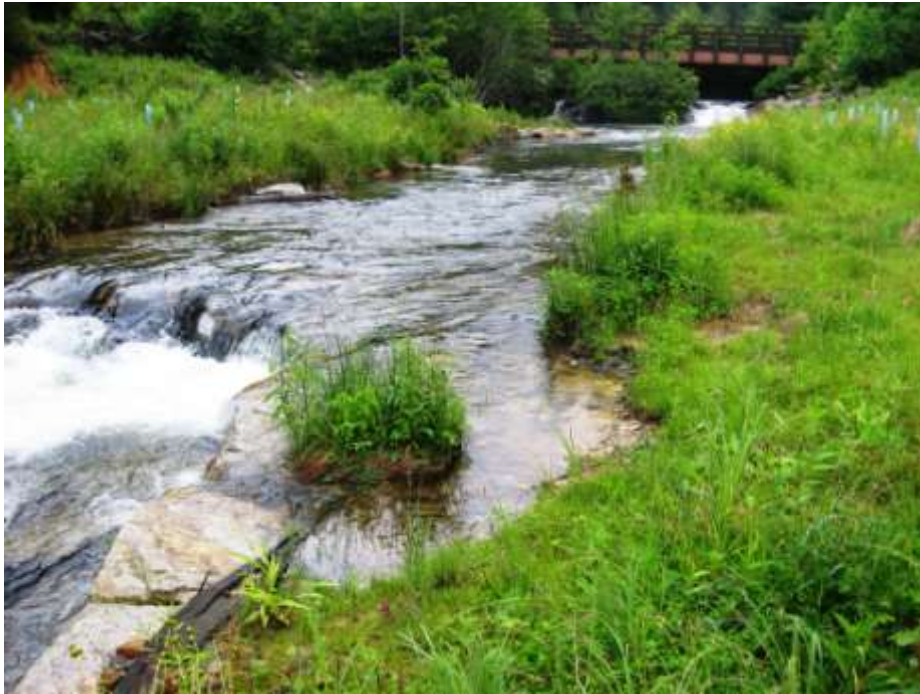
Photo above in July 2013: The stream repair has stabilized and vegetation is re-colonizing the area. The stream flow seen here is near bankfull after steady, heavy rains in the region over a period of days in late June and early July.

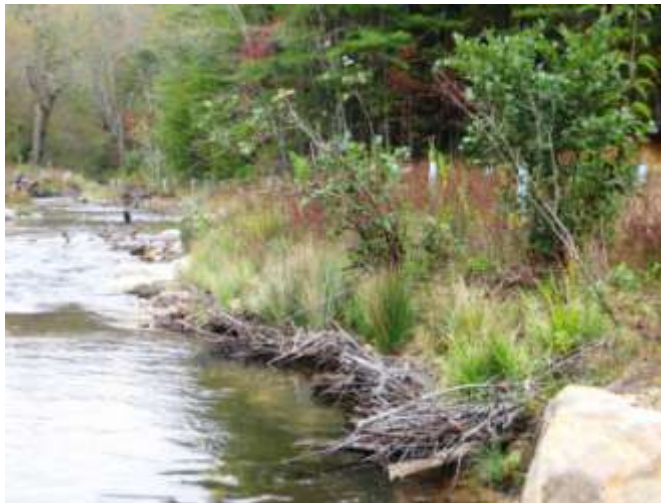
Photo Above, October 2012: Brush toe material on right bank that was installed during restoration is intact, providing habitat cover and bank stability.

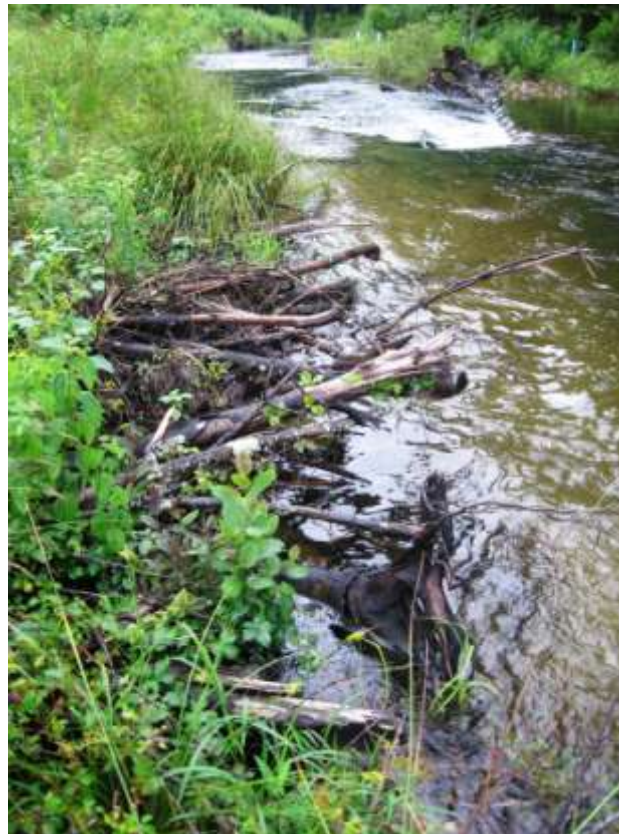
Photo Right, July 2013: Brush toe material on left bank remains intact and functioning, seen here at bankfull, or near bankfull.

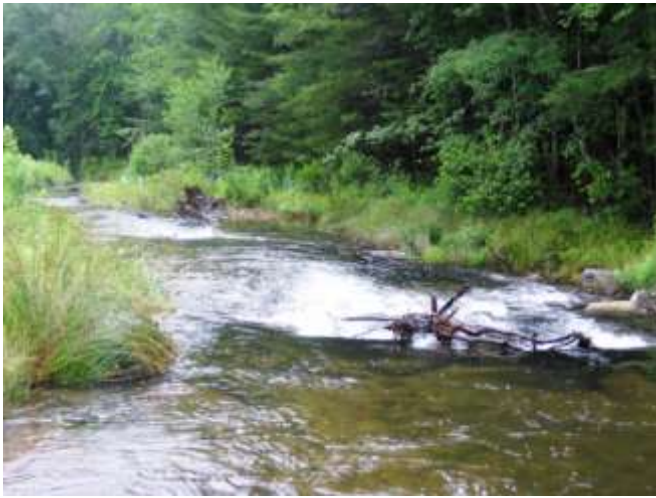
Photo Above Left, July 2013: Two vane structures functioning, with woody debris collected in the foreground.

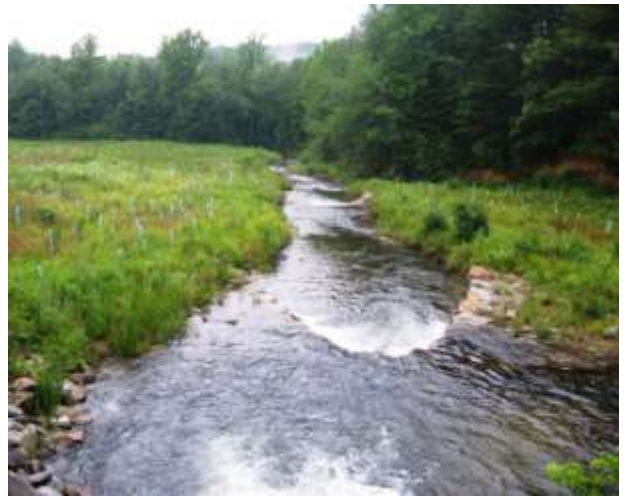
Photo Above Right, July 2013: Overview of restoration from the forest road bridge.

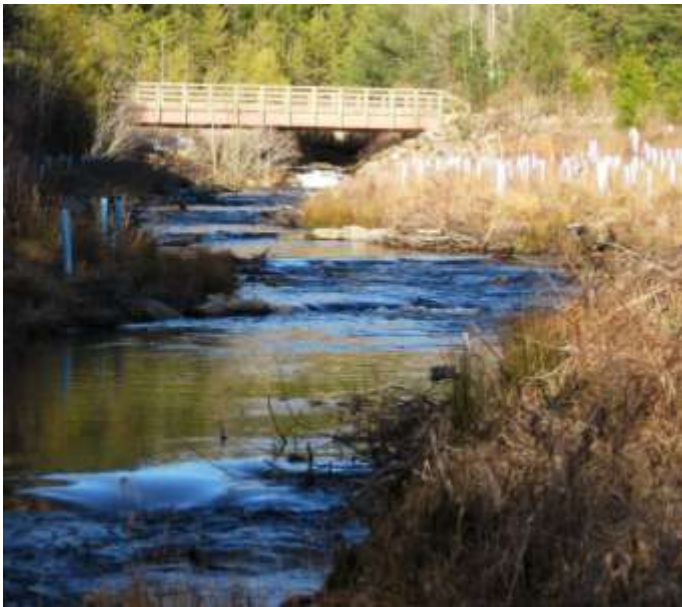
Photo Above, February 2013: View looking upstream from near the end of the restoration project.

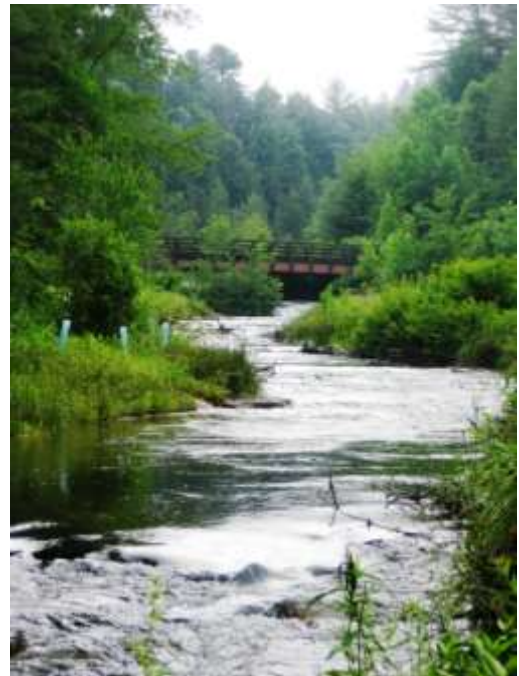
Photo Above, July 2013: Photo from same vantage point, with stream at or near bankfull stage.
