APPENDIX F

Area of Concern Assessments

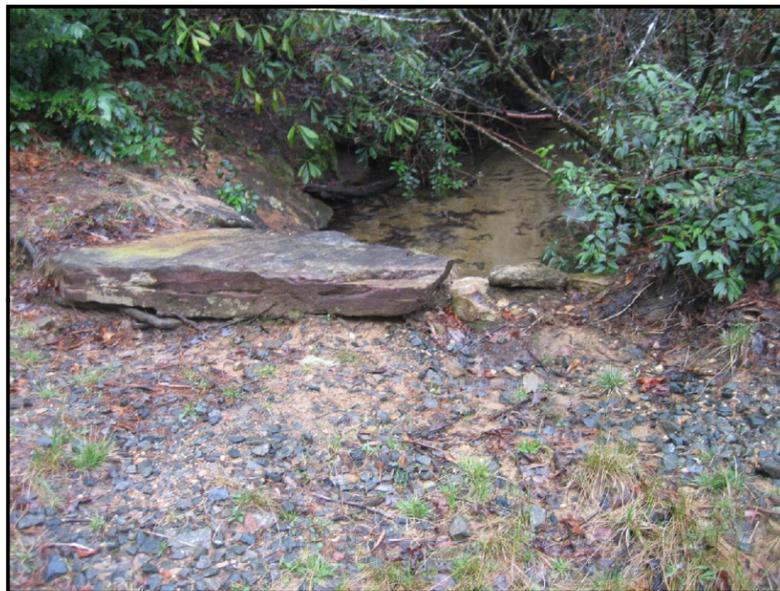
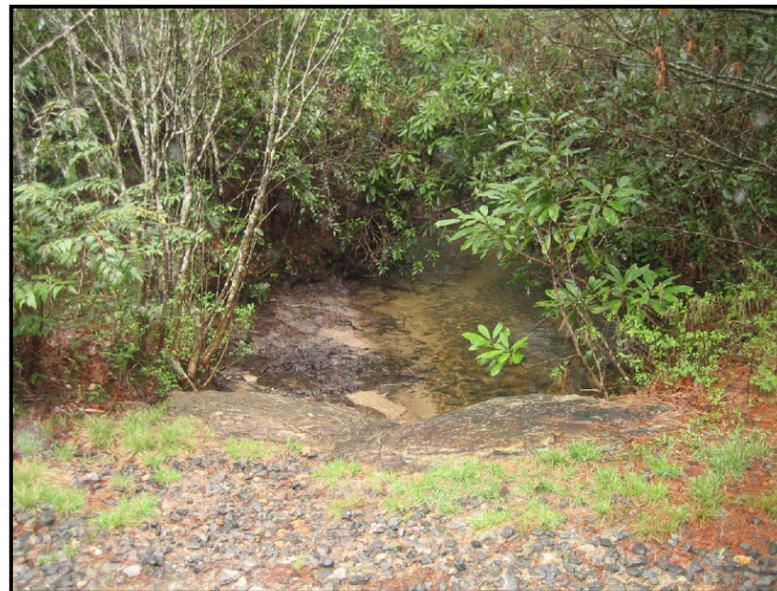
Minor sediment/ stormwater input to stream at trail crossing – install vegetation and/ or regrade trail for improvement.

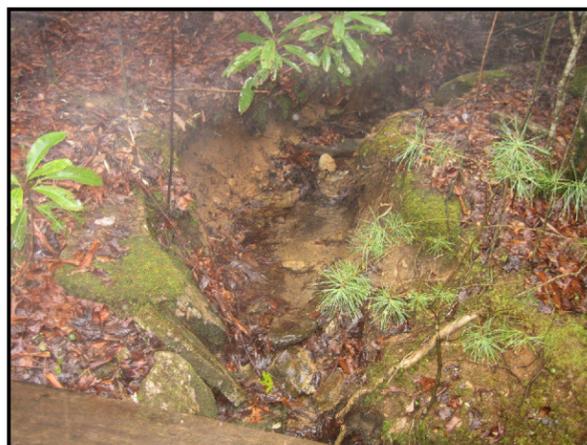
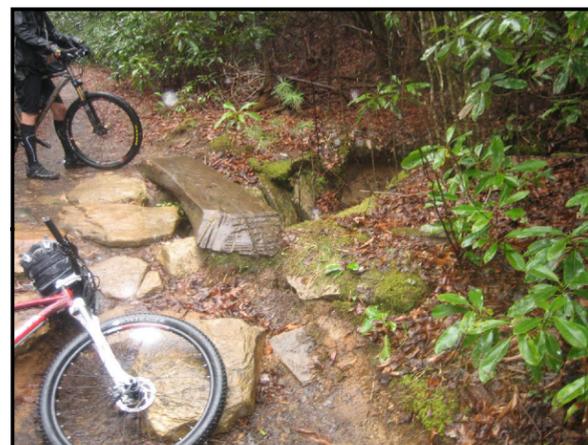
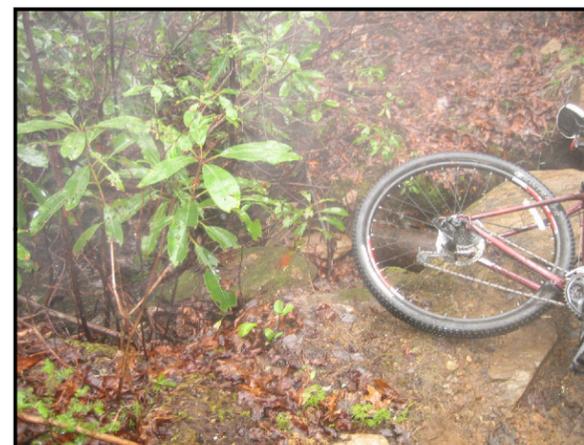
Stream banks eroded upstream/ downstream of culvert. Trail currently intact.

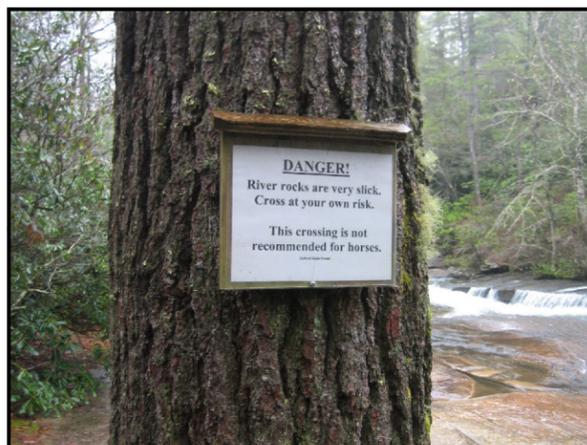
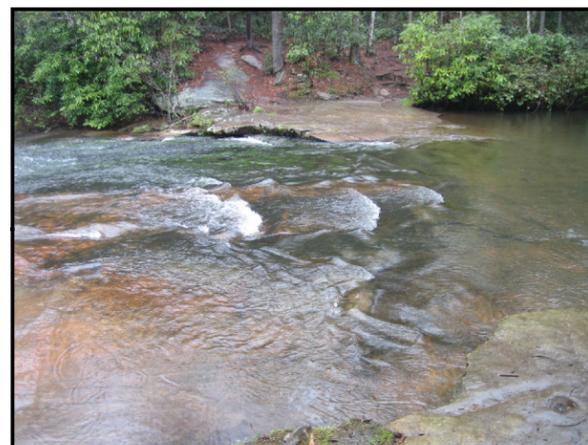
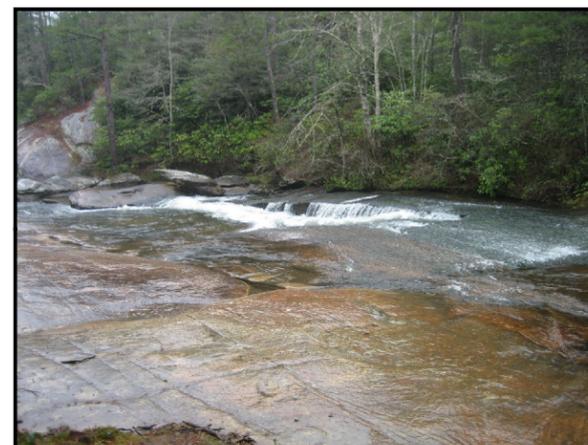
Comments
 Trail over widened and missing vegetation in vicinity of crossing. Actual crossing stable due to bedrock in riverbed.

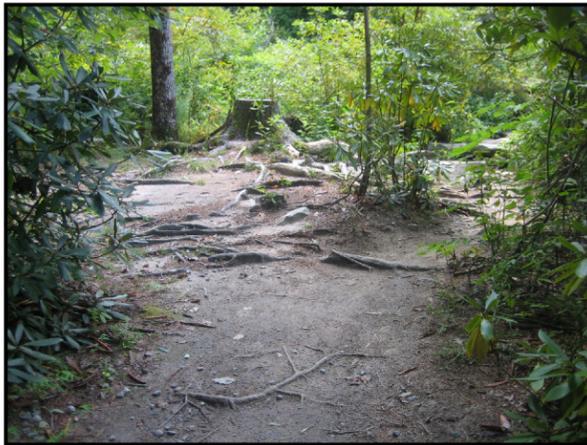
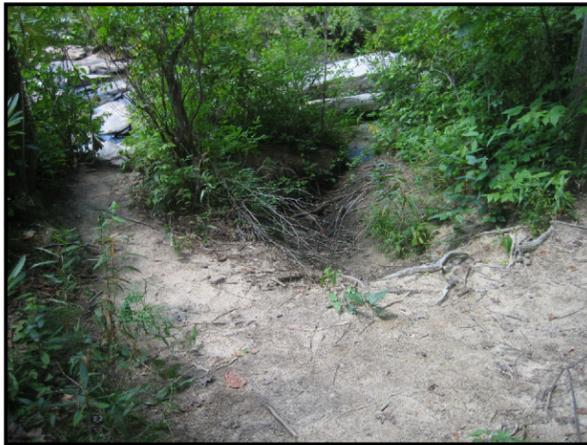
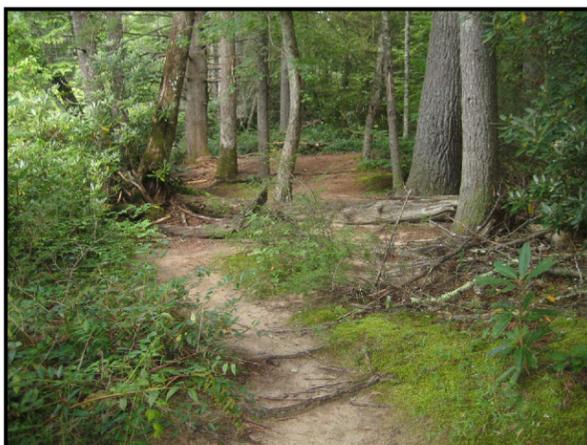
Culvert appears to be in good condition, though perched at downstream end. Trail serves as sediment source to stream, with sediment traps full.

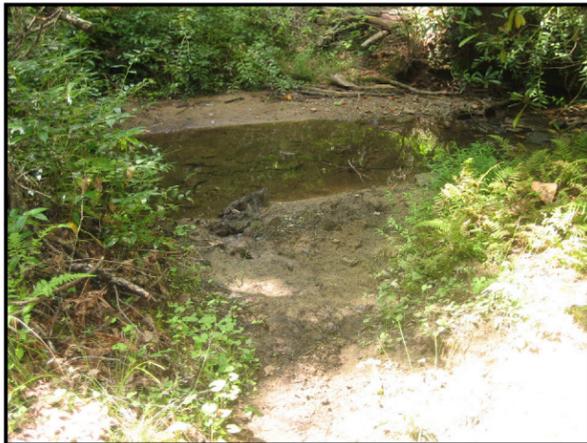
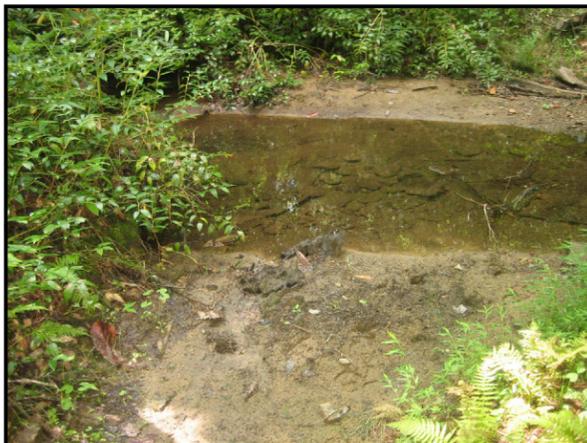
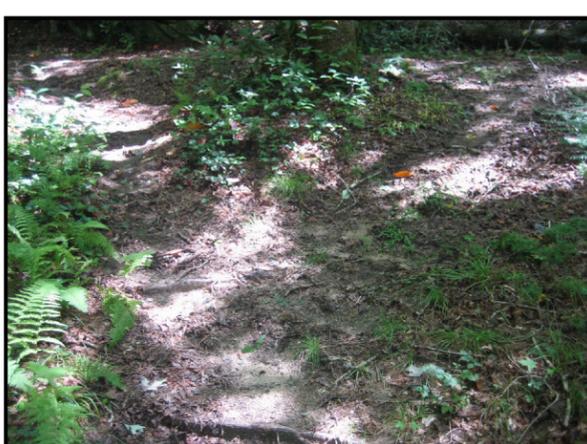
Comments
 Culvert exists and appears to be in good condition. Bare area between trail and stream caused/ exacerbated by human access and stormwater.

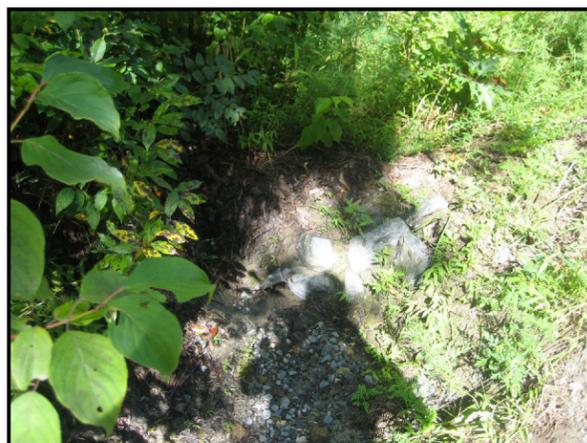
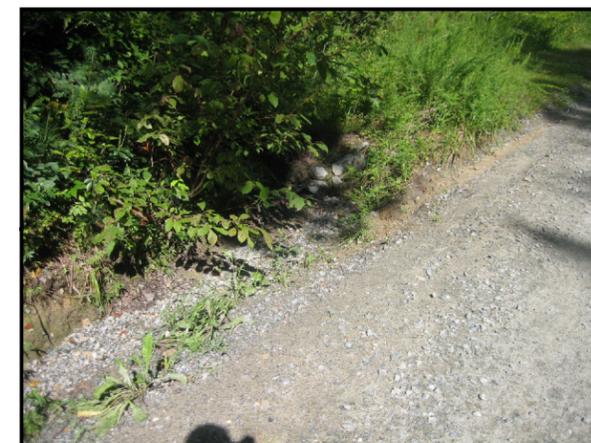
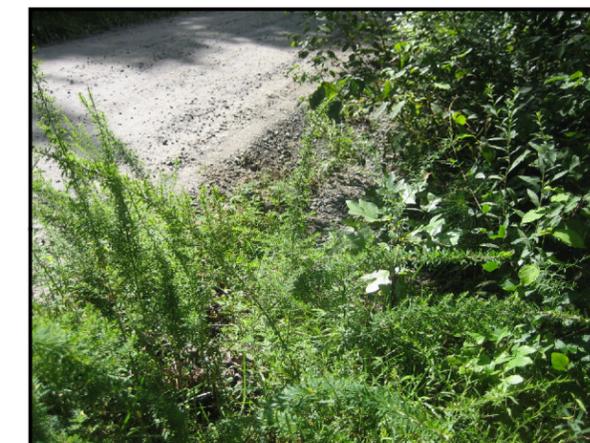
Comments
 Culvert under Plantation Trail filled with road sediment and perhaps crushed.

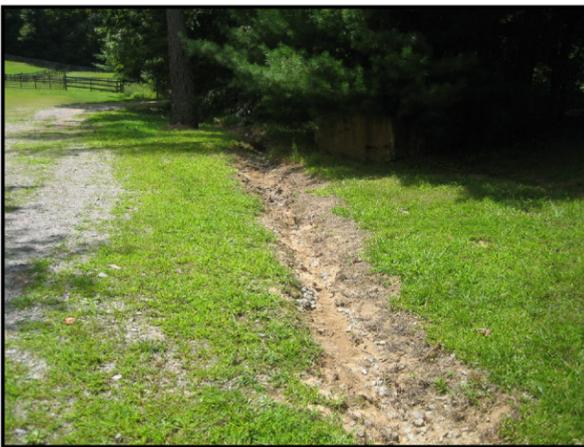
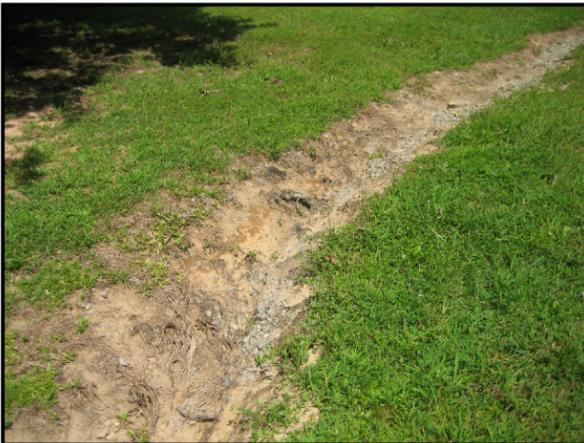
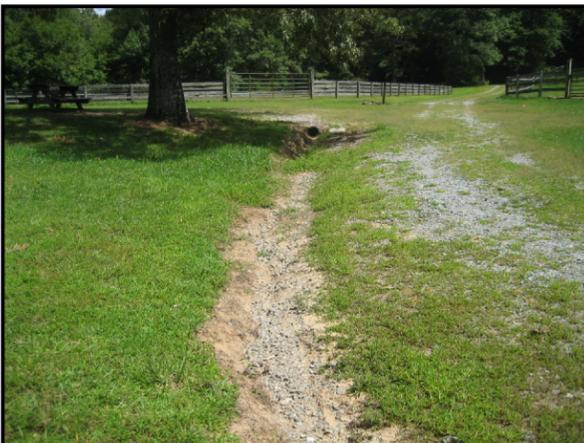
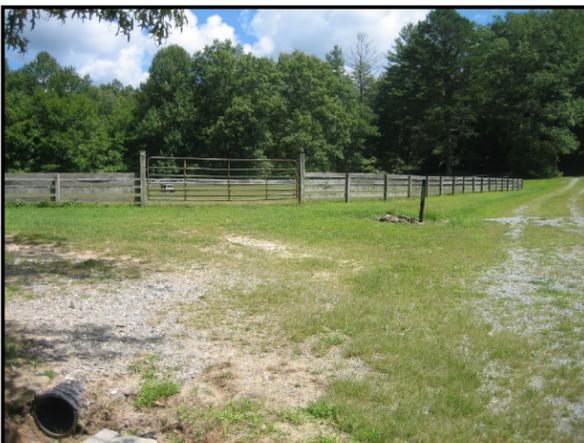
Comments
 Trail crossing serves as source of fine sediment. Head-cut downstream of trail may threaten trail and/ or be safety hazard in the future. Potentially install bridge. Culvert and stabilize head-cut.
