Water Resources Restoration Master Plan

DuPont State Recreational Forest
North Carolina

Prepared for:
North Carolina Forest Service

November 9, 2015

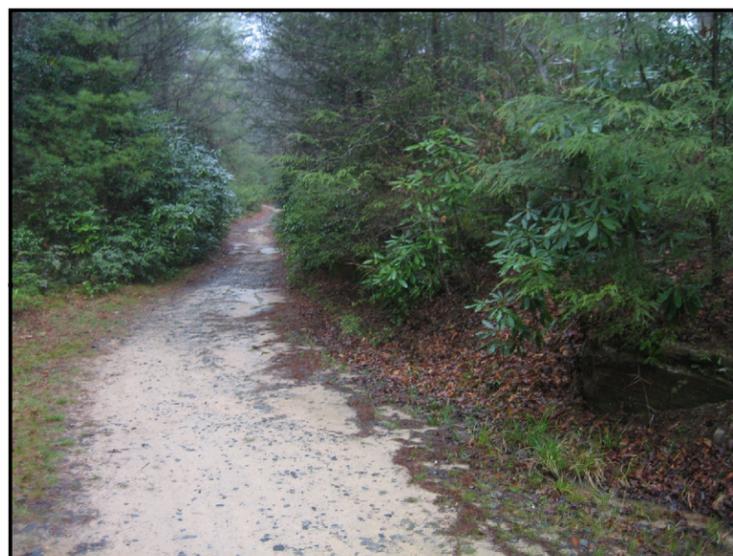
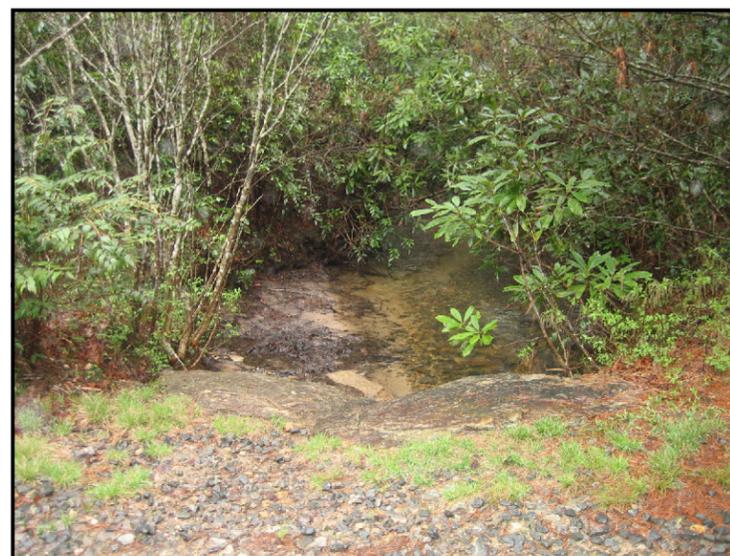
Stream Condition – Site: S01

See also P07; Corn Mill Shoals Trail in buffer, providing sediment/ stormwater source.

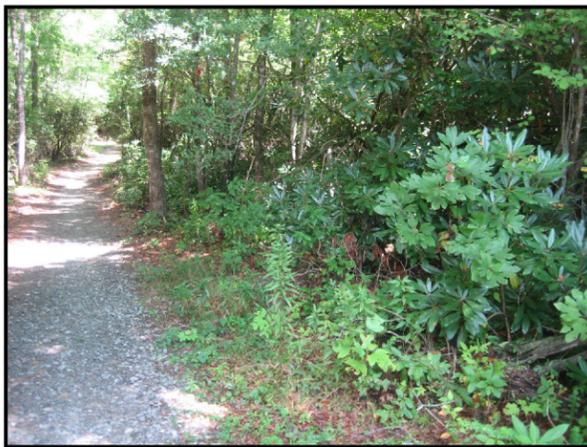
Stream Condition – Site: S02

Comments
 Trail (both open and closed – though still used) in buffer. Trails provide sediment source and restrict buffer vegetation. Lengthy powerline crossing affects buffer.

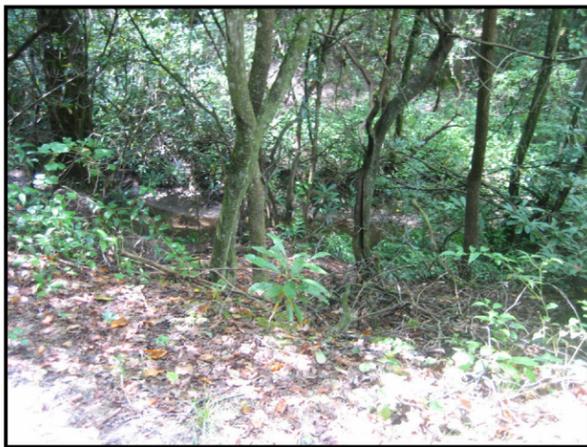
Stream Condition – Site: S03

Trail in buffer with sediment/ stormwater runoff from trail directed to stream. Upland crosion from power line crossing is also sediment source.

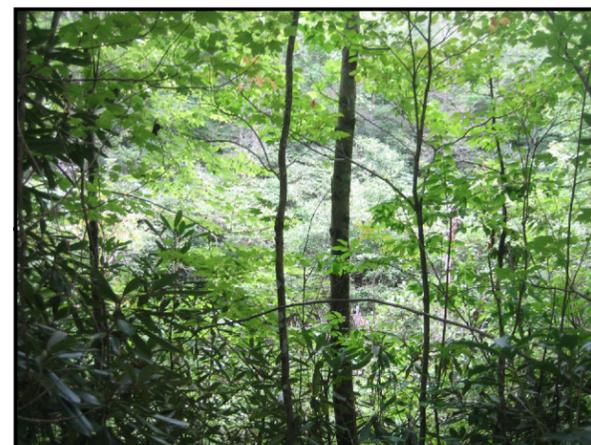
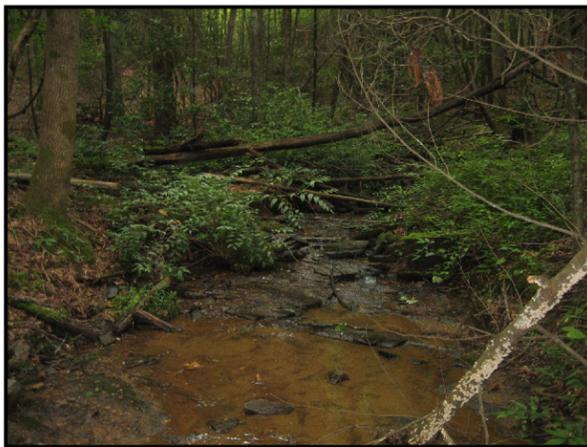
Stream Condition – Site: S05

Culvert clogged upstream of Conservation Road, creating large area of backwater in channel; woody vegetation has died as a result.

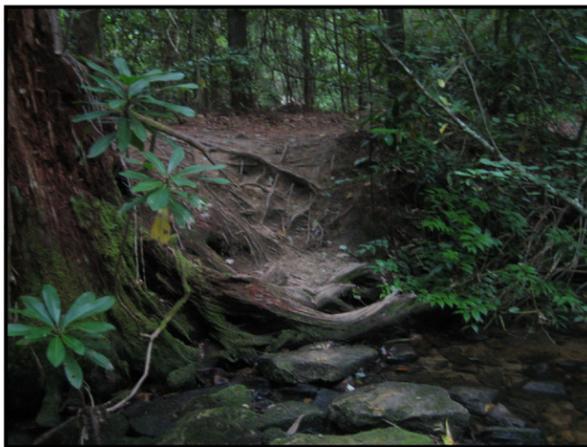
Stream Condition – Site: S06

Eroding left bank just downstream of bedrock grade control, fine sediment deposition in channel; trail near channel serves as sediment source.

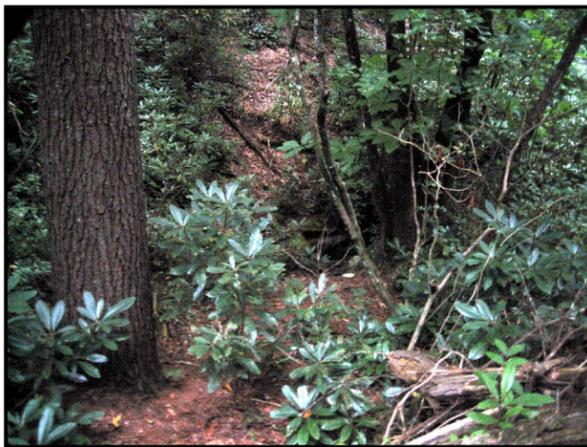
Stream Condition – Site: S07

Trail in buffer with unstable crossing (croding banks, overwide channel, sediment deposition).

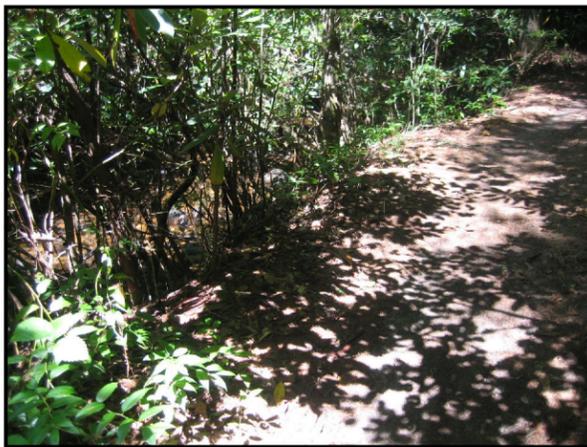
Stream Condition – Site: S09

Comments
Trail crossing stable. However, trail in buffer with minor stream bank erosion.

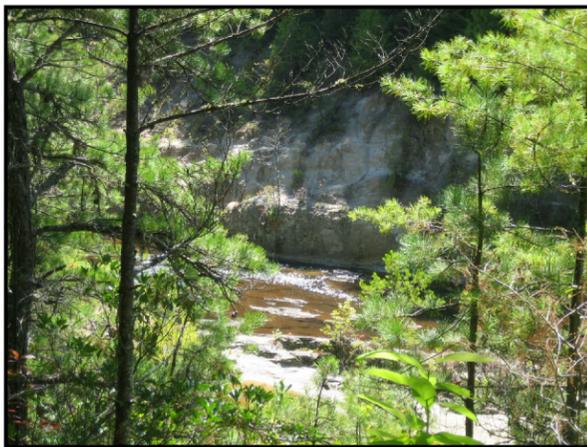
Stream Condition – Site: S10

Stream generally stable, though trail and levee in buffer are detrimental.

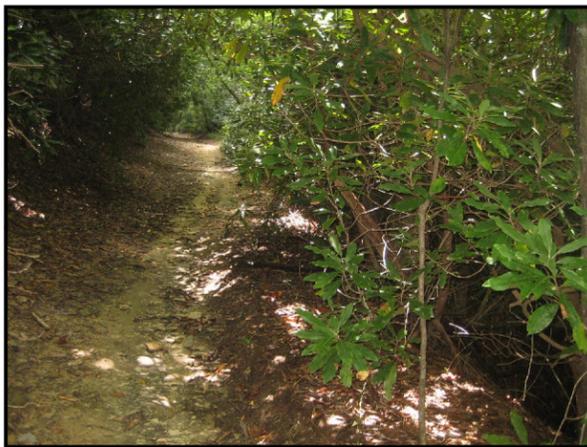
Stream Condition – Site: S12

Trail along river leads to sediment and stormwater input. Some croding banks and fine scdiment in river. BMPs exist on road, but require maintenance.

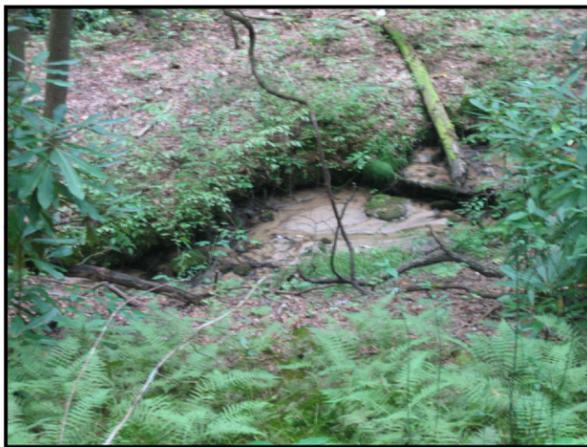
Stream Condition – Site: S14

Trail in buffer provides multiple sources of fine sediment, which is frequently evident in stream bed.

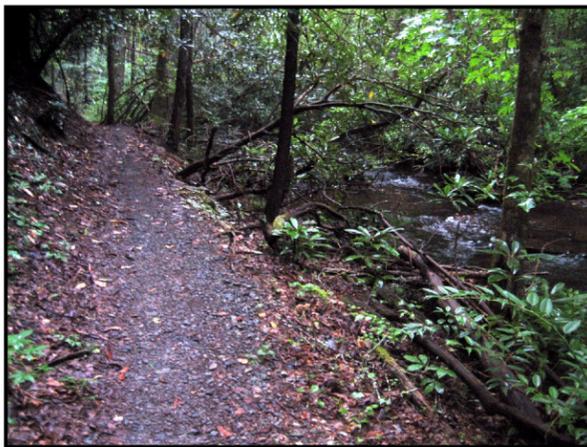
Stream Condition – Site: S15

Power line through watershed, trail and old road/ trail in buffer. Head-cut at top of reach, some bank erosion throughout reach.

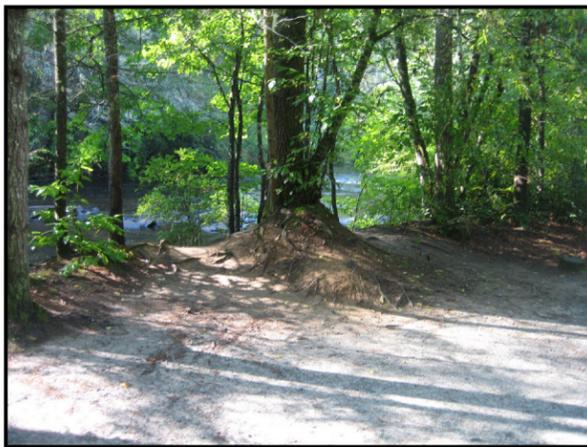
Stream Condition – Site: S16

Trail within buffer, resulting in reduced vegetation and sediment input.

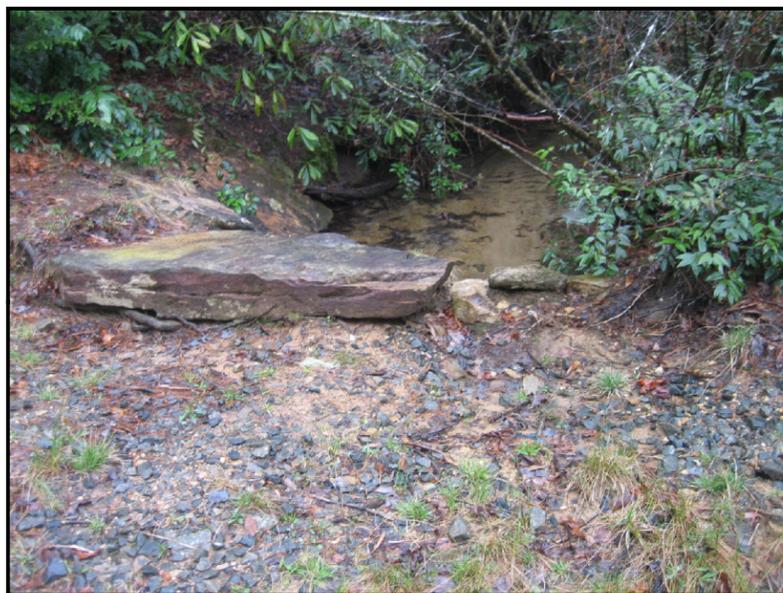
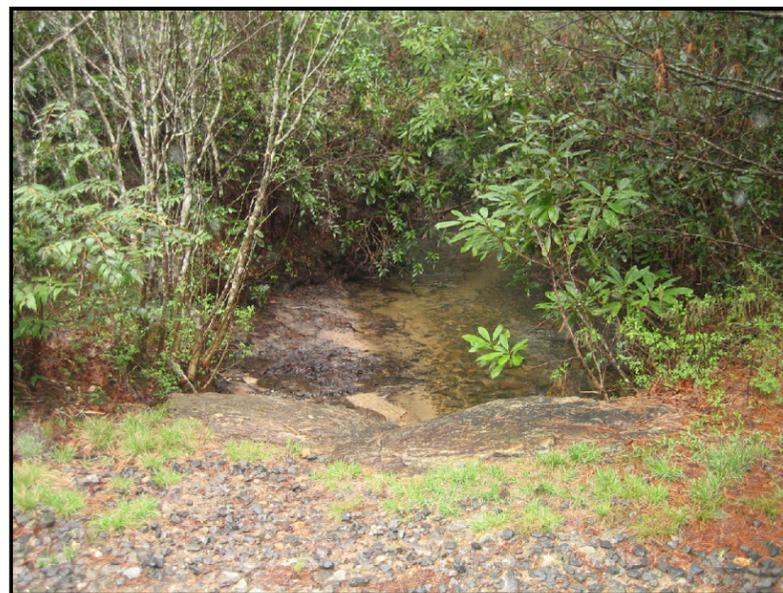
Comments
 Minor sediment/ stormwater input to stream at trail crossing – install vegetation and/ or regrade trail for improvement.

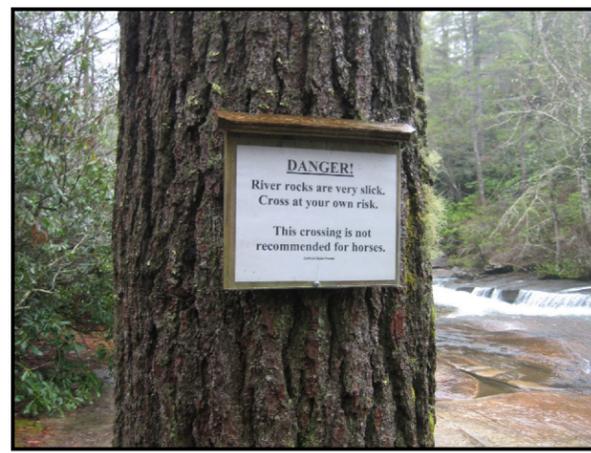
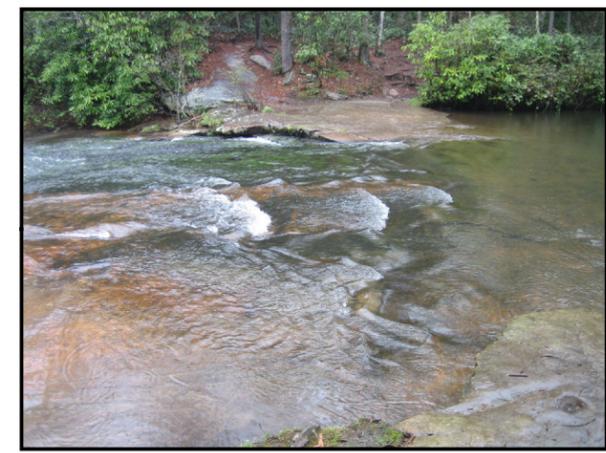
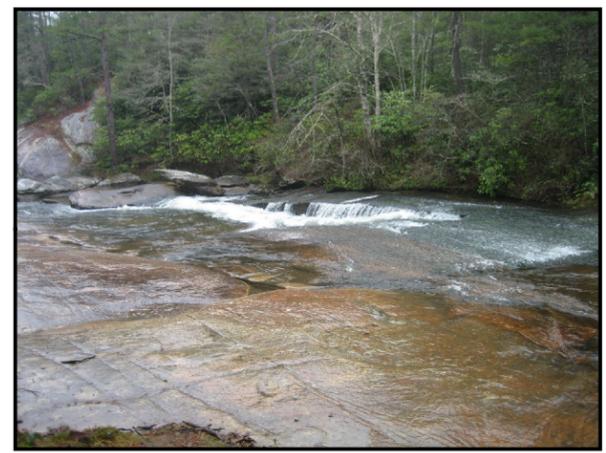
Area of Concern – Site: P11

Comments
 Trail over widened and missing vegetation in vicinity of crossing. Actual crossing stable due to bedrock in riverbed.

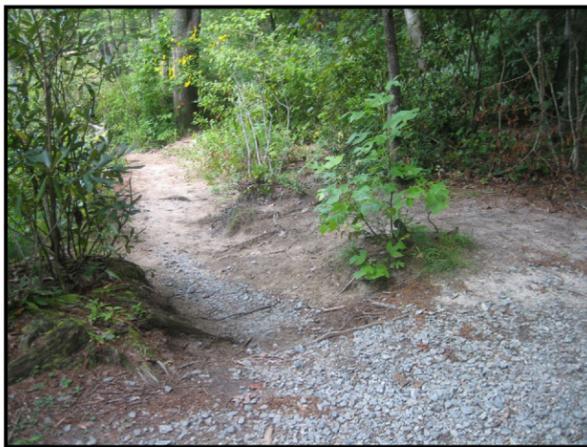
Area of Concern – Site: P12

Culvert appears to be in good condition, though perched at downstream end. Trail serves as sediment source to stream, with sediment traps full.

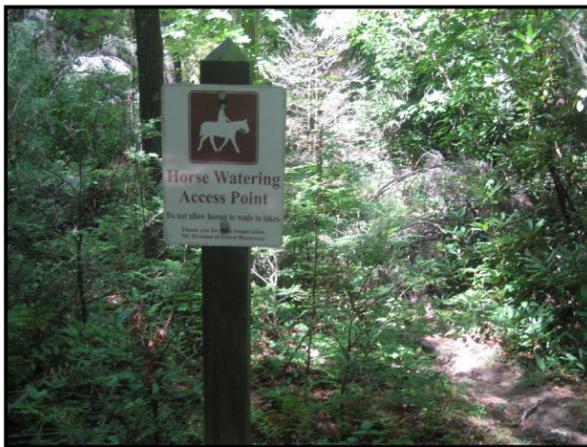
Area of Concern – Site: P14

Comments
 Culvert exists and appears to be in good condition. Bare area between trail and stream caused/ exacerbated by human access and stormwater.

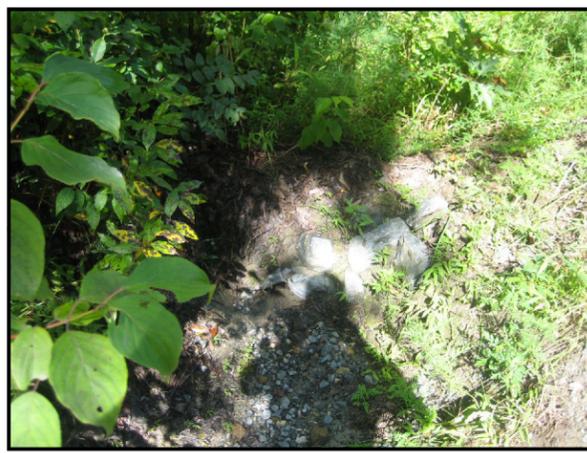
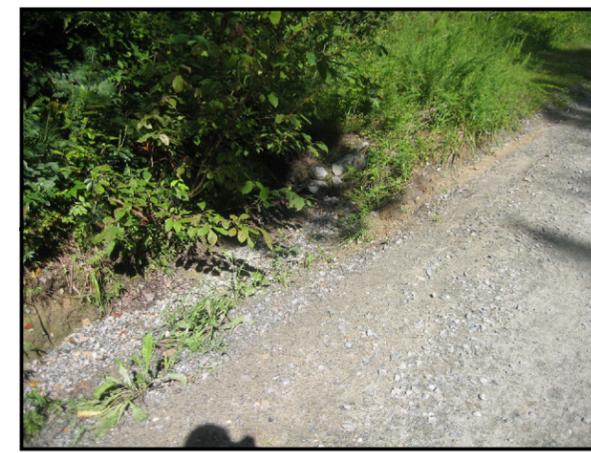
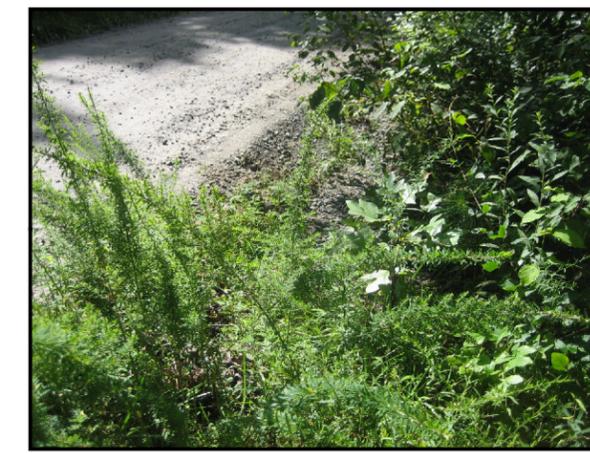
Comments
 Culvert under Plantation Trail filled with road sediment and perhaps crushed.
