Map Grid Location: **D9** Site visit date/ team): 4/13/15/ BK, JZ Drainage Area (Sq. Mi.): < 0.1 Name & Location: Drainage across Little River Trail 1. Culvert (diameter/material/length): Daquatic organism passage/ perched □clogged □crushed □erosion (upstream/ downstream) □piping □lack of natural bed □safety hazard □overtopping 2. Trail/ Road Impact (trail/ road name): Little River Trail □stormwater input ⊠sediment input □bridge □utilities ⊠unstable trail crossing ⊠erosion □safety hazard ⊠human impact (hiking/biking) ☐missing vegetation □equine/dog impacts 3. Upland/Stormwater □nonpoint source pollution □upland erosion □unvegetated upland area □pollutant point source 4. Lake/Pond/ Reservoir (reservoir name): □lack of vegetation □erosion □human impact (hiking/biking) □equine impact □safety hazard □water quality (temperature, algae, geese, fecal) 5. Other Problem Area(s)(list contributing factors)

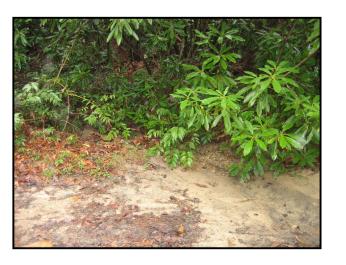
Stormwater drainage crosses Little River Trail, with trail serving as sediment source to Little River.
