Area of Concern – Site: P32

Map Grid Location: G7 Site visit date/ team): 8/31/15/ JZ Drainage Area (Sq. Mi.): -
Name & Location: Oak Tree Trail

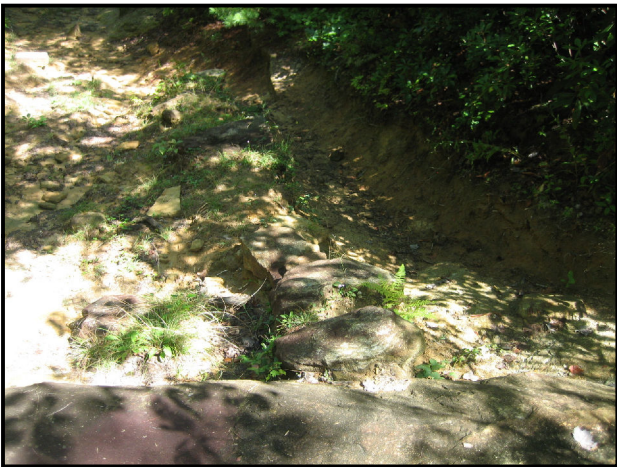
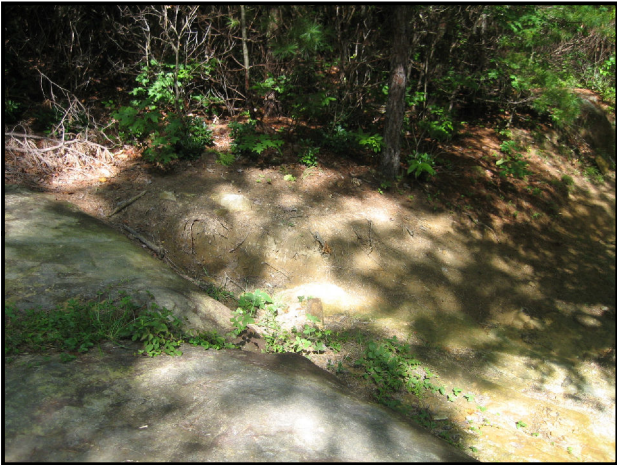
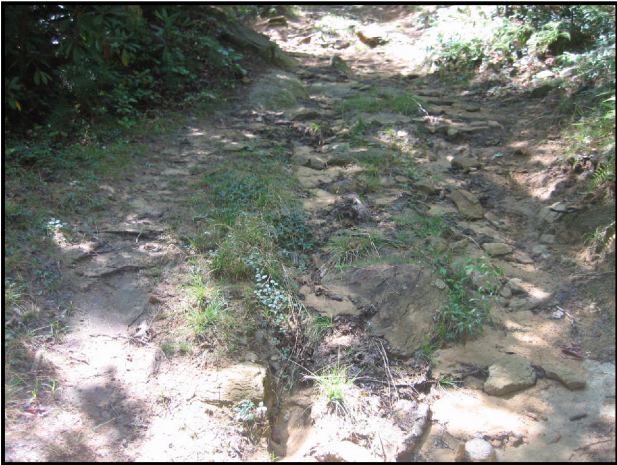
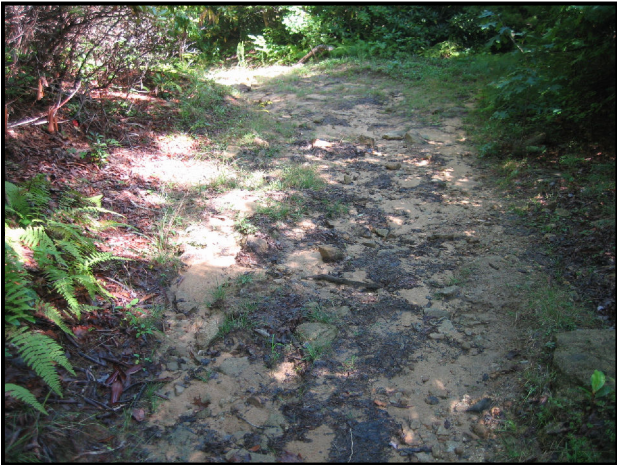
Upland sediment source on eroding, over widened trail. Trail serves as stormwater drainage to receiving water.

- Potential Solutions
- ☒ relocate trail/close trail/road

☒ vegetation/ shoreline planting
