Area of Concern – Site: P37

Map Grid Location: H6 Site visit date/ team): 8/26/15/ JZ Drainage Area (Sq. Mi.): < 0.1
Name & Location: Tributary at Sandy Trail

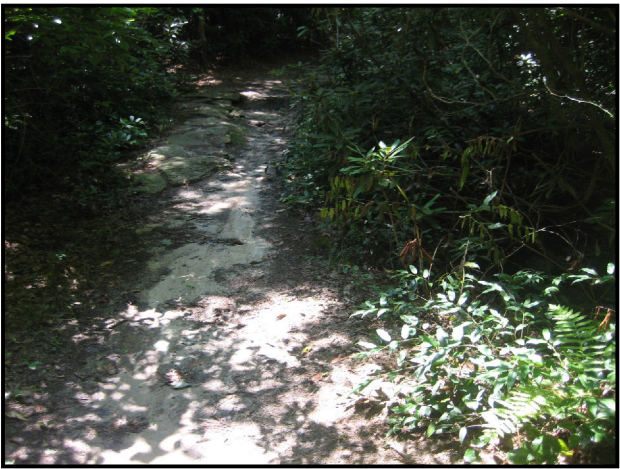
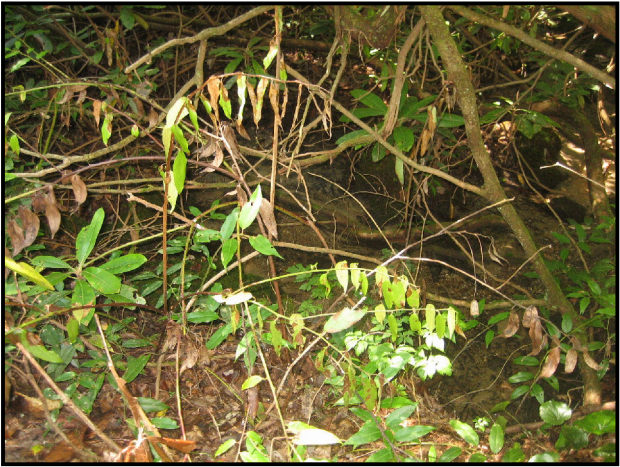
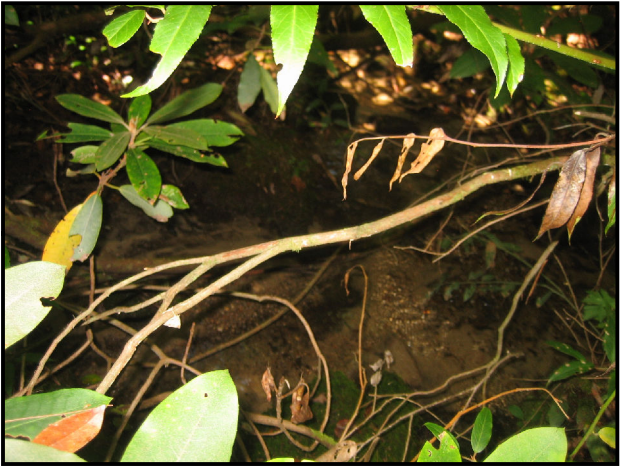
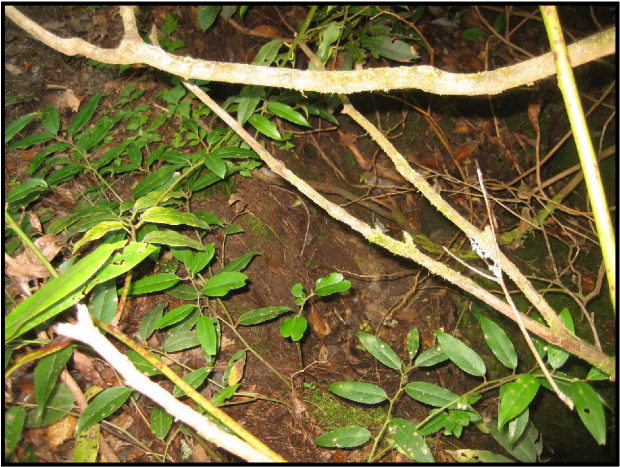
Comments
Hardened trail crossing, though trail still serves as sediment source. Minor bank erosion in channel just downstream of crossing.

- Potential Solutions**
☒relocate trail/close trail/road ☒trail/road crossing improvement
☒vegetation/ shoreline planting ☐mechanical grading
☐stormwater treatment ☐animal watering
☐human/ animal exclusion ☐culvert rehabilitation/ replacement
☐signs ☐culvert daylighting
☐maintenance ☐bridge replacement/improvement
