Area of Concern – Site: P39

Map Grid Location: H4 Site visit date/ team): 8/26/15/ JZ Drainage Area (Sq. Mi.): < 0.1
 Name & Location: Horse watering along Tarklin Branch Road

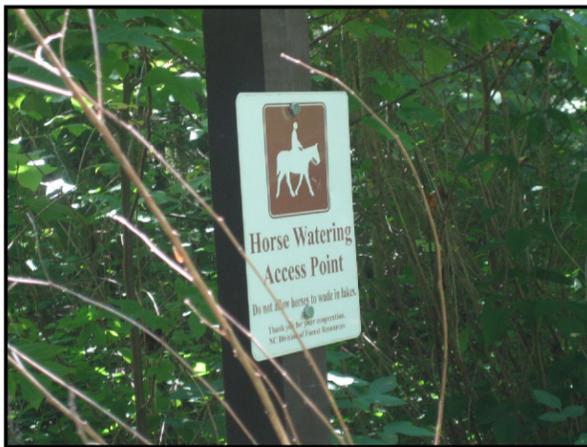
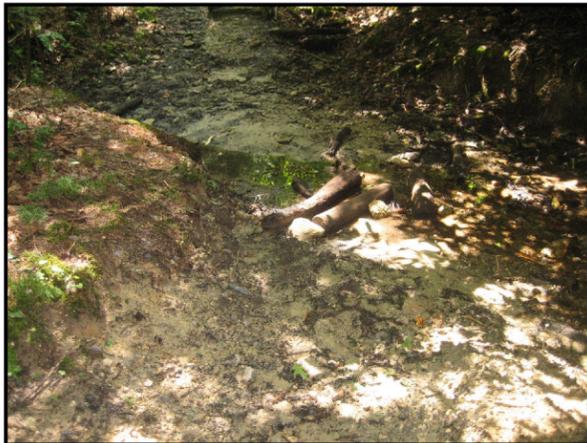
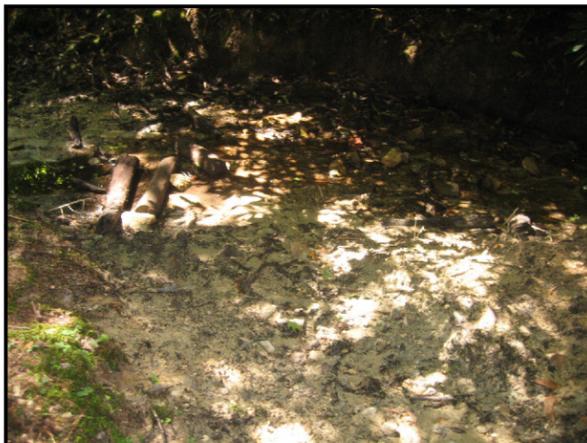
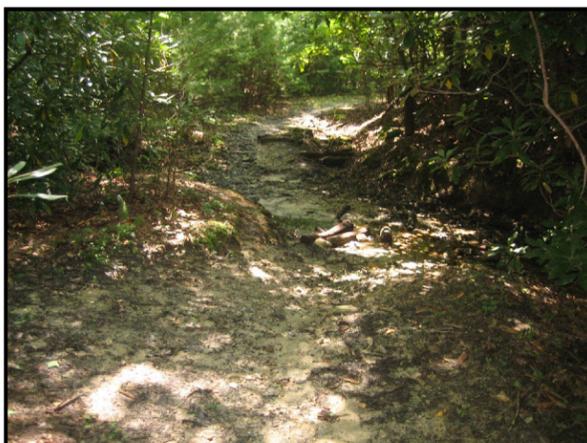
1. **Culvert (diameter/material/length):** _____
 clogged aquatic organism passage/ perched
 crushed erosion (upstream/ downstream)
 lack of natural bed piping
 safety hazard overtopping
2. **Trail/ Road Impact (trail/ road name):** Unnamed trail to horse watering
 stormwater input sediment input
 bridge utilities
 unstable trail crossing erosion
 safety hazard human impact (hiking/biking)
 missing vegetation equine/dog impacts
3. **Upland/ Stormwater**
 nonpoint source pollution upland erosion
 pollutant point source unvegetated upland area
4. **Lake/Pond/ Reservoir (reservoir name):** _____
 erosion lack of vegetation
 equine impact human impact (hiking/biking)
 safety hazard water quality (temperature, algae, geese, fecal)
5. **Other Problem Area(s)** (list contributing factors)

Trampled banks and sediment input to stream at signed horse watering area. Despite "Dead End Trail" sign, watering area also appears to be used as stream crossing.

| <input checked="" type="checkbox"/> relocate trail/close trail/road | <input type="checkbox"/> trail/road crossing improvement |
| <input checked="" type="checkbox"/> vegetation/ shoreline planting | <input type="checkbox"/> mechanical grading |
| <input type="checkbox"/> stormwater treatment | <input checked="" type="checkbox"/> animal watering |
| <input checked="" type="checkbox"/> human/ animal exclusion | <input type="checkbox"/> culvert rehabilitation/ replacement |
| <input checked="" type="checkbox"/> signs | <input type="checkbox"/> culvert daylighting |
