Area of Concern – Site: P40

Map Grid Location: H3 Site visit date/ team): 8/26/15/ JZ Drainage Area (Sq. Mi.): < 0.1  
Name & Location: Shoal Creek Tributary at Shoal Creek Trail

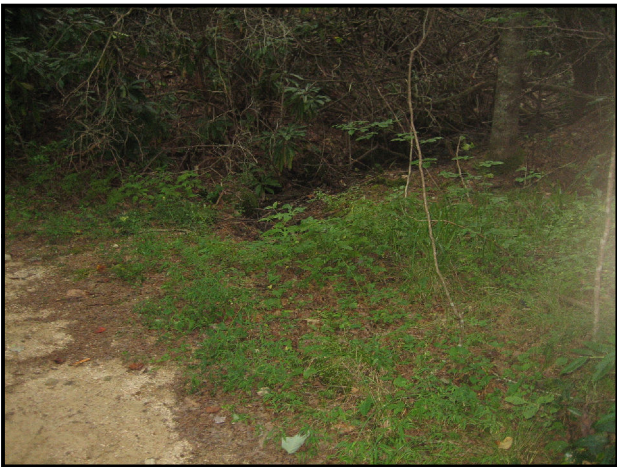
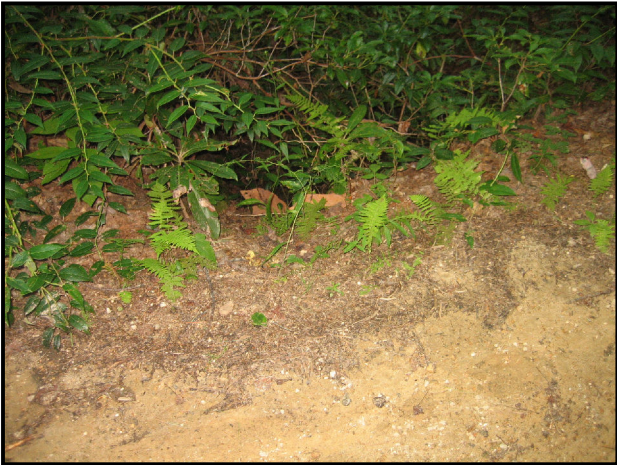
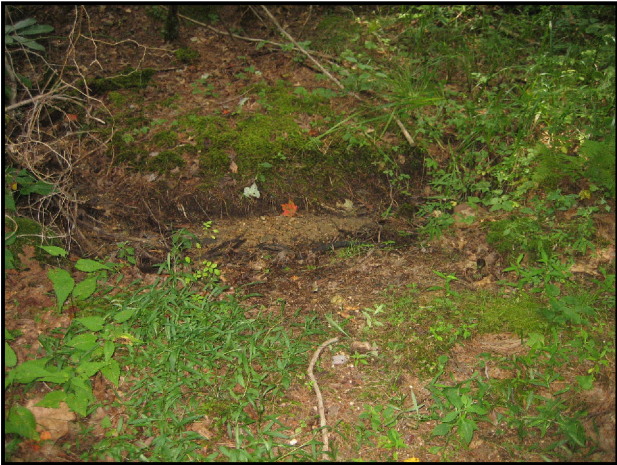
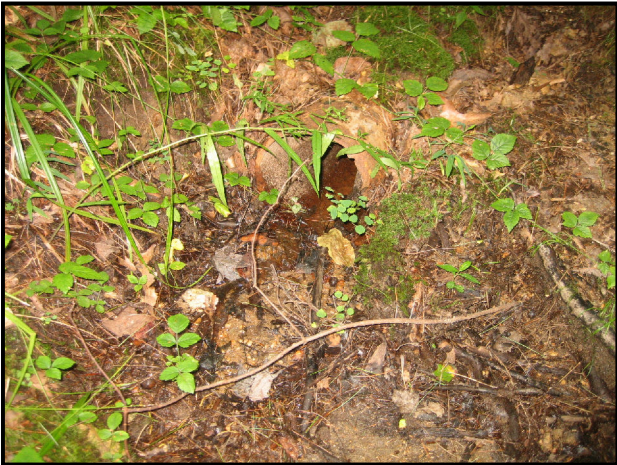
1. Culvert (diameter/material/length): 10”/ iron

☒erosion (upstream/ downstream)

☒missing vegetation

Comments  
Culvert appears to be in good condition. Bare areas in vicinity could benefit from vegetation.

☒vegetation/ shoreline planting
