Area of Concern – Site: P50

Map Grid Location: E8 Site visit date/ team): 8/30/15/ JZ Drainage Area (Sq. Mi.): < 0.1
 Name & Location: Tributary at Cedar Rock Trail

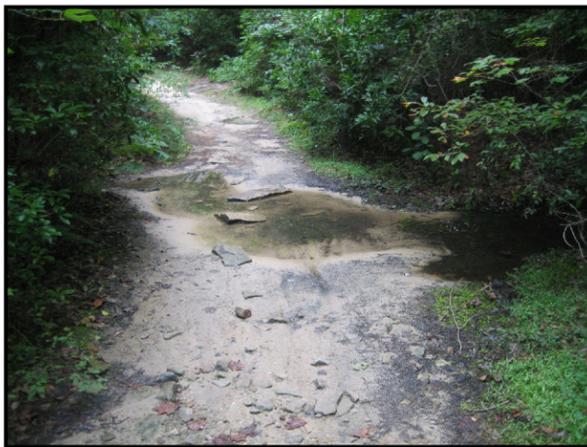
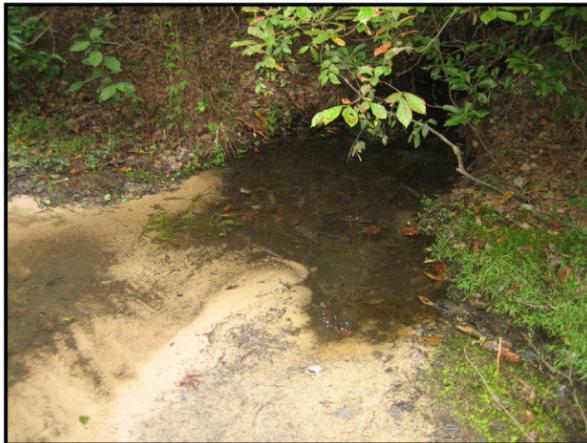
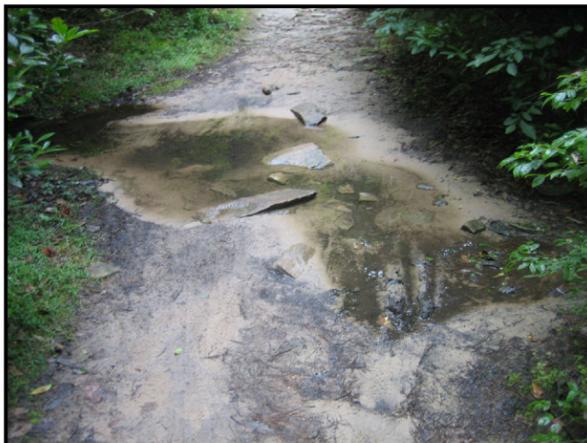
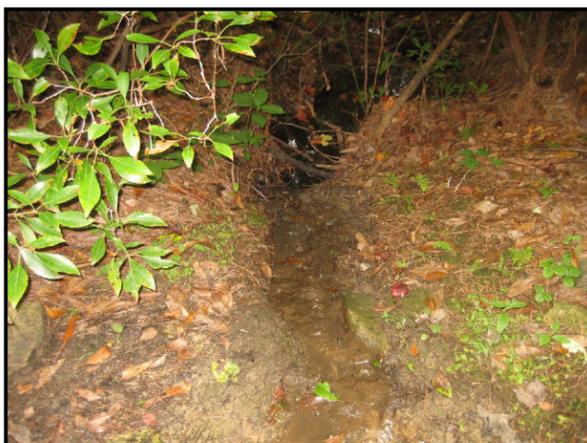
1. **Culvert (diameter/material/length):** _____
 clogged aquatic organism passage/ perched
 crushed erosion (upstream/ downstream)
 lack of natural bed piping
 safety hazard overtopping
2. **Trail/ Road Impact (trail/ road name):** Cedar Rock Trail
 stormwater input sediment input
 bridge utilities
 unstable trail crossing erosion
 safety hazard human impact (hiking/biking)
 missing vegetation equine/dog impacts
3. **Upland/ Stormwater**
 nonpoint source pollution upland erosion
 pollutant point source unvegetated upland area
4. **Lake/Pond/ Reservoir (reservoir name):** _____
 erosion lack of vegetation
 equine impact human impact (hiking/biking)
 safety hazard water quality (temperature, algae, geese, fecal)
5. **Other Problem Area(s)**(list contributing factors)

Trail crossing serves as source of fine sediment. Head-cut downstream of trail may threaten trail and/ or be safety hazard in the future. Potentially install bridge. Culvert and stabilize head-cut.

| <input checked="" type="checkbox"/> relocate trail/close trail/road | <input checked="" type="checkbox"/> trail/road crossing improvement |
