Stream Condition – Site: S01

Map Grid Location: D10 Site visit date/ team): 4/13/15 / BK, JZ Drainage Area (Sq. Mi.): 0.89  
Stream name & Location: Stream along Corn Mill Shoals Trail  
Streambed Substrate: Sand / Gravel Length (ft): +/- 235 Bankfull Width (ft): +/- 6

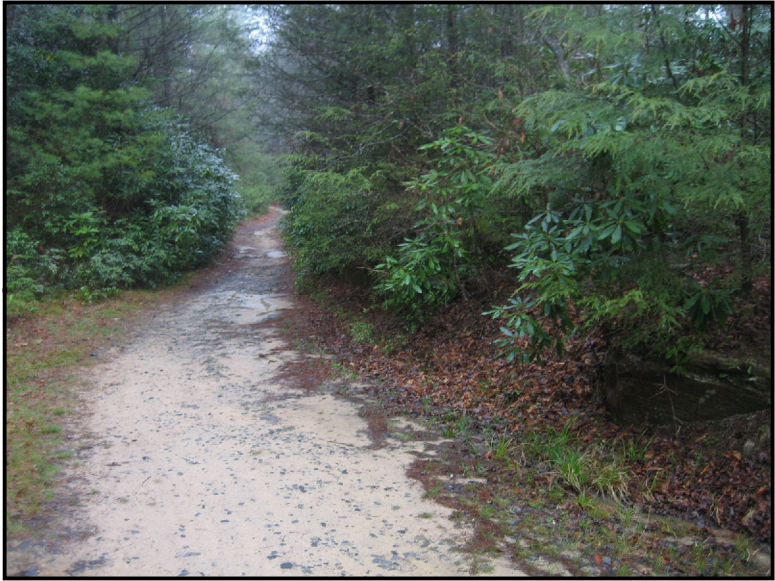
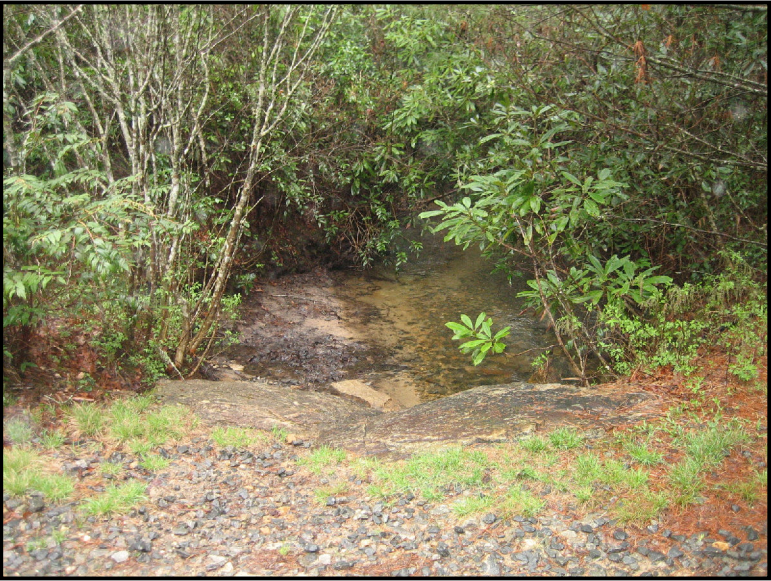
<b>1. Site and Watershed Conditions</b>	<b>2</b>
<input type="checkbox"/> stormwater input	<input checked="" type="checkbox"/> sediment input
<input type="checkbox"/> trampled banks	<input type="checkbox"/> equine/dog impacts
<input checked="" type="checkbox"/> trail crossing	<input checked="" type="checkbox"/> trail in buffer
<input checked="" type="checkbox"/> bridge/culvert/armoring	<input type="checkbox"/> utilities
<b>2. Channel Morphology and Condition</b>	<b>3</b>
<input type="checkbox"/> overwide	<input type="checkbox"/> incised
<input type="checkbox"/> straightened	<input type="checkbox"/> eroding banks
<input type="checkbox"/> head-cutting	<input type="checkbox"/> lack of bedform diversity
<input type="checkbox"/> high bed scour	<input checked="" type="checkbox"/> excessive sediment deposition
<b>3. Floodplain Morphology</b>	<b>3</b>
<input type="checkbox"/> incised channel	<input type="checkbox"/> entrenched channel

<input checked="" type="checkbox"/> floodplain fill/ levees	<input type="checkbox"/> irregular/ obstructed floodplain
<b>4. Vegetation</b>	<b>3</b>
<input checked="" type="checkbox"/> narrow buffer width	<input type="checkbox"/> invasive plants (banks/floodplain)
<input type="checkbox"/> poor overstory/tree cover	<input type="checkbox"/> bare areas/mineral soil (banks/floodplain)
<b>5. Habitat</b>	<b>3</b>
<input type="checkbox"/> lack of woody debris	<input type="checkbox"/> poor water quality (turbid, algae, temperature)
<input checked="" type="checkbox"/> lack of diverse bedform/ flow	<input type="checkbox"/> lack of fine roots, leaf packs, coarse substrate
<b>Score (of 20) and Rating</b> (Poor 0-7; Fair 8-12; Good 13-17; Excellent 18-20)	<b>14</b>

**Comments**  
See also P07; Corn Mill Shoals Trail in buffer, providing sediment/ stormwater source.

<b>Potential Solutions</b>	
<input checked="" type="checkbox"/> relocate/close trail	<input checked="" type="checkbox"/> trail crossing improvement
<input checked="" type="checkbox"/> vegetation planting	<input type="checkbox"/> mechanical grading
<input type="checkbox"/> in-stream structures	<input type="checkbox"/> watershed improvements
<input type="checkbox"/> preservation/ exclusion	<input type="checkbox"/> culvert rehabilitation/ replacement
<input type="checkbox"/> maintenance	<input type="checkbox"/> signs
