Stream Condition – Site: S03

Map Grid Location: E10 Site visit date/ team): 8/31/15 / JZ Drainage Area (Sq. Mi.): < 0.1

Stream name & Location: Tributary along Corn Mill Shoals Trail

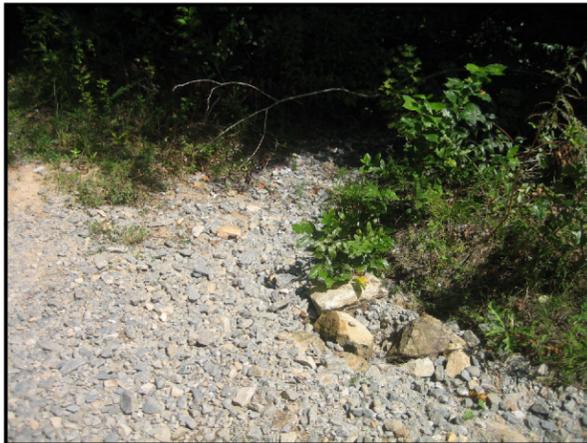
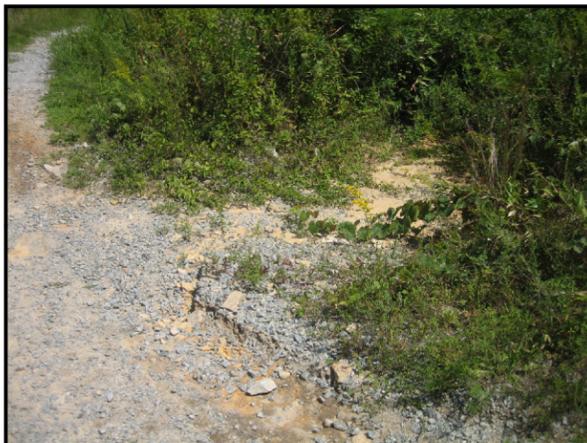
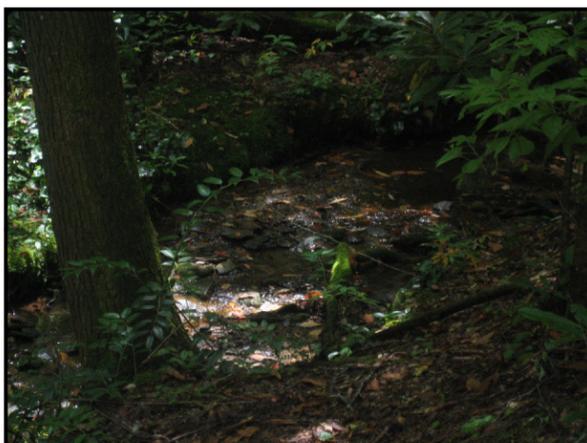
1. Site and Watershed Conditions	2
<input checked="" type="checkbox"/> stormwater input <input type="checkbox"/> trampled banks <input type="checkbox"/> trail crossing <input checked="" type="checkbox"/> bridge/culvert/armoring	<input checked="" type="checkbox"/> sediment input <input type="checkbox"/> equine/dog impacts <input checked="" type="checkbox"/> trail in buffer <input checked="" type="checkbox"/> utilities

2. Channel Morphology and Condition	3
<input type="checkbox"/> overwide <input type="checkbox"/> straightened <input type="checkbox"/> head-cutting <input type="checkbox"/> high bed scour	<input type="checkbox"/> incised <input type="checkbox"/> eroding banks <input type="checkbox"/> lack of bedform diversity <input checked="" type="checkbox"/> excessive sediment deposition

3. Floodplain Morphology	3
<input type="checkbox"/> incised channel <input type="checkbox"/> floodplain fill/ levees	<input checked="" type="checkbox"/> entrenched channel <input type="checkbox"/> irregular/ obstructed floodplain

4. Vegetation	3
<input checked="" type="checkbox"/> narrow buffer width <input type="checkbox"/> poor overstory/tree cover	<input type="checkbox"/> invasive plants (banks/floodplain) <input checked="" type="checkbox"/> bare areas/mineral soil (banks/floodplain)

5. Habitat	3
<input type="checkbox"/> lack of woody debris <input type="checkbox"/> lack of diverse bedform/ flow	<input type="checkbox"/> poor water quality (turbid, algae, temperature) <input checked="" type="checkbox"/> lack of fine roots, leaf packs, coarse substrate
Score (of 20) and Rating (Poor 0-7; Fair 8-12; Good 13-17; Excellent 18-20)	14

Trail in buffer with sediment/ stormwater runoff from trail directed to stream. Upland crosion from power line crossing is also sediment source.

| <input checked="" type="checkbox"/> relocate/close trail | <input type="checkbox"/> trail crossing improvement |
| <input checked="" type="checkbox"/> vegetation planting | <input type="checkbox"/> mechanical grading |
