Stream Condition – Site: S04

Stream name & Location: Tributary along Barn Trail

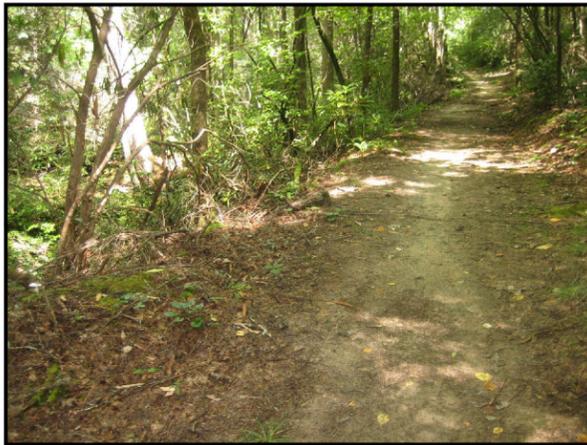
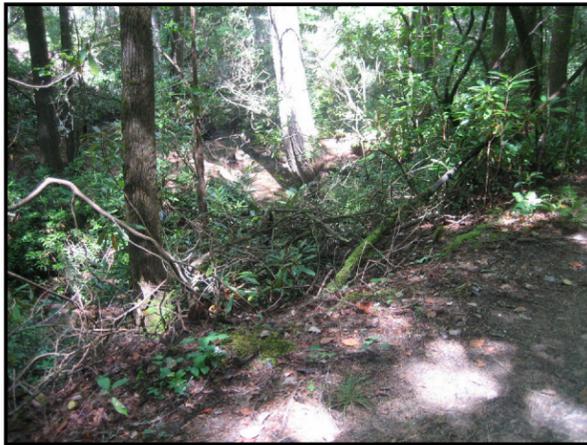
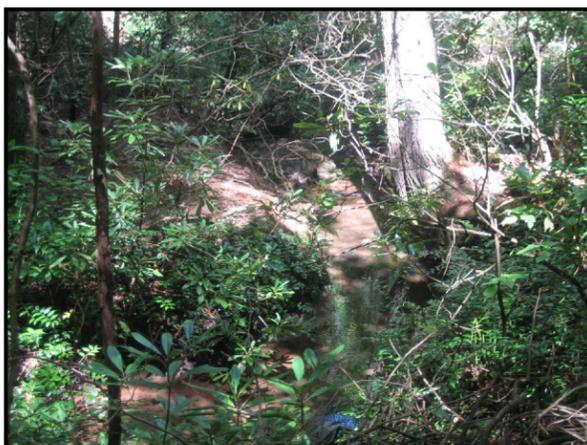
1. Site and Watershed Conditions	2
<input type="checkbox"/> stormwater input <input type="checkbox"/> trampled banks <input type="checkbox"/> trail crossing <input type="checkbox"/> bridge/culvert/armoring	<input checked="" type="checkbox"/> sediment input <input type="checkbox"/> equine/dog impacts <input checked="" type="checkbox"/> trail in buffer <input type="checkbox"/> utilities

2. Channel Morphology and Condition	3
<input type="checkbox"/> overwide <input type="checkbox"/> straightened <input type="checkbox"/> head-cutting <input type="checkbox"/> high bed scour	<input type="checkbox"/> incised <input checked="" type="checkbox"/> eroding banks <input type="checkbox"/> lack of bedform diversity <input checked="" type="checkbox"/> excessive sediment deposition

3. Floodplain Morphology	3
<input type="checkbox"/> incised channel <input type="checkbox"/> floodplain fill/ levees	<input checked="" type="checkbox"/> entrenched channel <input type="checkbox"/> irregular/ obstructed floodplain

4. Vegetation	3
<input type="checkbox"/> narrow buffer width <input type="checkbox"/> poor overstory/tree cover	<input type="checkbox"/> invasive plants (banks/floodplain) <input checked="" type="checkbox"/> bare areas/mineral soil (banks/floodplain)

5. Habitat	3
<input type="checkbox"/> lack of woody debris <input type="checkbox"/> lack of diverse bedform/ flow	<input type="checkbox"/> poor water quality (turbid, algae, temperature) <input checked="" type="checkbox"/> lack of fine roots, leaf packs, coarse substrate
Score (of 20) and Rating (Poor 0-7; Fair 8-12; Good 13-17; Excellent 18-20)	14

Trail in buffer with sediment/ stormwater runoff from trail.

| <input checked="" type="checkbox"/> relocate/close trail | <input type="checkbox"/> trail crossing improvement |
| <input checked="" type="checkbox"/> vegetation planting | <input type="checkbox"/> mechanical grading |
| <input checked="" type="checkbox"/> preservation/ exclusion | <input type="checkbox"/> culvert rehabilitation/ replacement |
