Stream Condition – Site: S14

Map Grid Location: H2 Site visit date/ team): 8/26/15 / JZ Drainage Area (Sq. Mi.): < 0.1

Stream name & Location: Tributary along Rifle Trail

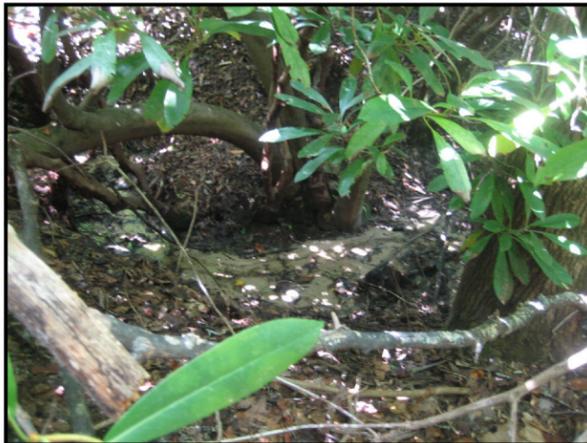
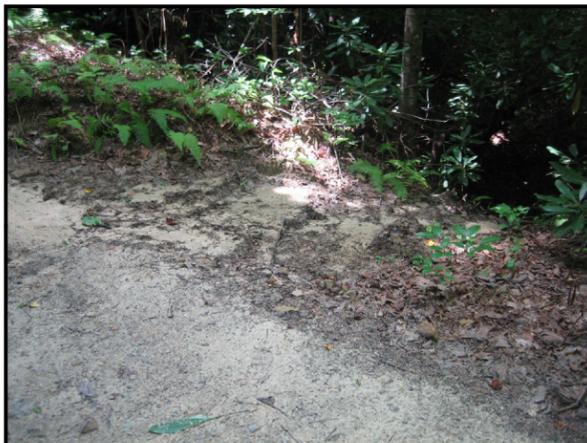
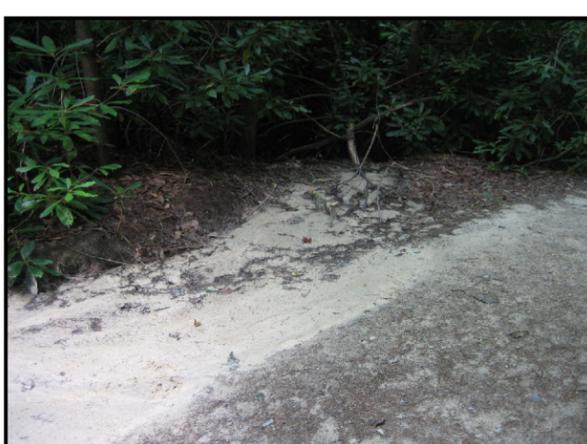
1. Site and Watershed Conditions	1
<input checked="" type="checkbox"/> stormwater input <input type="checkbox"/> trampled banks <input checked="" type="checkbox"/> trail crossing <input type="checkbox"/> bridge/culvert/armoring	<input checked="" type="checkbox"/> sediment input <input type="checkbox"/> equine/dog impacts <input checked="" type="checkbox"/> trail in buffer <input type="checkbox"/> utilities

2. Channel Morphology and Condition	2
<input type="checkbox"/> overwide <input type="checkbox"/> straightened <input type="checkbox"/> head-cutting <input type="checkbox"/> high bed scour	<input type="checkbox"/> incised <input type="checkbox"/> eroding banks <input checked="" type="checkbox"/> lack of bedform diversity <input checked="" type="checkbox"/> excessive sediment deposition

3. Floodplain Morphology	1
<input checked="" type="checkbox"/> incised channel <input checked="" type="checkbox"/> floodplain fill/ levees	<input checked="" type="checkbox"/> entrenched channel <input type="checkbox"/> irregular/ obstructed floodplain

4. Vegetation	2
<input checked="" type="checkbox"/> narrow buffer width <input type="checkbox"/> poor overstory/tree cover	<input type="checkbox"/> invasive plants (banks/floodplain) <input checked="" type="checkbox"/> bare areas/mineral soil (banks/floodplain)

5. Habitat	2
<input type="checkbox"/> lack of woody debris <input checked="" type="checkbox"/> lack of diverse bedform/ flow	<input type="checkbox"/> poor water quality (turbid, algae, temperature) <input checked="" type="checkbox"/> lack of fine roots, leaf packs, coarse substrate
Score (of 20) and Rating (Poor 0-7; Fair 8-12; Good 13-17; Excellent 18-20)	8

Trail in buffer provides multiple sources of fine sediment, which is frequently evident in stream bed.

| <input checked="" type="checkbox"/> relocate/close trail | <input type="checkbox"/> trail crossing improvement |
| <input checked="" type="checkbox"/> vegetation planting | <input type="checkbox"/> mechanical grading |
| <input checked="" type="checkbox"/> preservation/ exclusion | <input type="checkbox"/> culvert rehabilitation/ replacement |
| <input type="checkbox"/> maintenance | <input checked="" type="checkbox"/> signs |
