NCDA&CS - North Carolina Forest Service

Stream Restoration Post-Implementation Annual Monitoring Report

Year 3: 2014

“DuPont State Forest Lake Julia Outfall Stream Restoration”

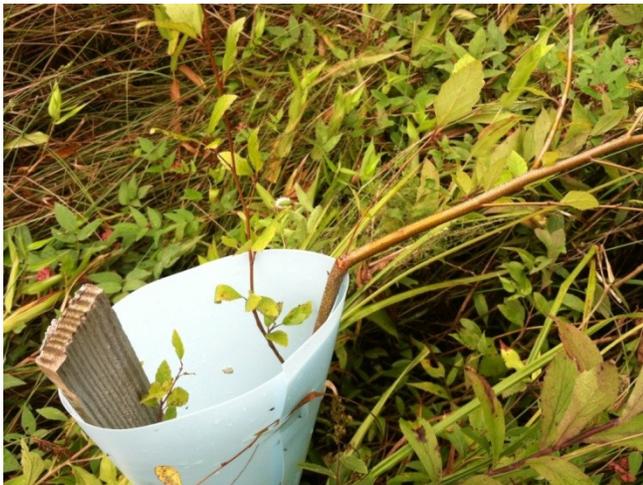
Vegetation of established seedlings continued to show good growth, despite damage to some seedlings observed in August 2013 after an intense high-water flow event that snapped off the tops of seedlings and matted down others due to the force of the floodwaters.

A river birch seedling snapped off due to floodwater flows. August 2013.

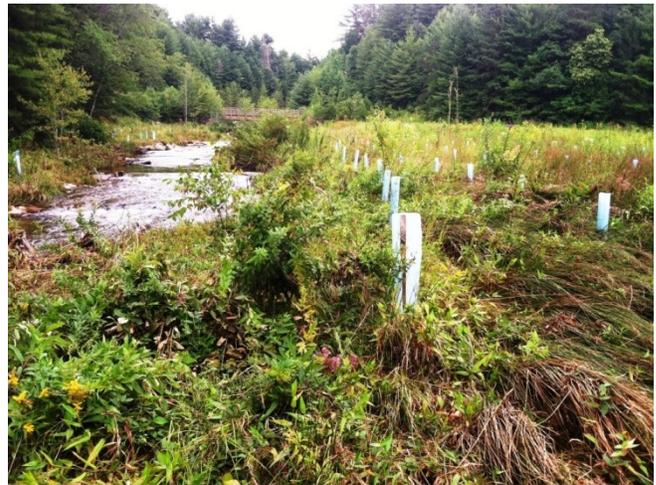
Heavily matted vegetation in the left-bank floodplain. Tree tubes were ripped open by the floodwaters. August 2013.

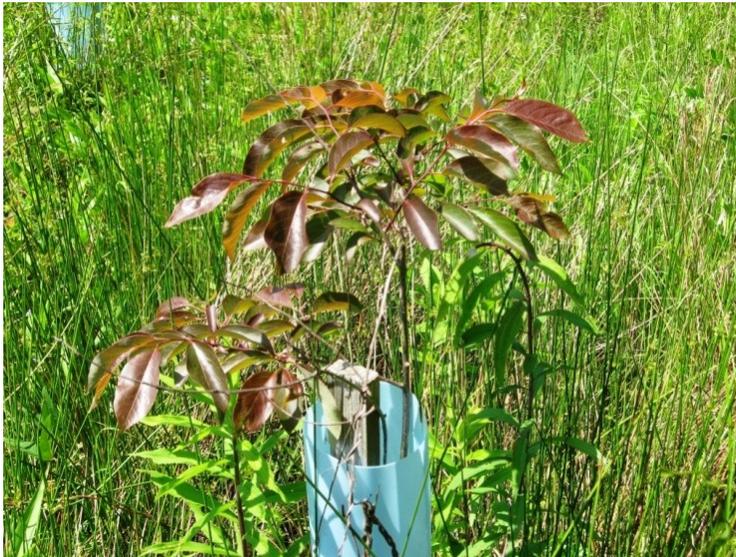
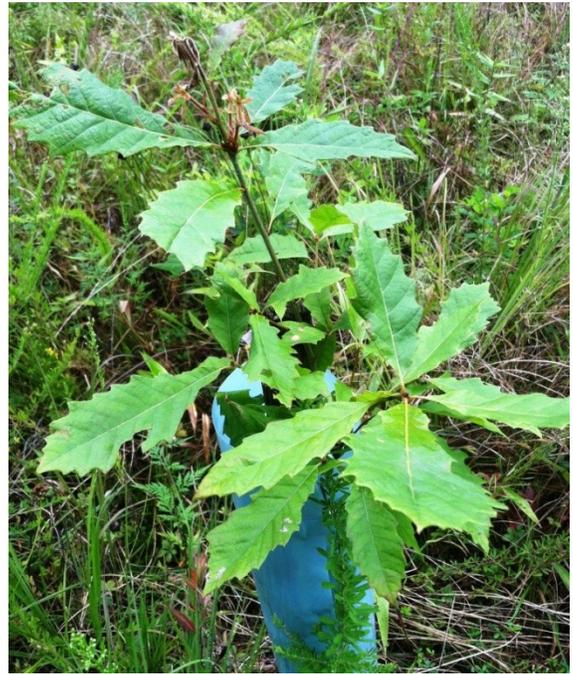
Seedlings continue to grow well, with many of them reaching heights beyond the protective tree shelter tubes. We will evaluate the need to either retain or remove the tubes in 2014-2015. Both photos taken June 2014.

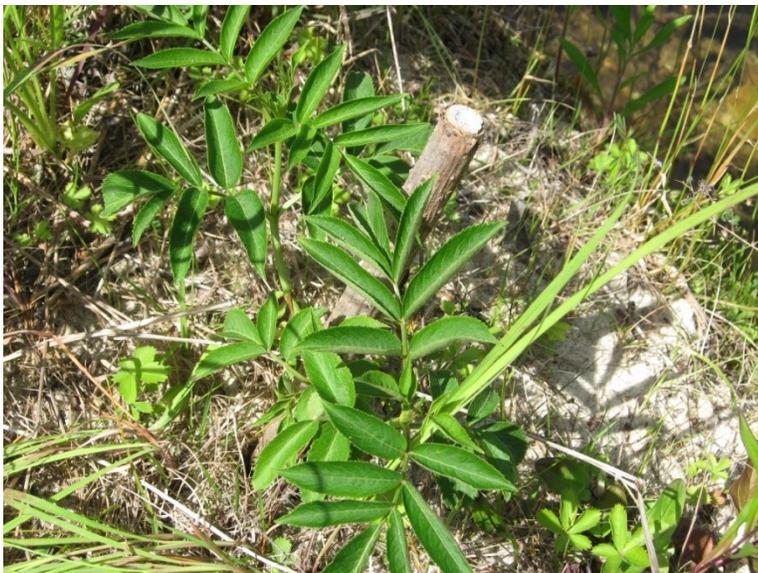
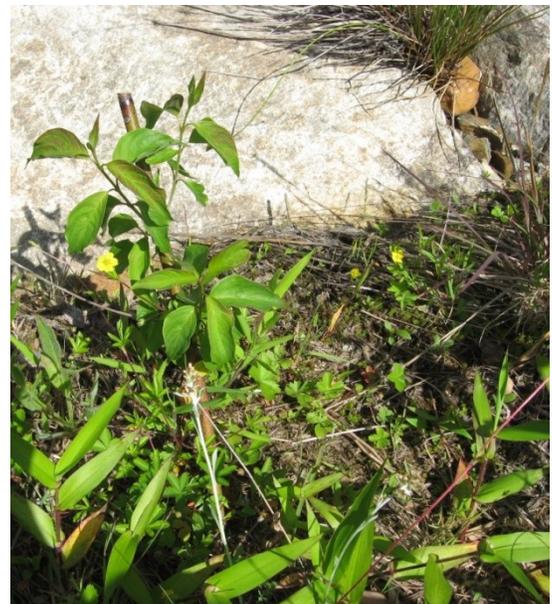
Additional live stake installation was conducted by NCFS staff in March 2014 to help fill in areas which were lacking vegetation immediately along the streambank. Initial follow-up observations made in June 2014 showed that nearly all of the live stakes had successfully sprouted.

Photos above and right from June 2014, showing sprouting growth of new live stakes that were installed in March 2014.

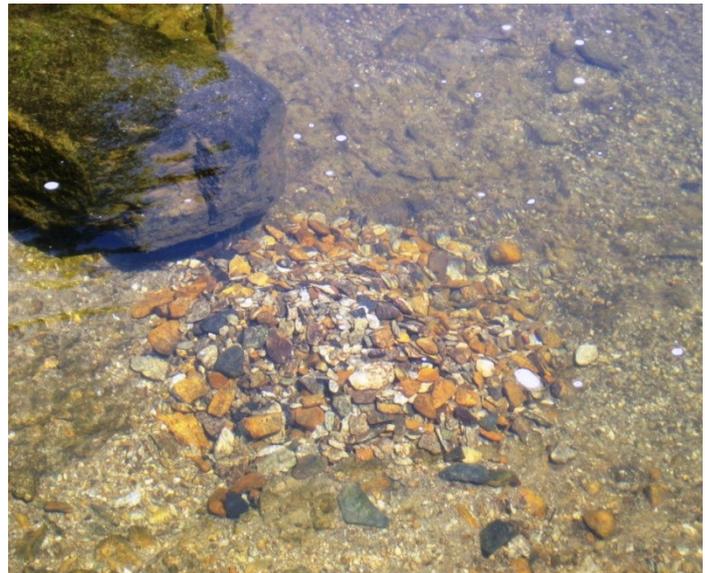
Casual observations indicate that fish may be using the restored reach for spawning. The photo at right was taken in June 2014, showing a nesting pile of small rocks in the channel.

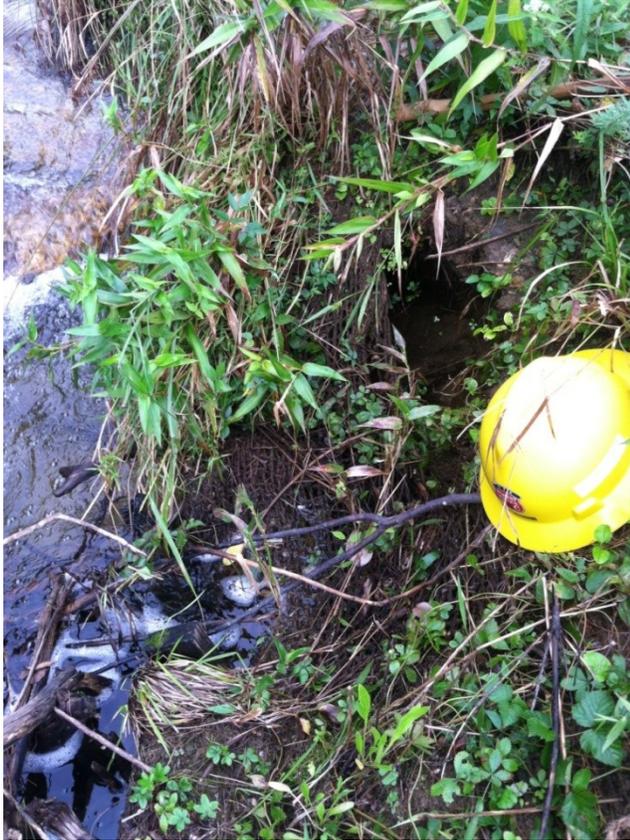
Observed in August 2013, there was a small area of left-bank that had scoured away and was beginning to partially undercut the stream bank. This was likely in response to strong flood flows that occurred on the site during 2013. The larger structures, including rock and log vanes, appeared intact and functioning.

- Purchase temperature data loggers and install in the restored stream segment.
- Install the large interpretive sign that provides an overview of the restoration project.
- Monitor stream bank and make adjustments as needed to assure stability.
- Maintain collaborative water temperature study with NCWRC.
- Conduct a survey of vegetation to assess overall survival and growth; monitor for invasives.
- Use the site for field study, educational workshops, and training as needed or requested.

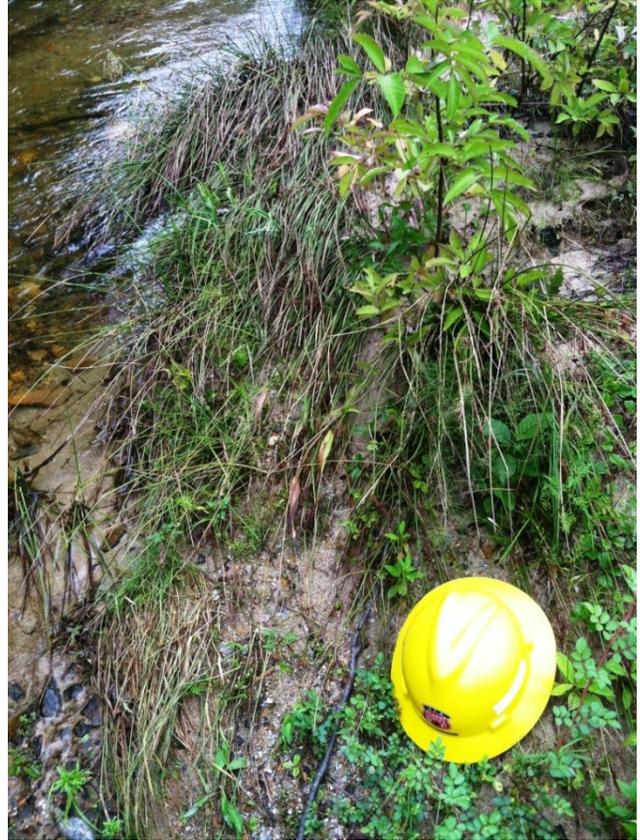
Sediment deposition is occurring across the floodplain area, demonstrating connectivity between the stream and its new floodplain. Photo below is from August 2013.

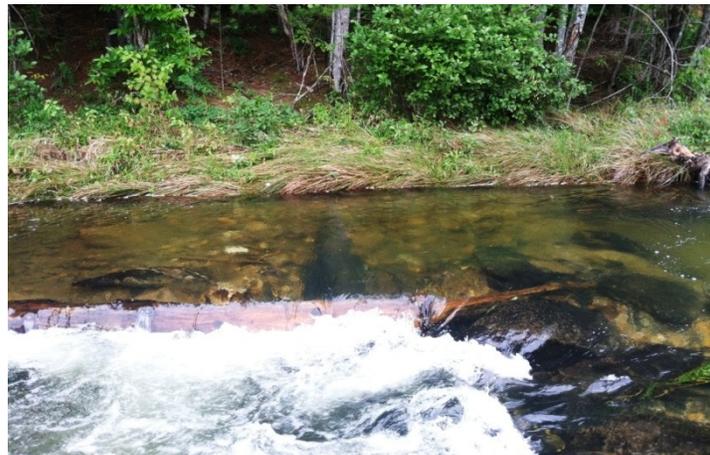
Photo from August 2013 showing a combination rock/log vane structure functioning. Note the matted down vegetation on the far bank, indicating the extent of floodplain flow.

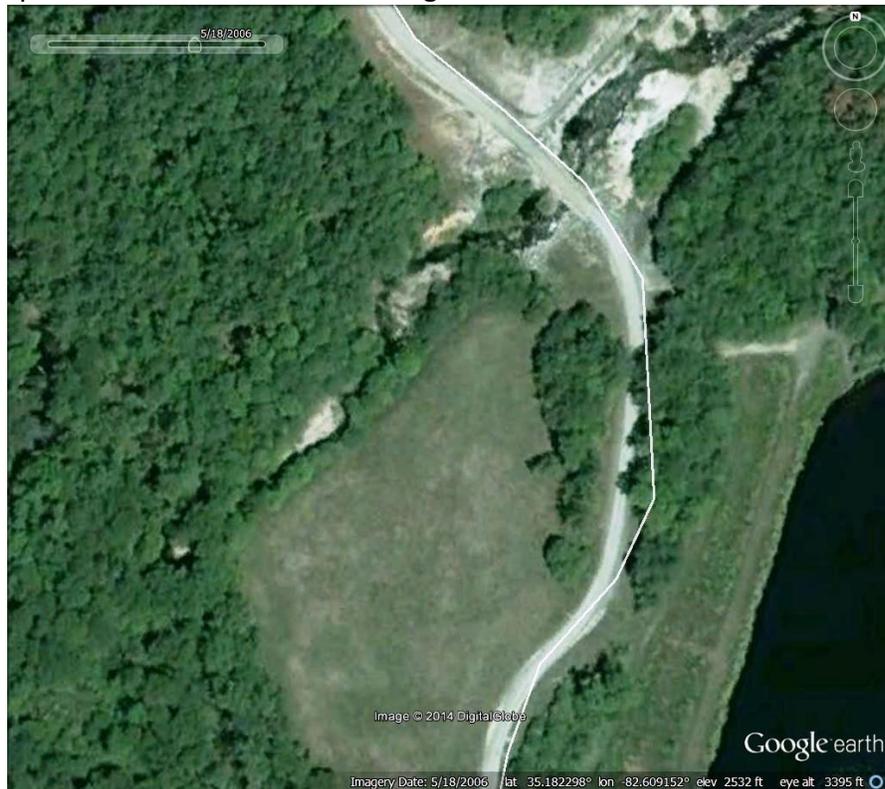
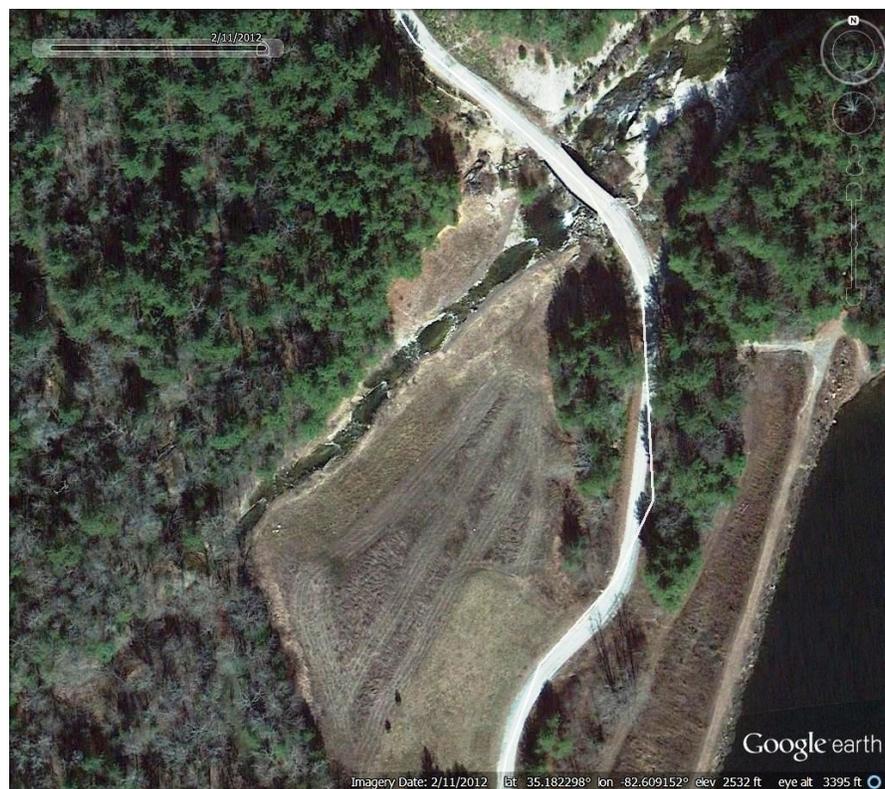
Aerial/satellite imagery available from Google Earth now shows the restored stream segment, as compared with its previous condition. The new alignment and boulder vanes are clearly seen.

Image above is dated May 2006. Image below is dated February 2012.
