# Restoration and Stabilization of Hooker Falls Access Area

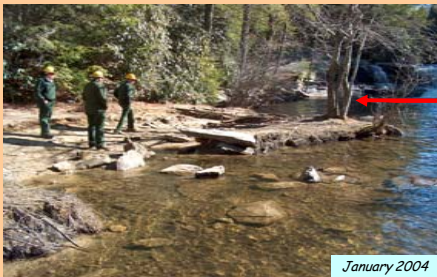
February 2007

Major erosion damage occurred to the river bank during flooding in 2004 and 2005. The lack of soil-binding ground vegetation allowed floodwaters to wash away a large section of the river's edge. The Little River began to carve away at its own banks below Hooker Falls, and would continue to do so if restoration work was not undertaken.

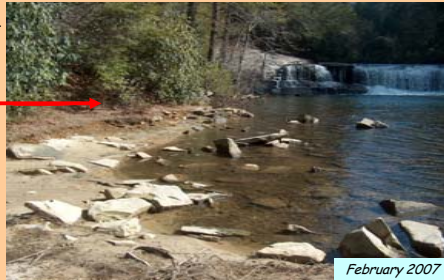
January 2004

Did you notice that the tree was swept away?

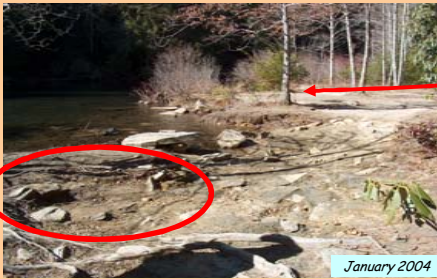
June 2005

Did you notice that another tree was swept away?

Look at how much the floodwaters carved away the river bank!
