## **NCDA&CS - North Carolina Forest Service**

# **Stream Restoration Post-Implementation Annual Monitoring, Final Report: Year 5 - 2013**

For the N.C. Clean Water Management Trust Fund (CWMTF)  
Project #2004A-411:  
“Rendezvous Mountain Purlear Creek Stream Restoration”

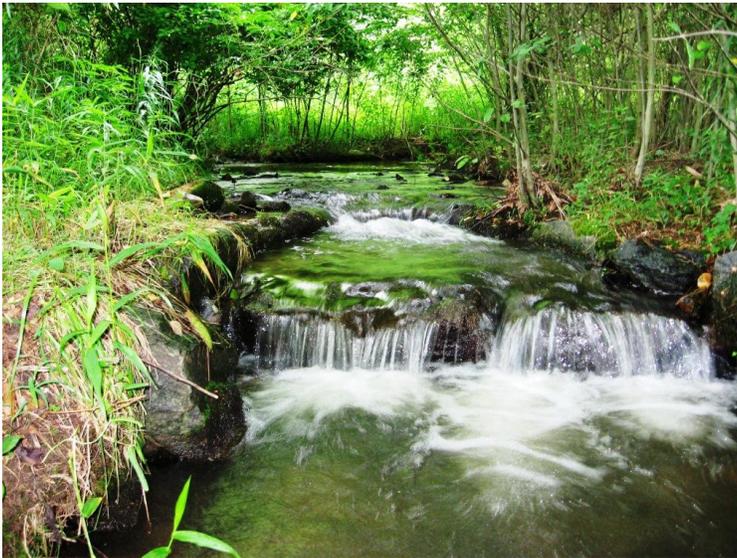
*Photo above shows a step-series of two rock vanes, immediately downstream from the confluence of the UT-Purlear, with the mainstem of Purlear Creek. Photo at right shows some minor bank erosion of the right bank, along the UT-Purlear. Both photos were taken June 27, 2013.*

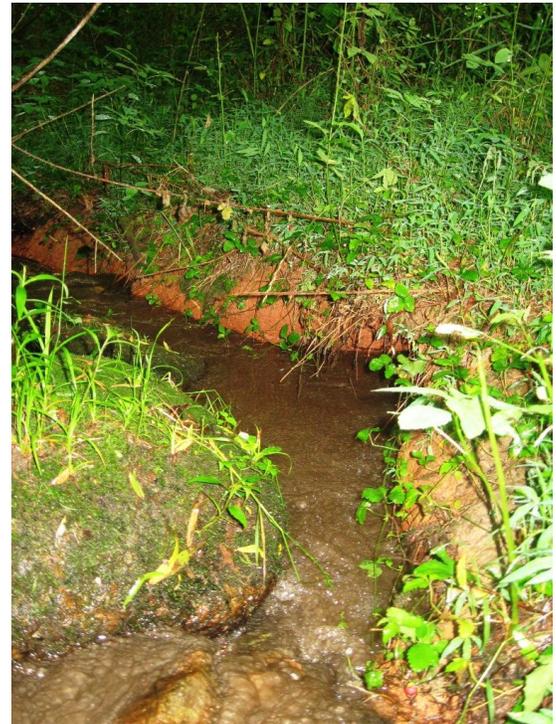
Visual assessments reveal that the overall stream is retaining its structure, with some minor bank erosion observed in places. No problems have been noted with any of the in-stream structures. Incursion of old legacy sediments from upstream, beyond the restoration reach, continue to mobilize in the restored system. This sediment source remains unclear and will continue to be investigated.

With the relatively firm rooting of permanent vegetation along both sides of the creek now well established, we do not expect major bank loss going forward. The floodplain remains connected to the stream, allowing high water flows to spill out of the channel.

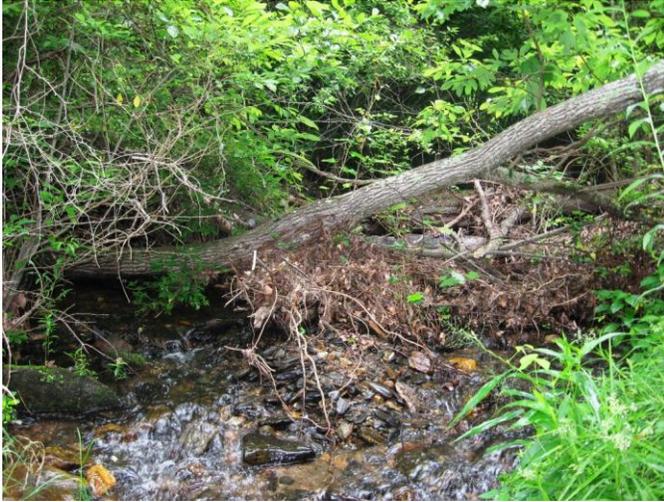
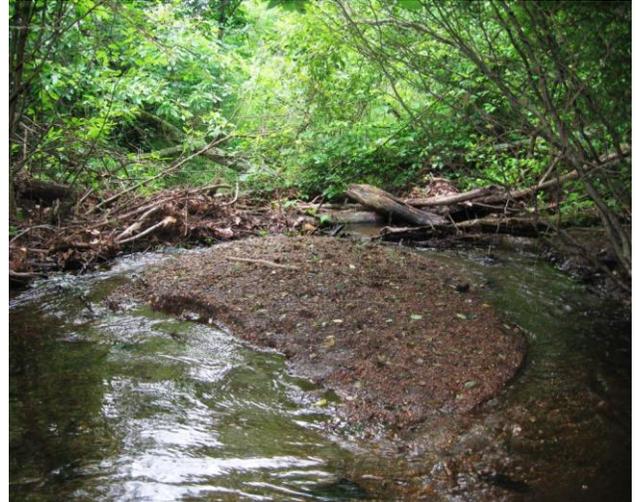
Upstream from the confluence of UT-Purlear and mainstem Purlear Creek, there was a large woody debris jam observed in mid-Summer (seen in the photos below) that occurred when a legacy tree either blew-down, or broke off and fell into the stream. This debris jam had been in place long enough for a sizeable sandbar to form behind it, and the stream's flow had split into two pathways through the debris. Most likely, we will leave the debris jam in place, unless major bank structural loss begins to occur.

*Large debris jam in the mainstem Purlear Creek. Photos taken June 27, 2013.*

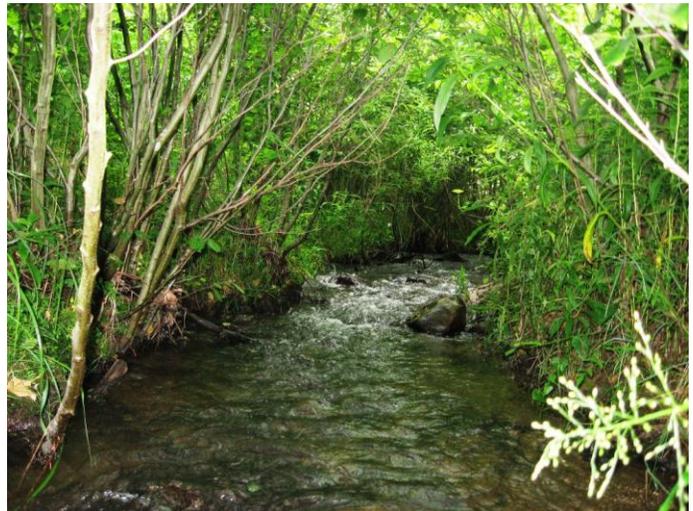
Growing-season shade from trees and woody shrubs appears to be increasing both in area and length along the stream corridor.

The photo at right was taken June 27, 2013, and shows the degree of shade being cast upon a segment of Phase 2 that was restored.

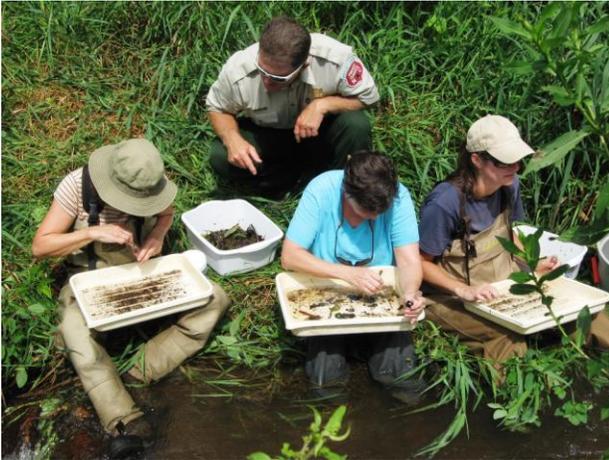
We participated in a special study conducted by the N.C. Division of Water Resources (Quality) in the summer of 2013. The study investigated the re-colonization of restored streams by benthic macroinvertebrates. The findings of the sampling and overall project are still being prepared by NCDWR.

Photo at left from July 2013 shows biologists identifying and collecting samples from Purlear Creek.
