YEAR IN REVIEW 2016

North Carolina Forest Service, Nonpoint Source & Water Quality programs

Forests & Watersheds

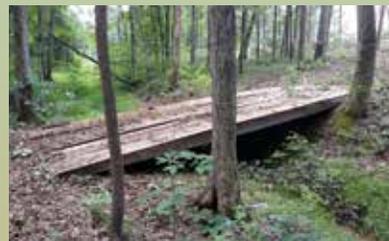
Left: A set of properly installed bridgemats protecting the stream channel;

N.C. Forest Service allows loggers to borrow agency-owned portable steel bridgemats to help protect water resources. This service is provided to loggers to demonstrate the advantages over other stream crossing methods. During 2016, NCFS bridgemats were implemented on 38 logging jobs and utilized on 45 stream and/or ditch crossings to access an estimated 1,932 acres of timber.

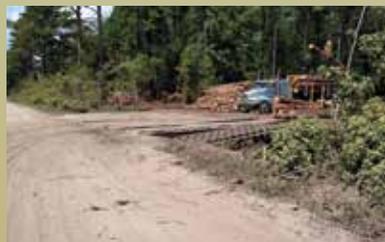
Above: Bridgemats and logging mats installed over a roadside ditch.

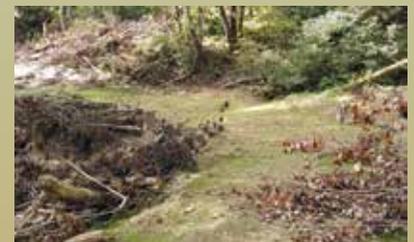
Below: A skid trail stabilized with brush barriers, grass seed, and straw mulch.

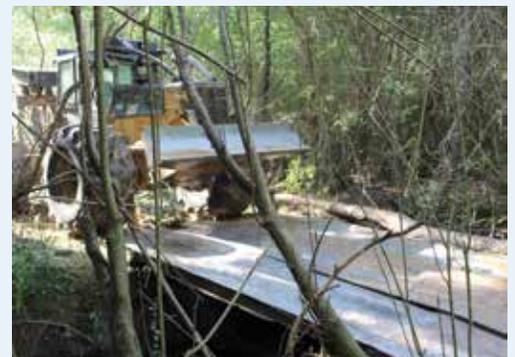
Above: NCFS bridgemats in use on a logging job in Halifax County.

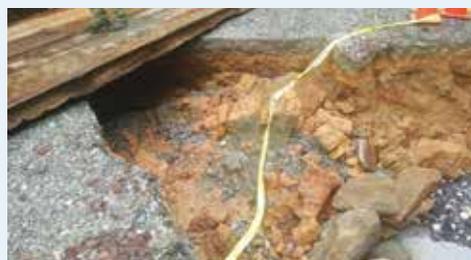
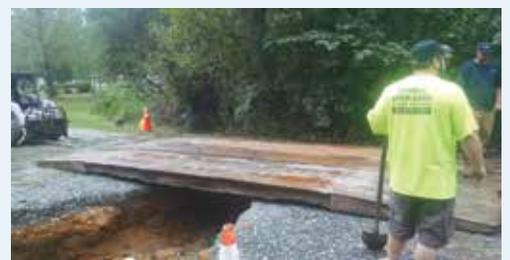
Below: NCFS bridgemats installed over road washout as temporary access in Alamance County

Right: View of a road washout where NCFS bridgemats were used as a temporary crossing in Alamance County

Bridgemats were also used for an emergency response purpose this past September. NCFS delivered a set of bridgemats to an Alamance County community cut off from a storm-induced culvert failure. This temporary fix provided access to dozens of homes and was highlighted by local television media.

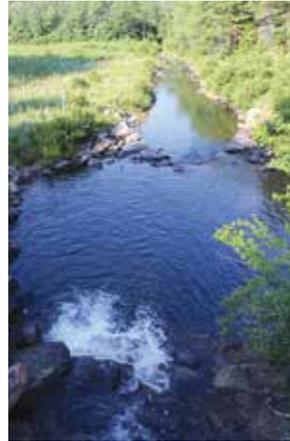
Left: view of the outfall restoration project in June 2016; **Right:** rainbow trout caught in the restored stream

Post-restoration monitoring was completed on the Lake Julia Outfall Restoration Project, located in DuPont State Recreational Forest. Trout appear to seasonally access the restored stream when water temperatures drop to a trout tolerant range (fall, winter, and spring). Streamside vegetation has begun shading parts of the stream. A kiosk was installed as an educational tool and depicts the nature and purpose of this stream restoration.

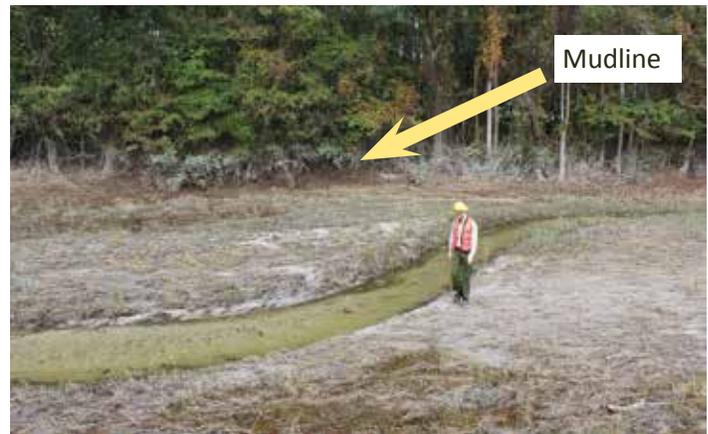
Right: A section of restored stream after Hurricane Matthew. Note the mudline on the vegetation in the background showing the water level at peak flood stage.

This restoration project located at the Claridge State Forest Tree Nursery in Wayne County aimed to reconstruct about 1 mile of stream. The floodplain had been widened (increasing the floodwater storage capacity) and the stream redirected to meander within the floodplain (slowing down water flow). Prior to Hurricane Matthew, this project was about 80% complete. The extent of damage from flooding is being evaluated by NCDOT, who is overseeing this restoration.

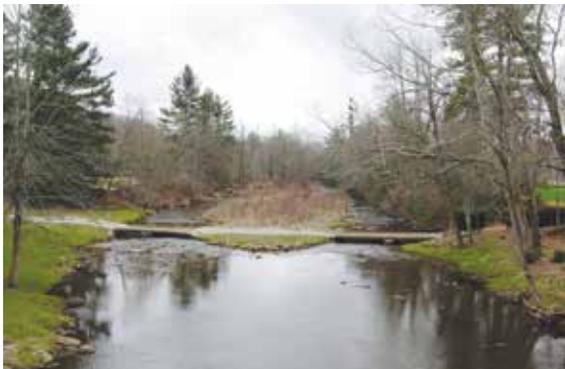
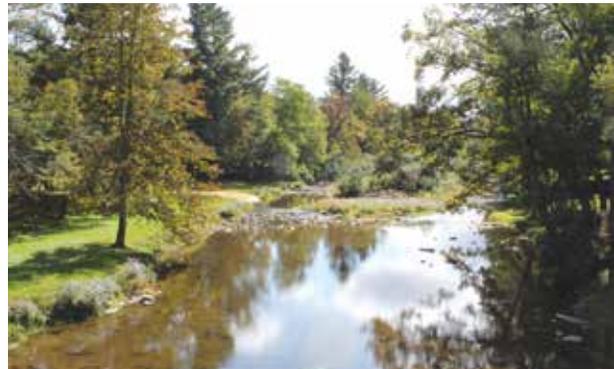
Left: Low-water bridge before removal; **Right:** Low-water bridge removed

The Water Resources Branch was awarded grant money to restore a section of the Linville River located on Gill State Forest in Avery County. During 2016, demolition of a low-water bridge and soil stabilization following bridge removal was completed. The restoration project planning and permitting will take place in 2017, and the river restoration construction in 2018.
