Area of Concern – Site: P03

Map Grid Location: D7 Site visit date/ team): 8/26/15 / JZ Drainage Area (Sq. Mi.): < 0.1
 Name & Location: Tributary at Pine Tree Trail

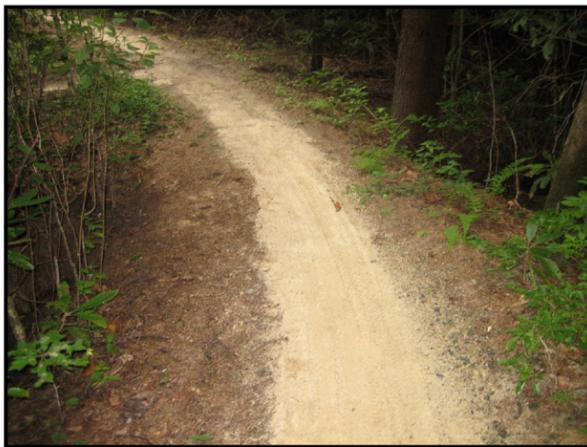
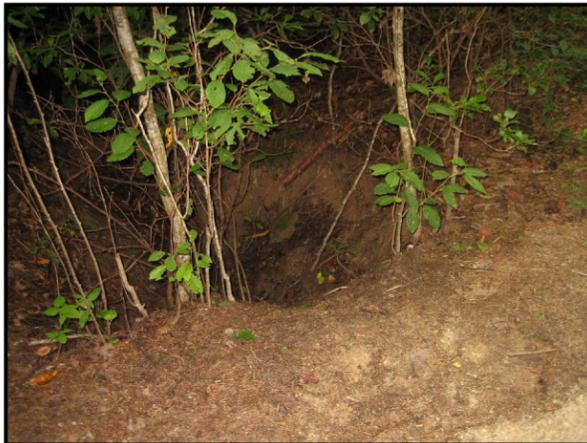
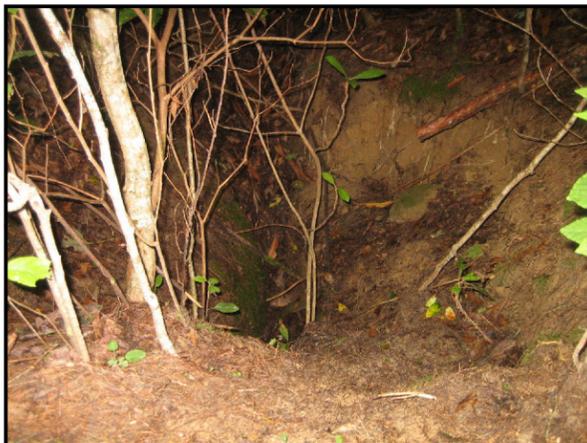
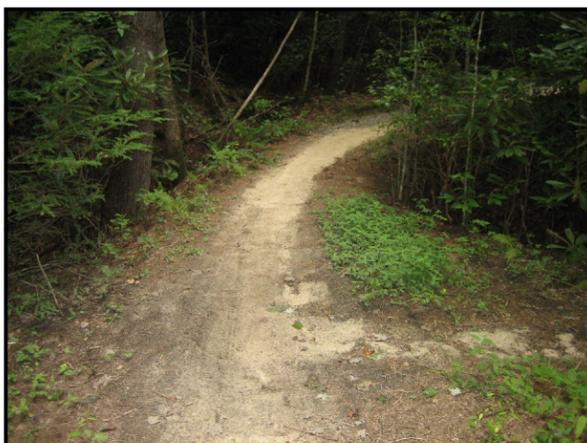
<input type="checkbox"/> clogged	<input checked="" type="checkbox"/> aquatic organism passage/ perched
<input type="checkbox"/> crushed	<input checked="" type="checkbox"/> erosion (upstream/ downstream)
<input type="checkbox"/> lack of natural bed	<input type="checkbox"/> piping
<input type="checkbox"/> safety hazard	<input type="checkbox"/> overtopping
2. **Trail/ Road Impact (trail/ road name):** Pine Tree Trail

<input type="checkbox"/> stormwater input	<input checked="" type="checkbox"/> sediment input
<input type="checkbox"/> bridge	<input type="checkbox"/> utilities
<input type="checkbox"/> unstable trail crossing	<input type="checkbox"/> erosion
<input type="checkbox"/> safety hazard	<input checked="" type="checkbox"/> human impact (hiking/biking)
<input type="checkbox"/> missing vegetation	<input type="checkbox"/> equine/ dog impacts
3. **Upland/ Stormwater**

Some sediment input from trail. Channel bank erosion downstream of trail at culvert outlet.

| <input checked="" type="checkbox"/> relocate trail/close trail/road | <input checked="" type="checkbox"/> trail/road crossing improvement |
