Non-Point Source (NPS) and Water Quality Programs

2008
Year in Review
Success Stories & Accomplishments

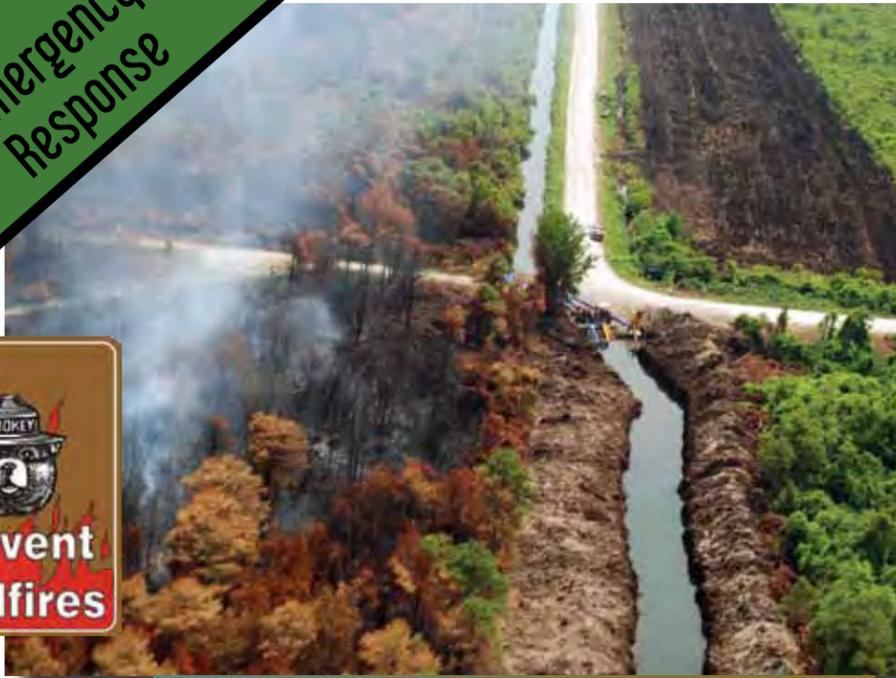
Canal used as a water source for high-capacity pumps on the Evans Road Fire.

Seventy-one (71) water pumping sites were established. Water was pumped and transported a cumulative distance of 36 miles to and within the fire area, and elevated as much as 17 feet from its source origin to its delivery point on the fire, due to changes in landscape topography.

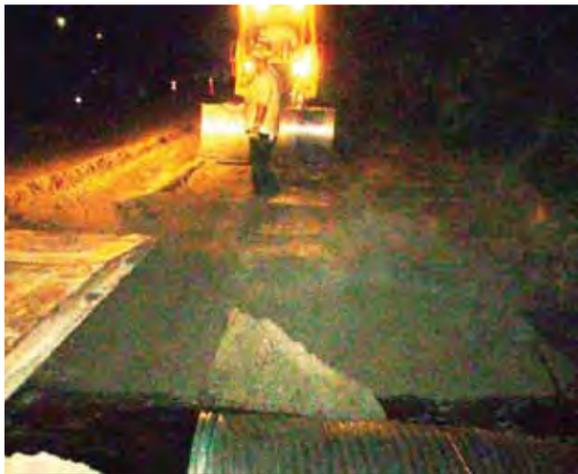
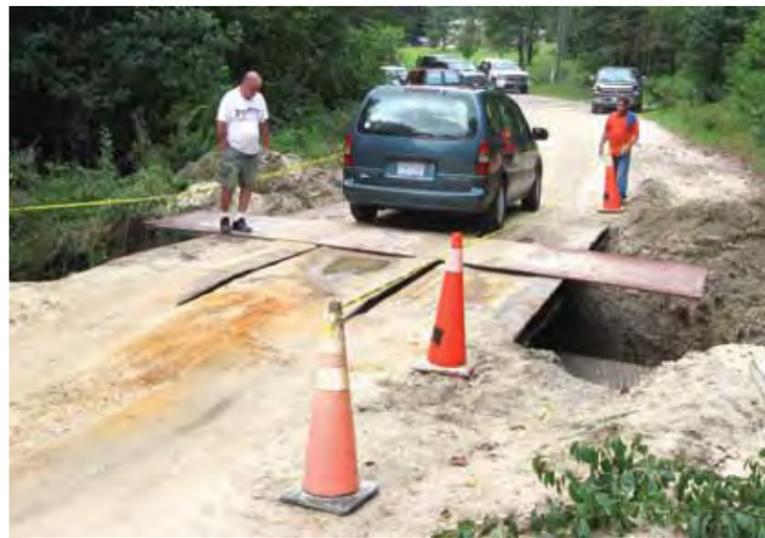
Our logging bridgemats were pressed into emergency service in September after 8-inches of rain from Tropical Storm Hanna washed away the only access road for the 80 residents in the Moore County community of Riverbend. Local forest rangers reacted quickly to aid the community by installing the logging bridgemats overnight (left). The bridgemats (right) were in place for one week until replaced by another, more rugged temporary portable bridge brought in from the Division of Forest Resources district office in Whiteville.

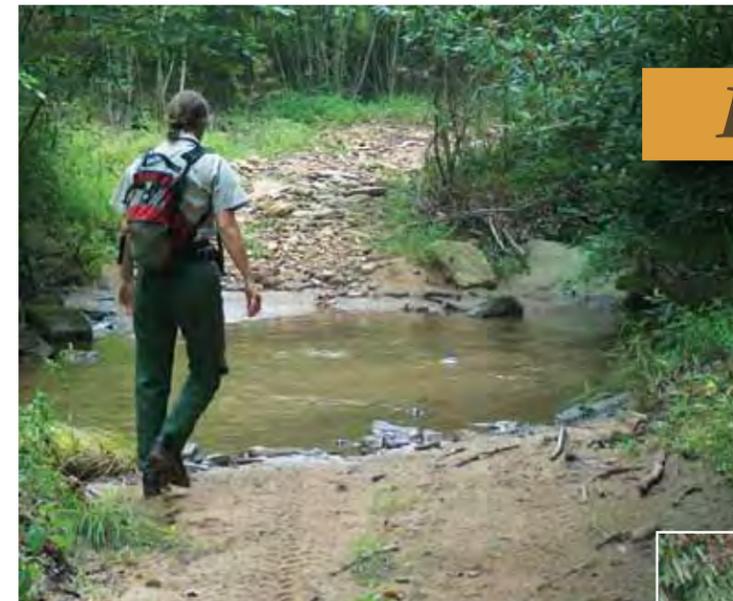
Before

- ✗ Road surface was washed away.
- ✗ Loose silt and sediment could erode into the stream.
- ✗ Approachways at the stream crossing were not firm and stable for vehicle use.

Demonstrating Best Management Practices (BMPs) for low-water ford stream crossings at Rendezvous Mountain Educational State Forest in Wilkes County.

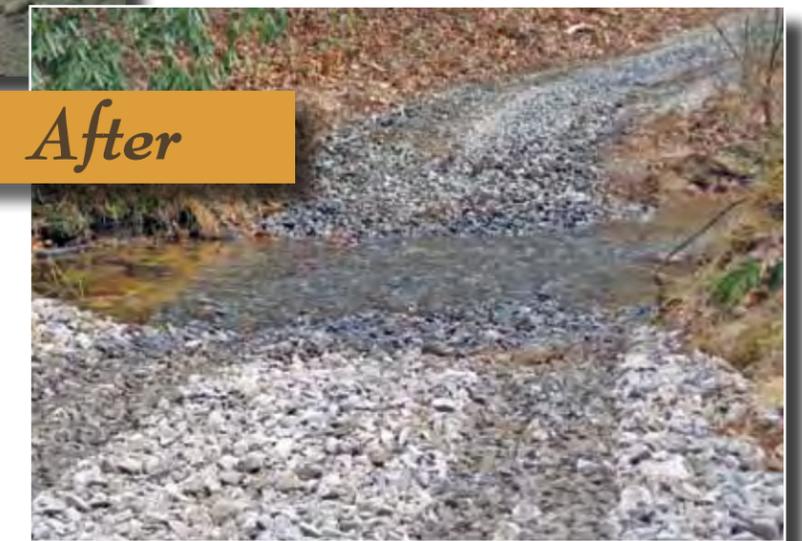
After

- ✓ Road is graded for better control of runoff.
- ✓ Crushed ballast on the road improves surface drainage.
- ✓ Approachways are stabilized to keep soil from being pulled into the stream by vehicle tires.
- ✓ The stream bottom is protected with a layer of stone, while still allowing water and aquatic organisms to pass through.

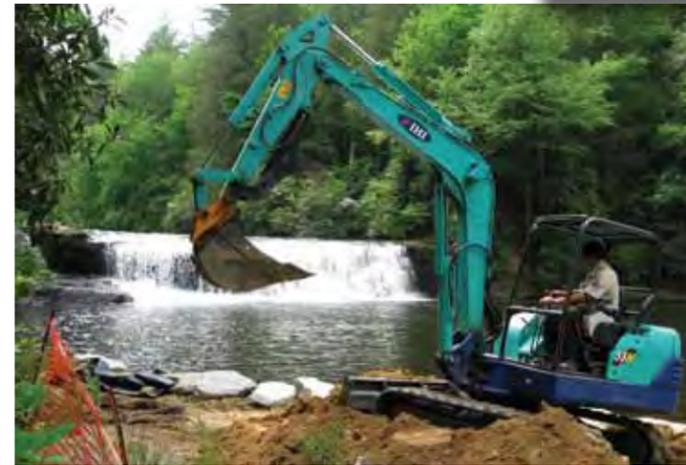
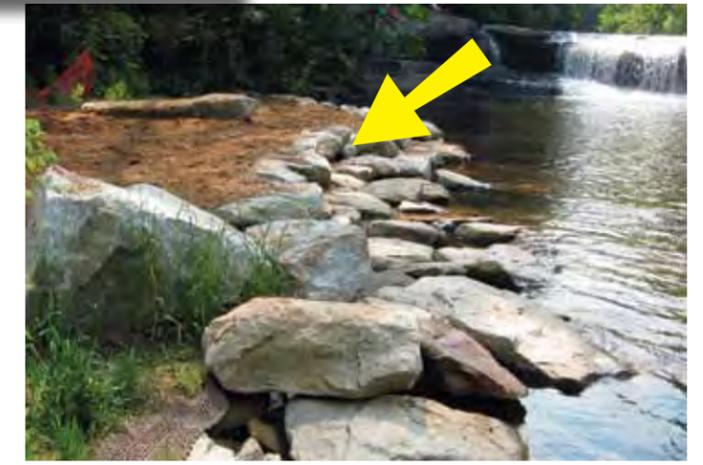
Further stabilization and protection of the river bank near Hooker Falls at DuPont State Forest was completed. We added a layer of boulders (arrow) along the river's edge to prevent overwash and erosion. This additional work complemented the overall restoration that was accomplished in 2007.

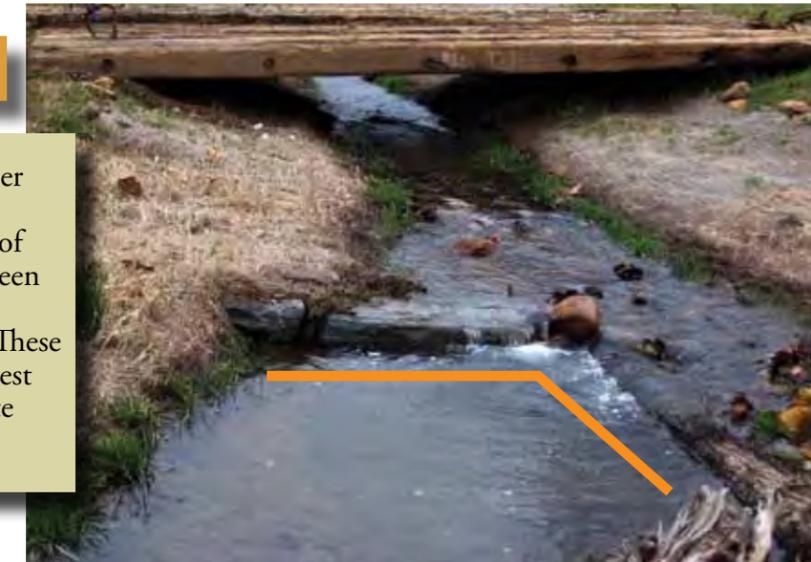
A set of our retired timber bridgemats is shown at right, crossing a section of Purlear Creek that has been restored at Rendezvous Mountain State Forest. These mats allow access by Forest Rangers and demonstrate forestry BMPs.

Note the V-shaped structure installed in the stream channel, made up of a flat boulder and log. This structure directs the flowing water towards the center of the channel so the water will not erode and undercut the stream bank.

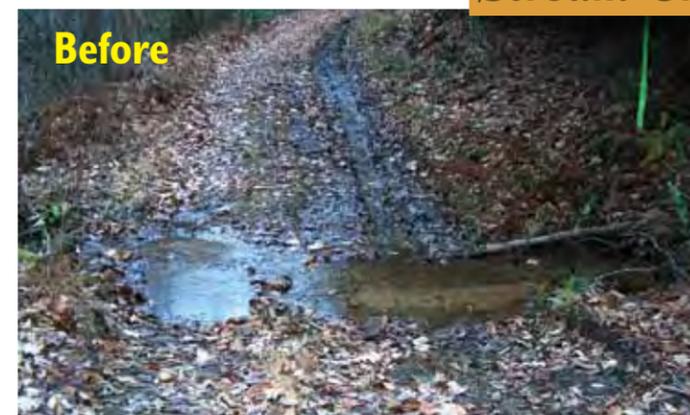
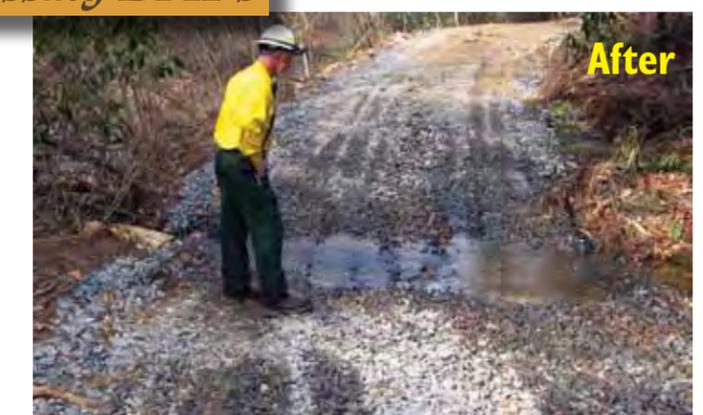
Another low-water ford stream crossing that we improved and rehabilitated utilizing BMPs to complete the work. Before the work, the soft roadbed allowed ruts to funnel runoff into the stream and limited access to a large area of the State Forest. After the work, the roadbed is firm and surface drainage is improved. Water quality is enhanced by eliminating muddy runoff and preventing sediment from washing into the stream.
