**An Assessment
of Forestry
Best Management Practices
in North Carolina
2012-2016**

**Prepared by:
Water Resources Branch
North Carolina Forest Service**

North Carolina Department of Agriculture and Consumer Services

March - 2018

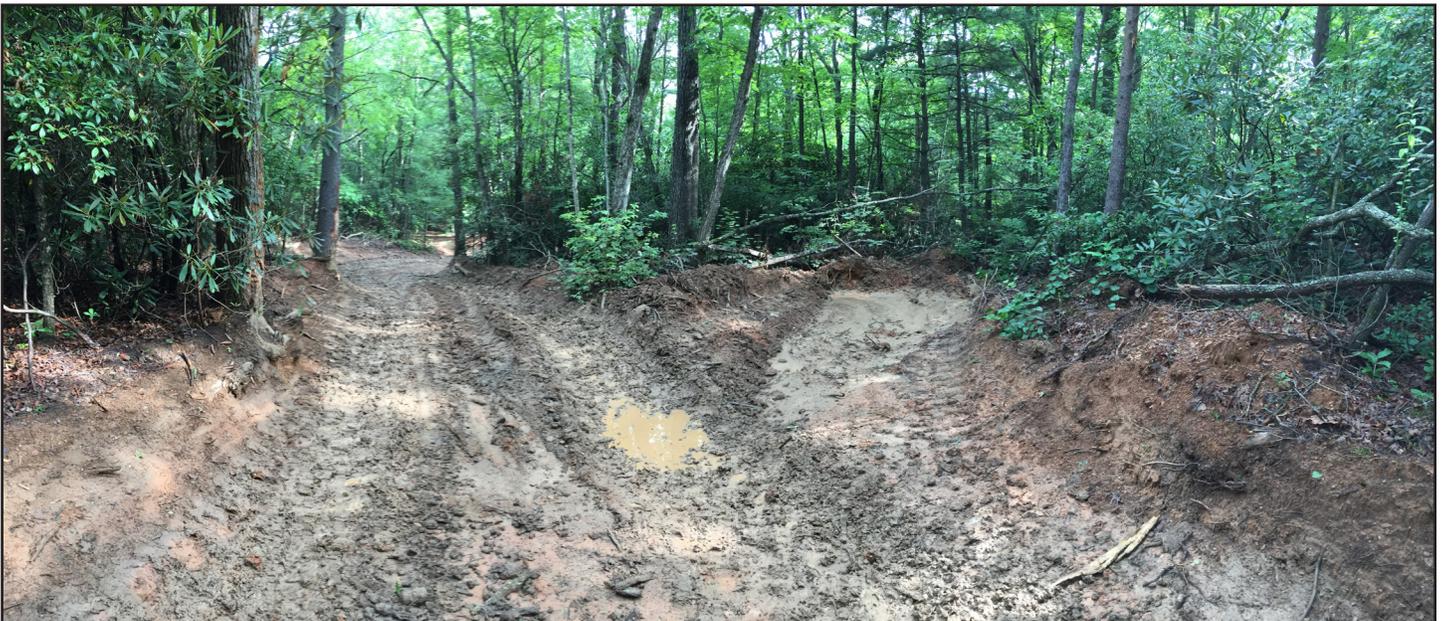
Photo 1. Though equipment traffic over this wet soil has the potential to cause rutting, the operator installed periodic turnouts on this skid trail to capture runoff, as seen on the right side of the skid trail.

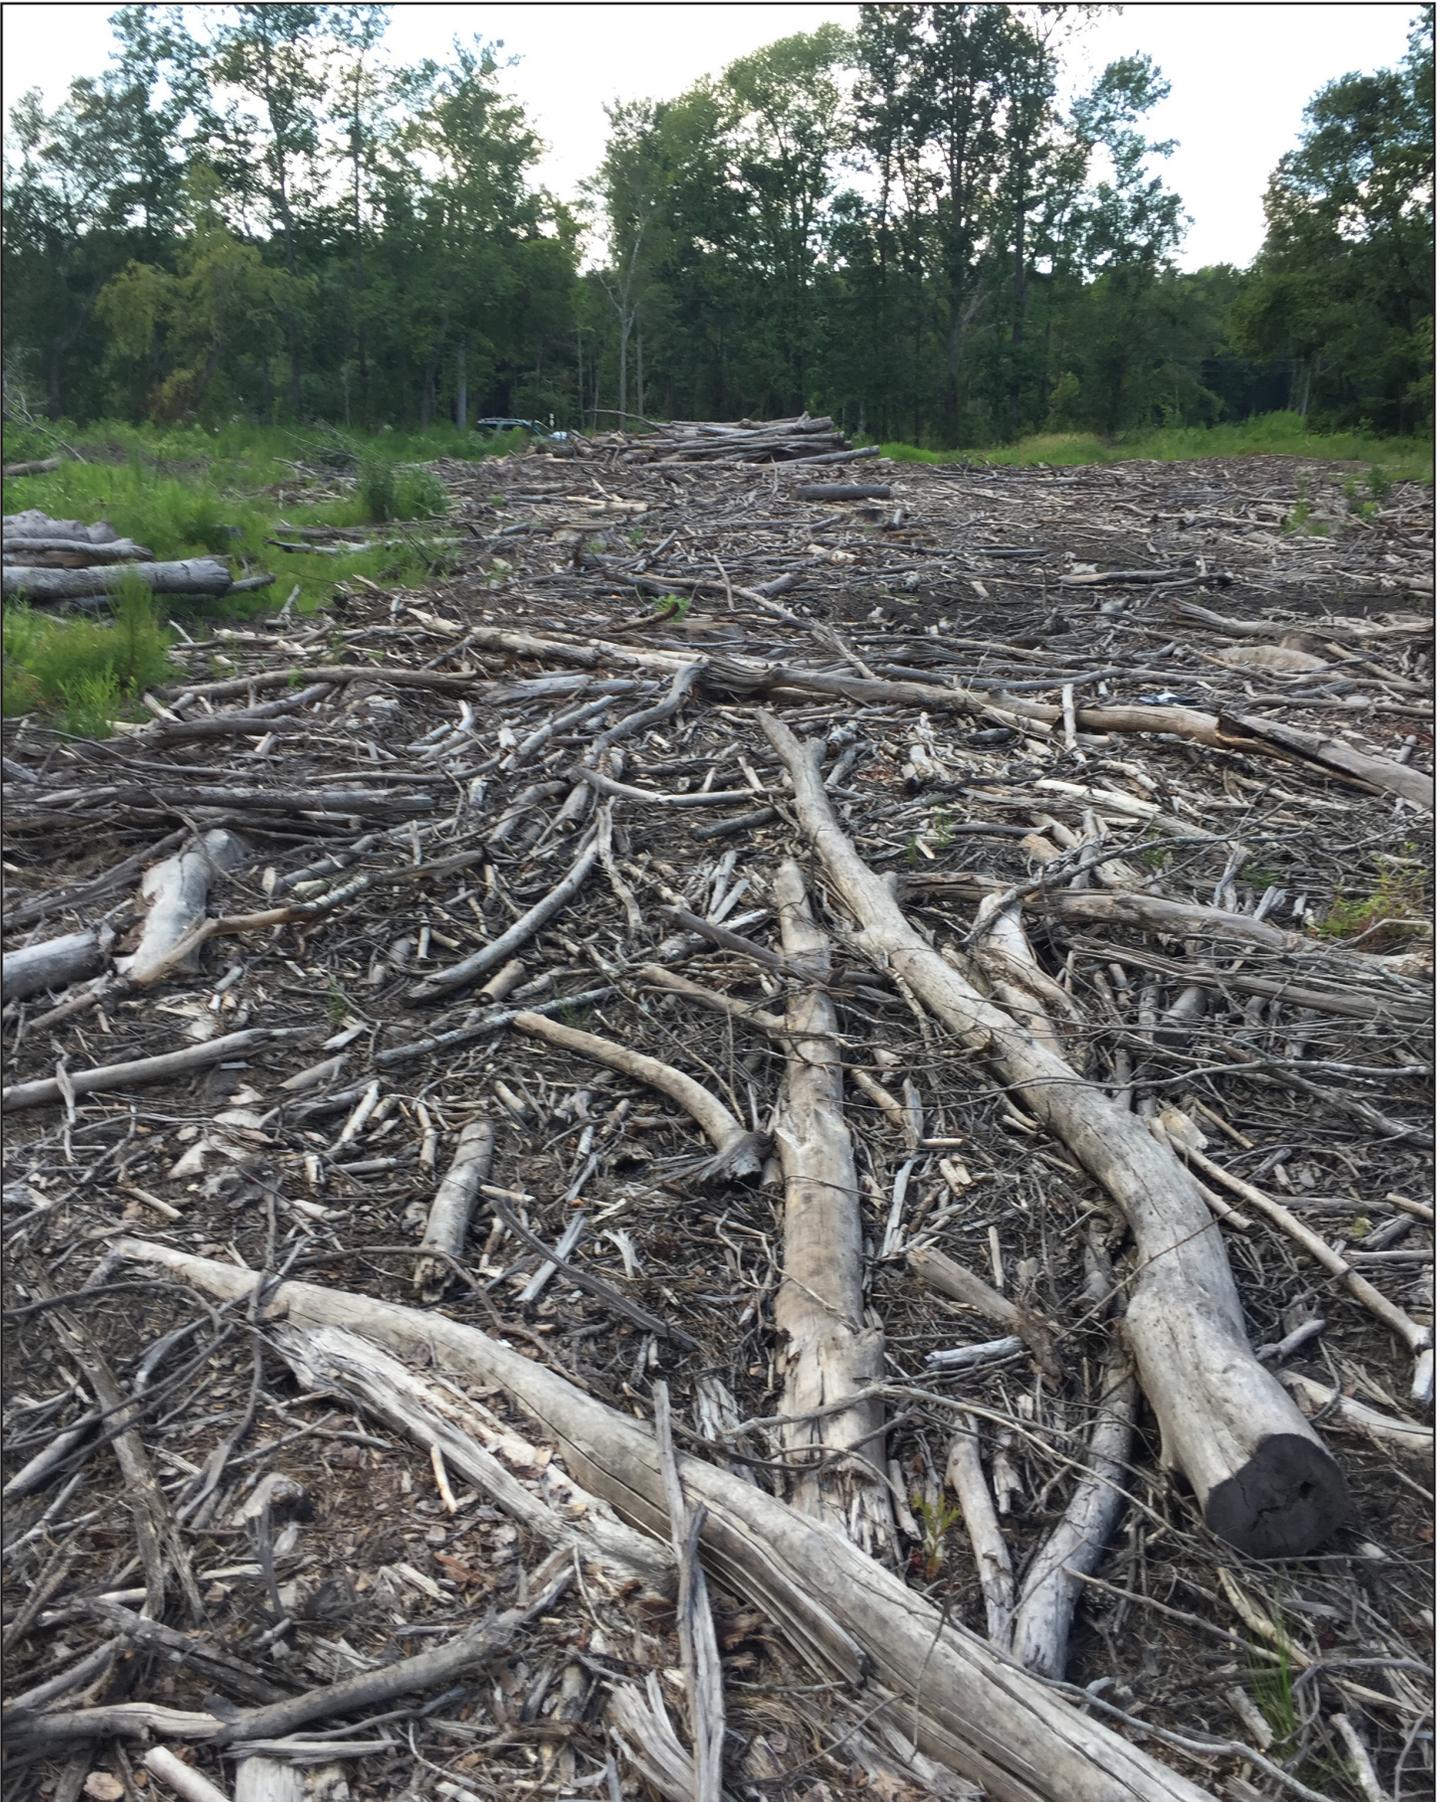
Photo 2. The practice seen in this photo of covering bare soil with logging debris substantially reduces erosion and prevents sediment and runoff from reaching waterbodies.

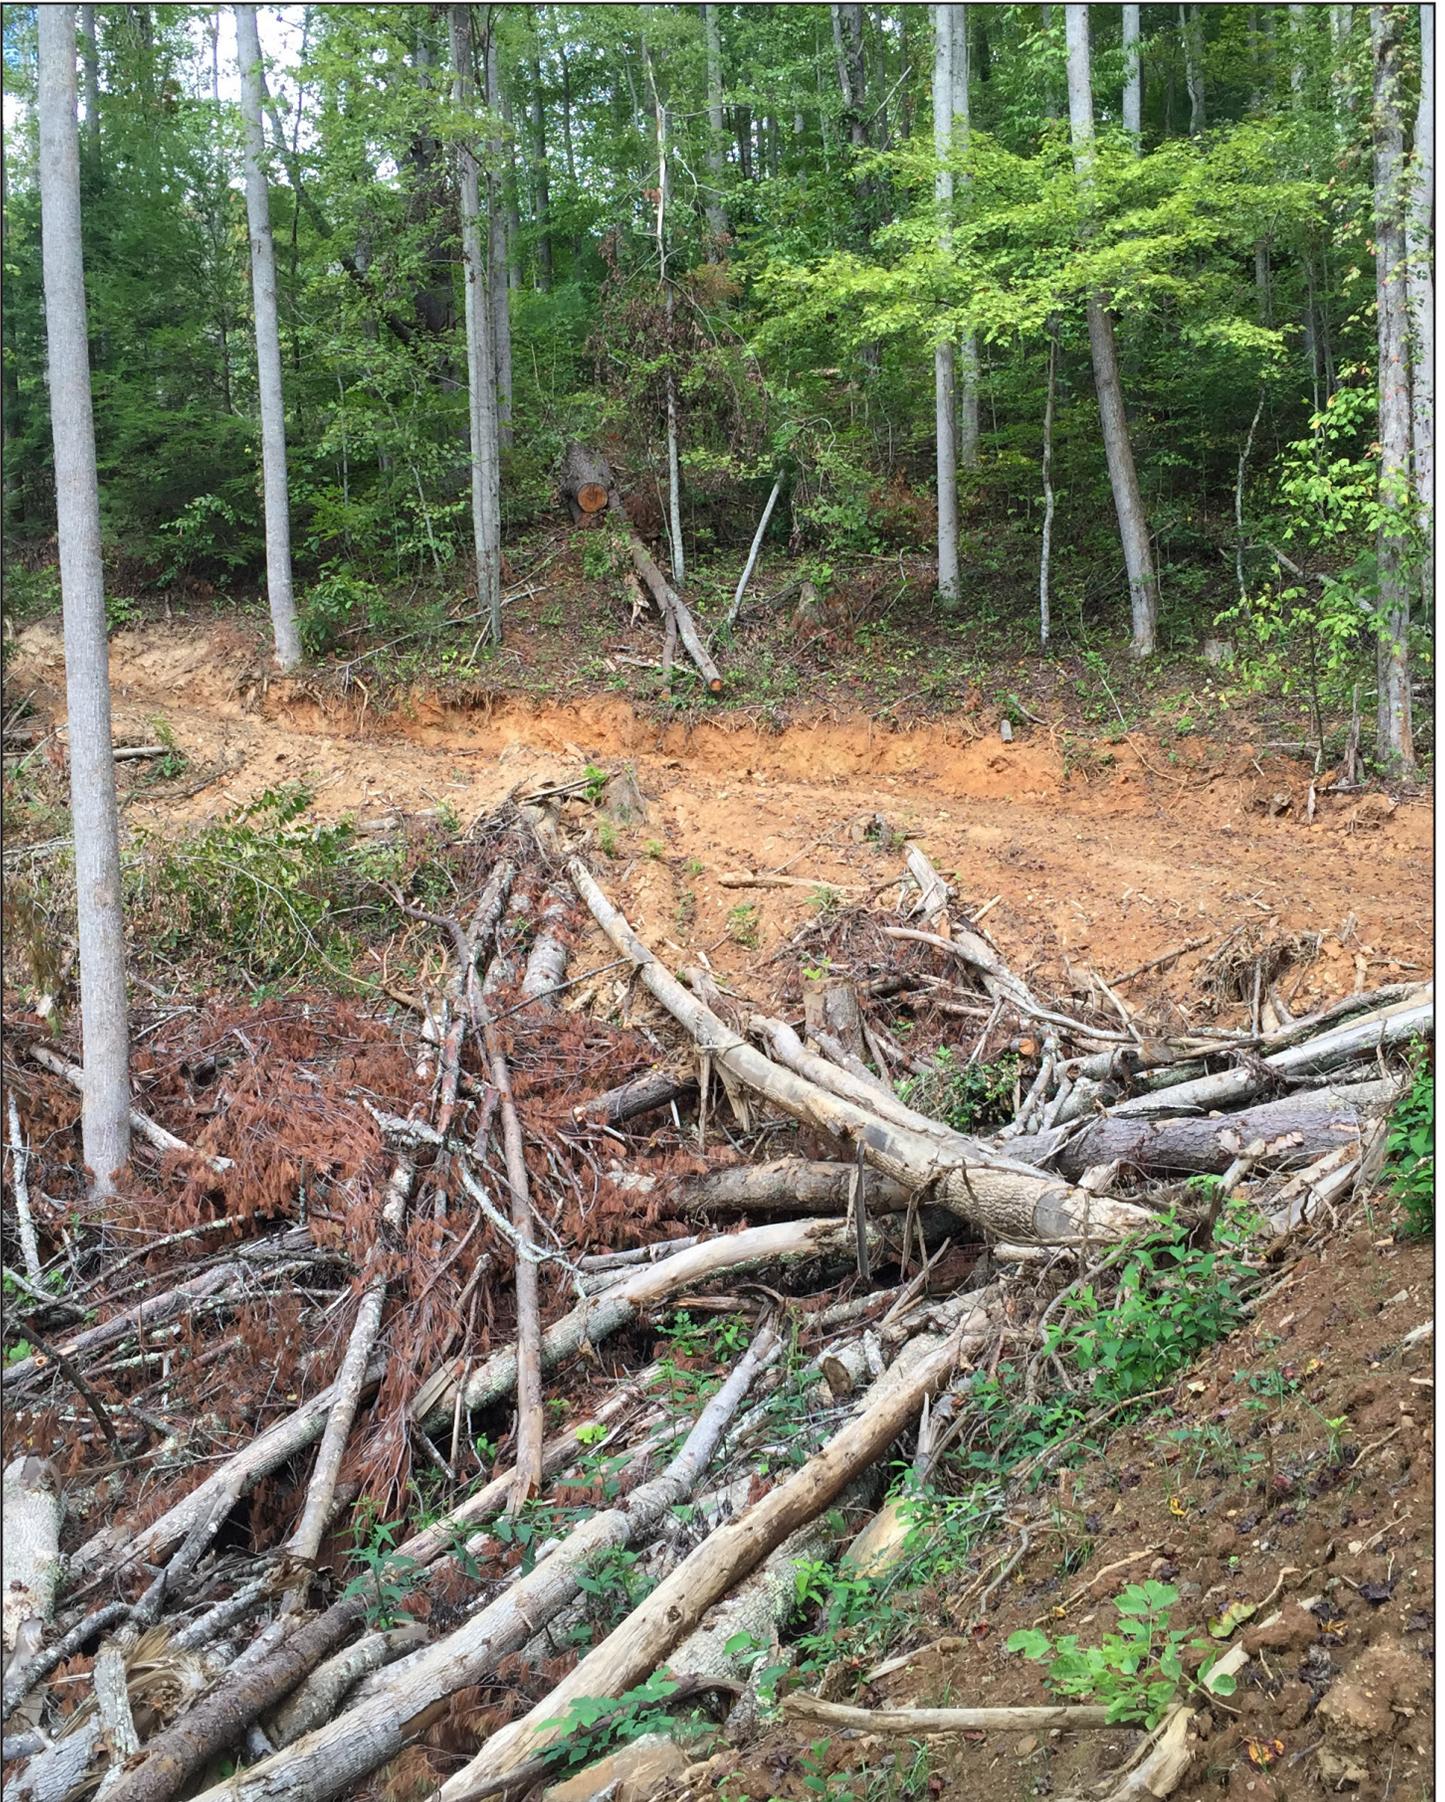
Photo 3. At this site, the forest operator placed logging debris along the edge of a skid trail to prevent sediment from traveling downslope. However, sediment movement could be prevented further by placing some of that debris atop of the skid trail itself.

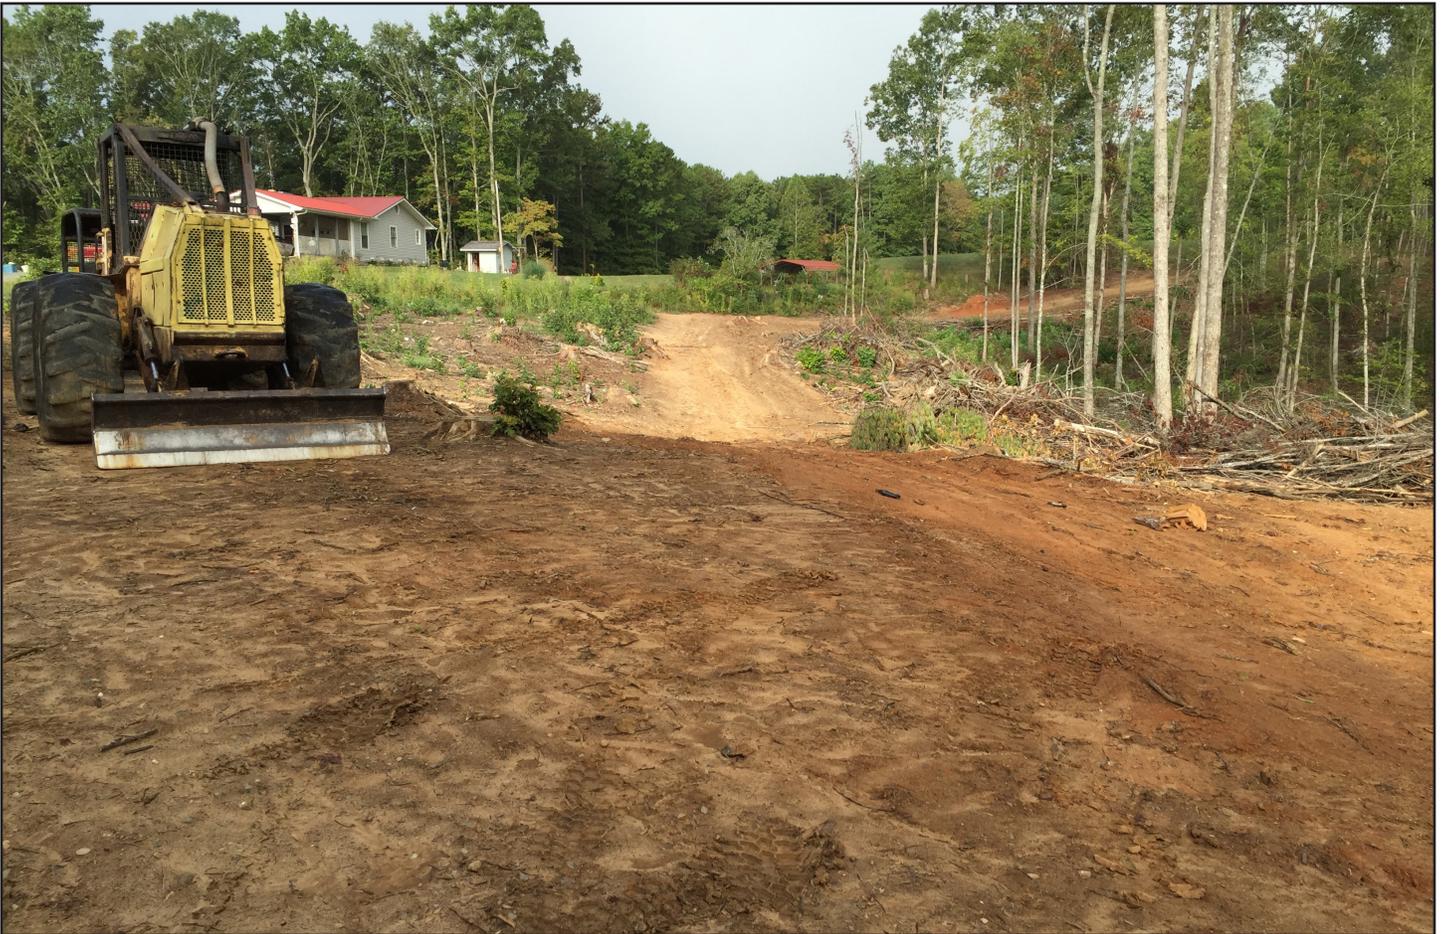
Photo 4. On this site in the Mountains, the deck is situated on a flat area near the top of a ridge, and a brush barrier on the right side of the picture helps to prevent sediment from traveling downslope into a ravine. However, more logging debris could be placed on the deck and the skid trail in the background, to further limit soil disturbance and erosion.

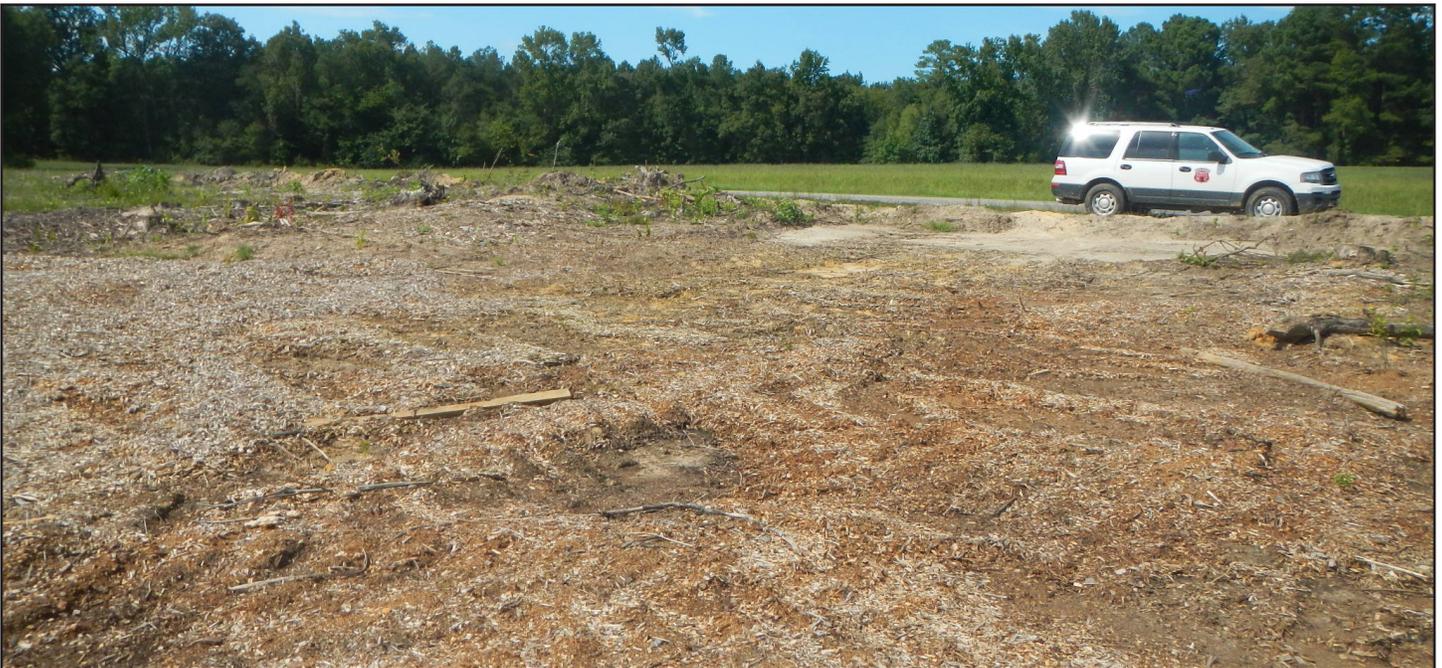
Photo 5. This deck was used for a timber harvest that utilized an in-woods whole tree chipper. The wood chips are scattered across the deck sufficiently to stabilize the flat ground and provide groundcover. Note the clean appearance of the deck, with most woody material having been utilized. Such thorough utilization of the timber can reduce the need for site preparation and associated costs for reforestation.

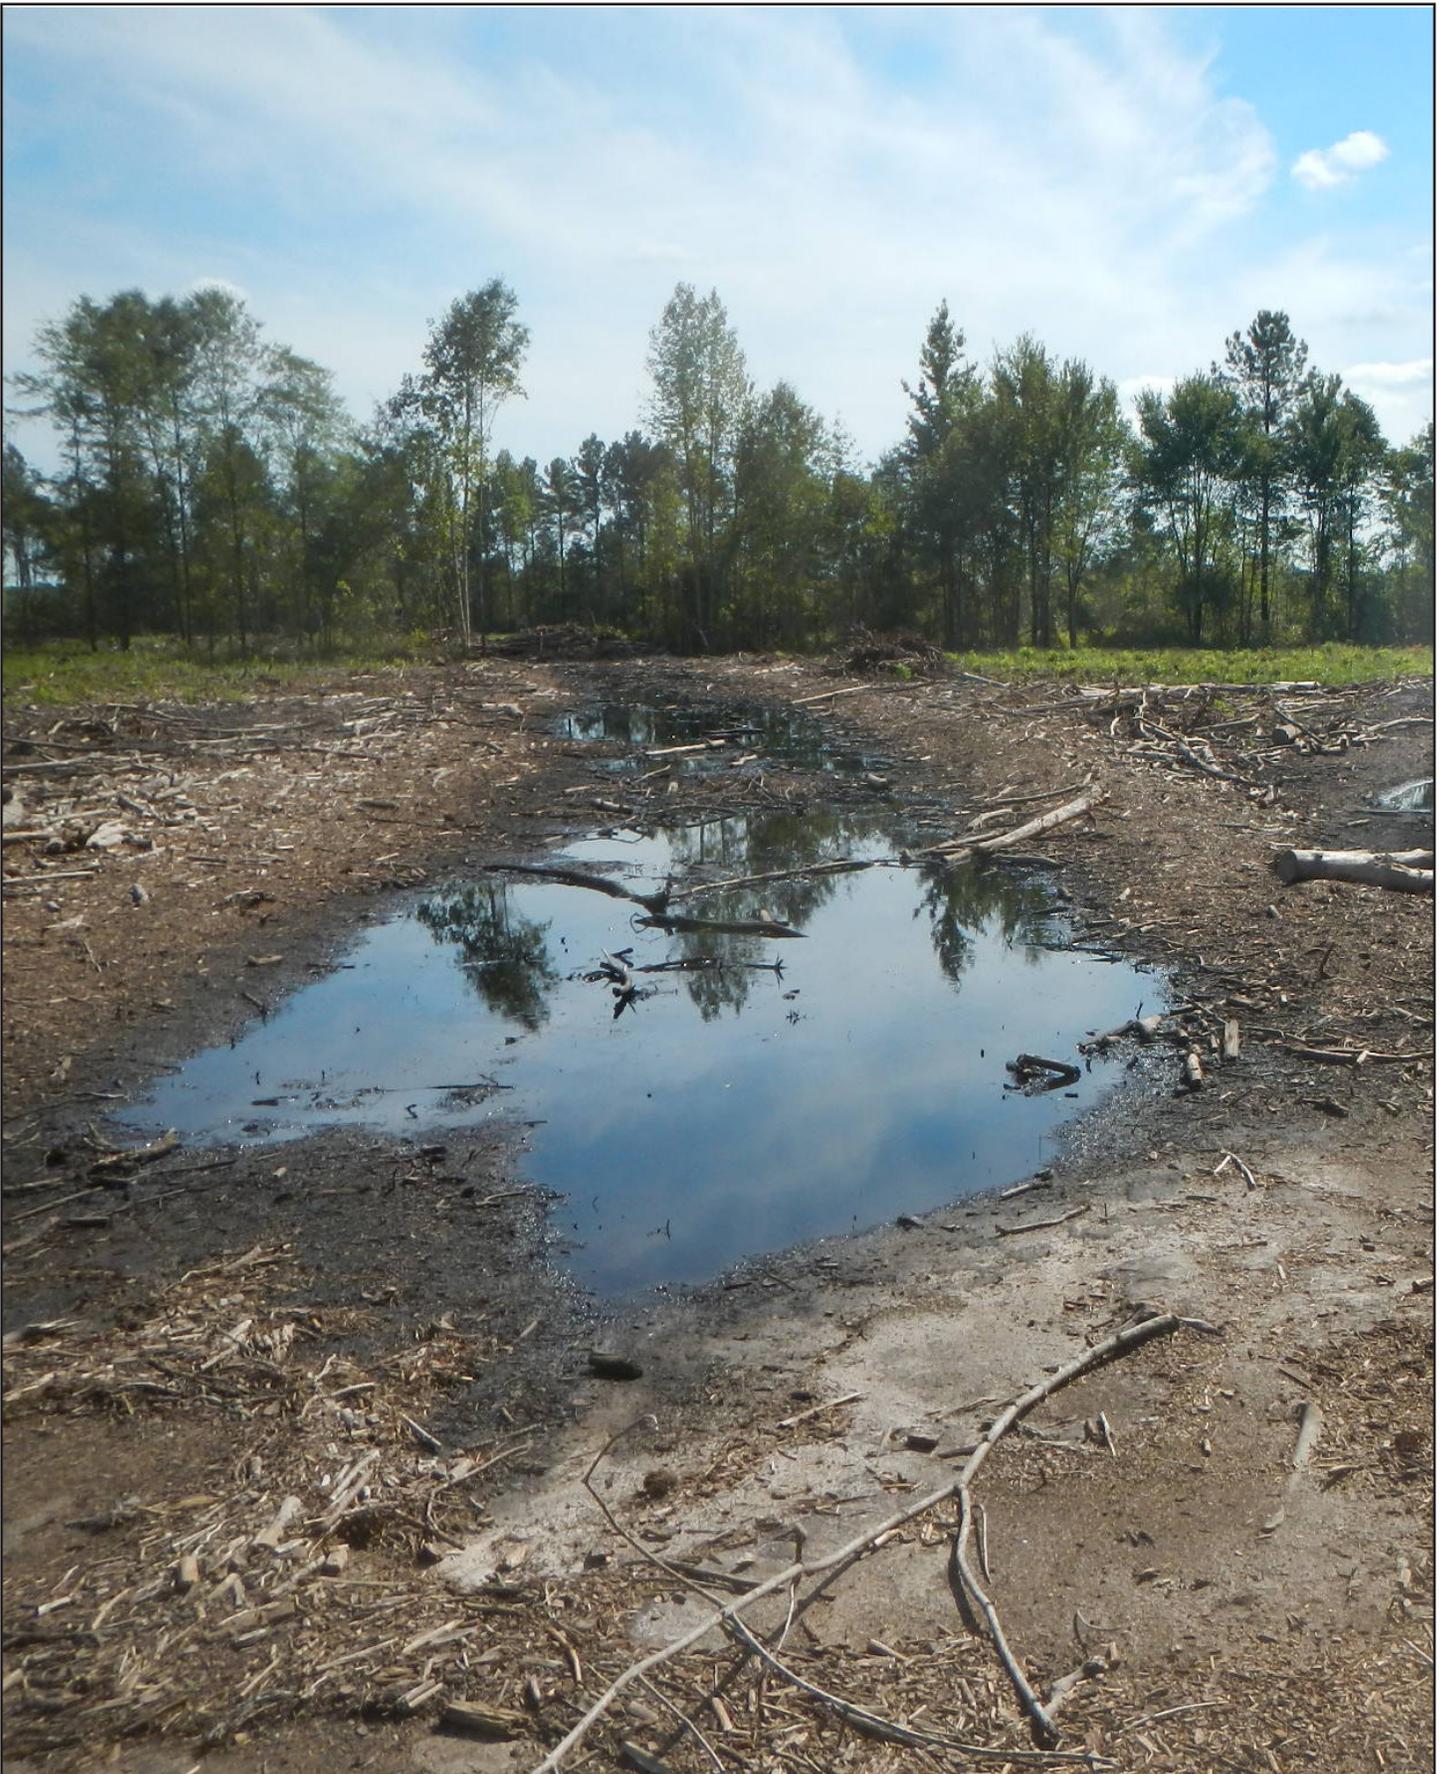
Photo 6. Water is standing in the main skid trails on this harvested site. While the soil in the primary skid trails may exhibit signs of compaction, soil disturbance on the overall tract was minimized by concentrating skidding on the main skid trails and avoiding widespread, randomized skidding.

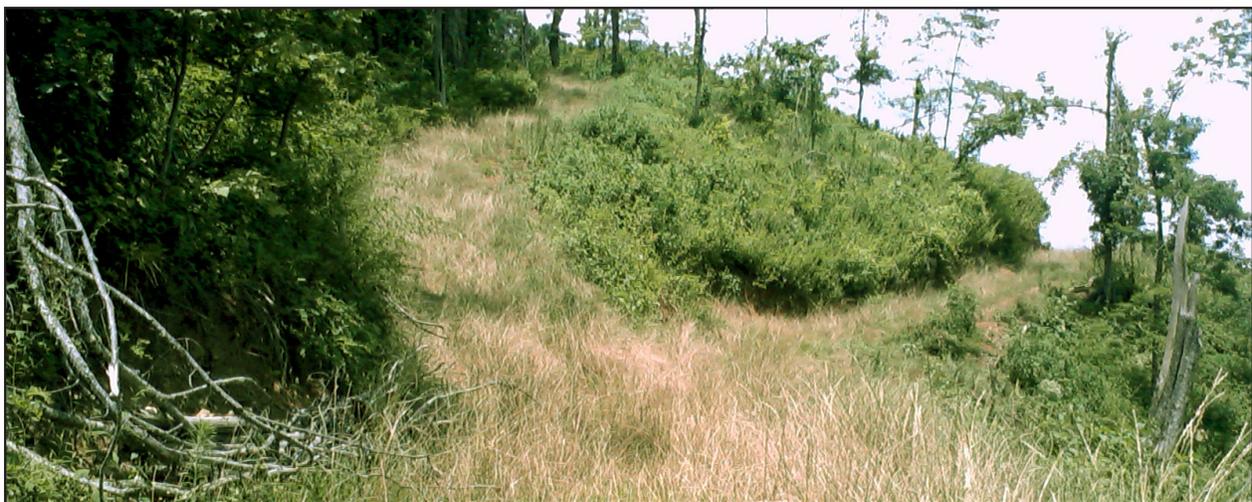
Photo 7. Skid trails are stabilized with ample groundcover vegetation.

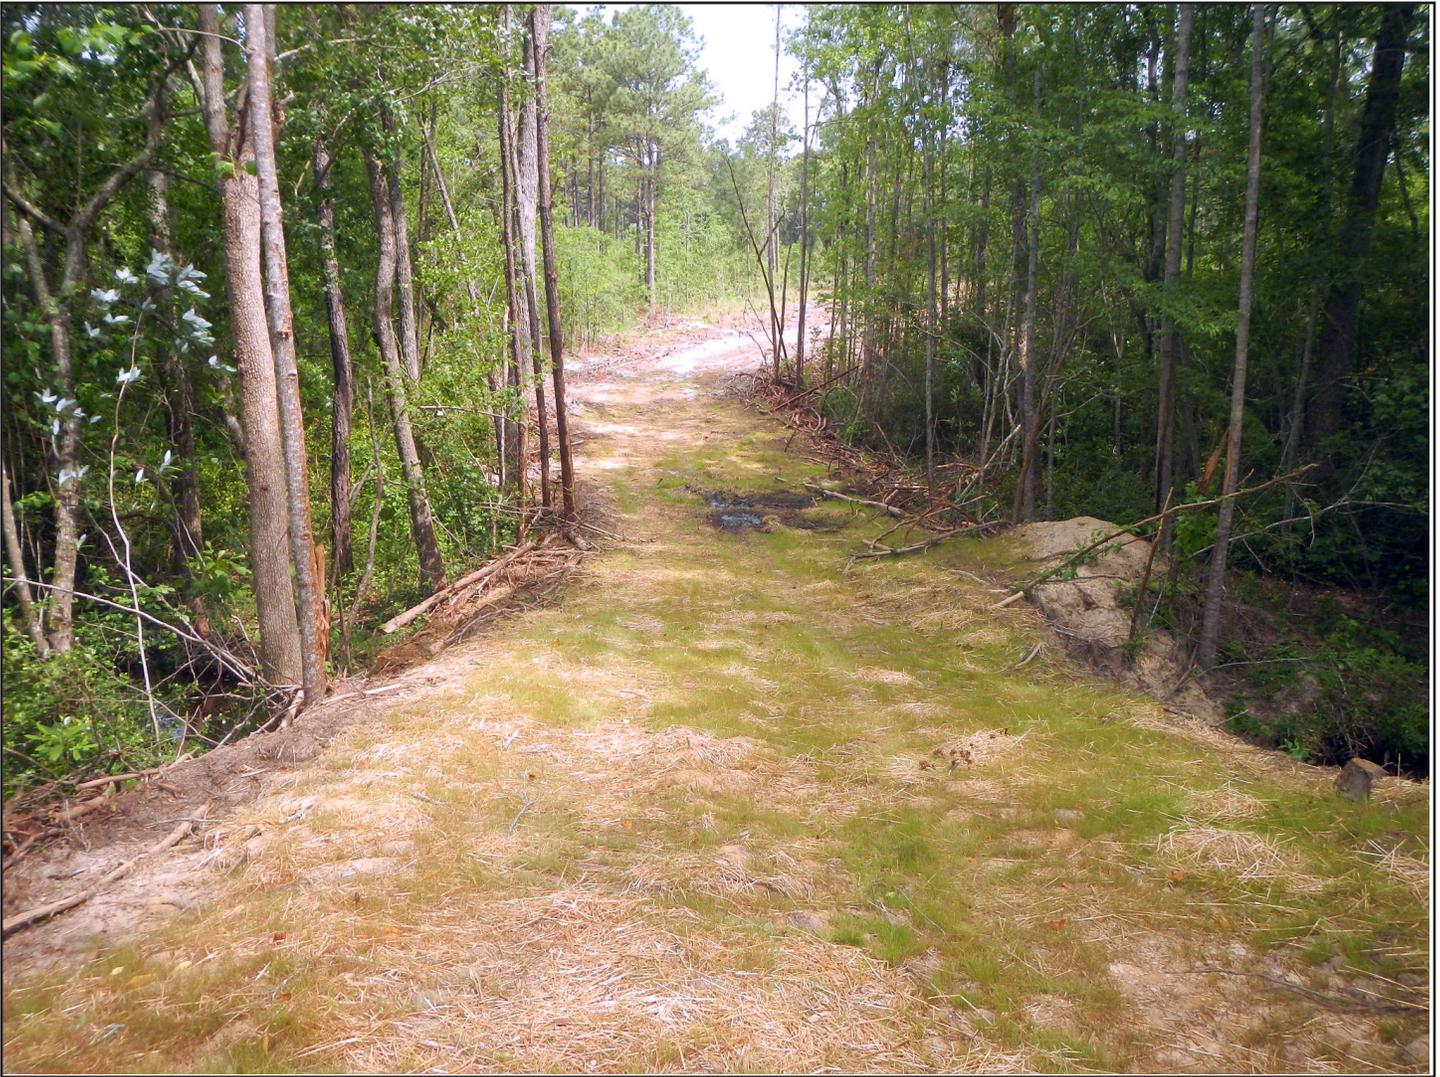
Photo 8. This roadway through a SMZ has new vegetation emerging that will stabilize the soil.

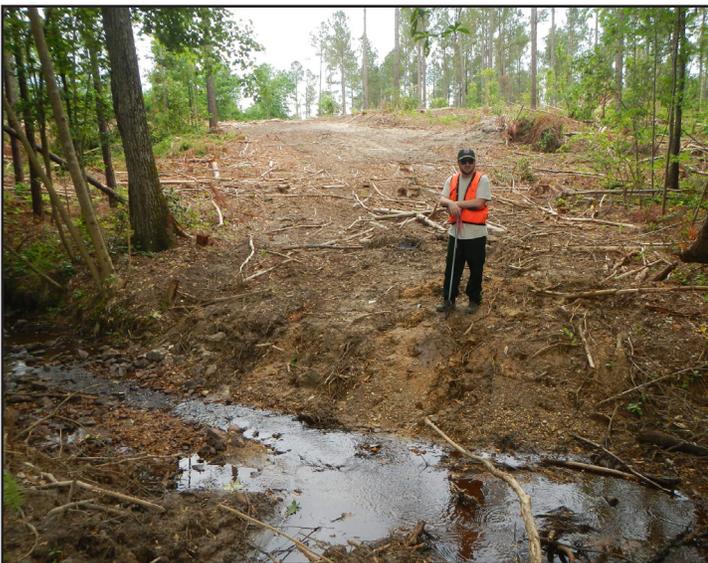
Photo 9. Stream crossing that was removed and still in need of BMP stabilization.

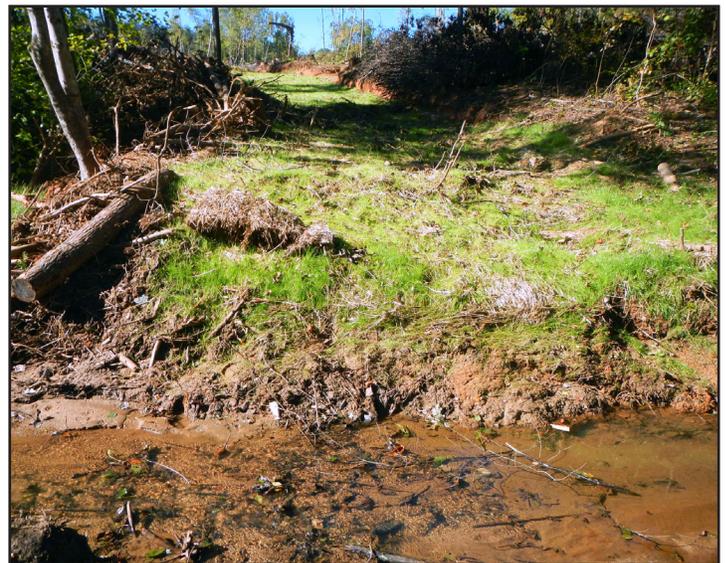
Photo 10. A properly stabilized stream crossing with ground vegetation established and water diversions installed.

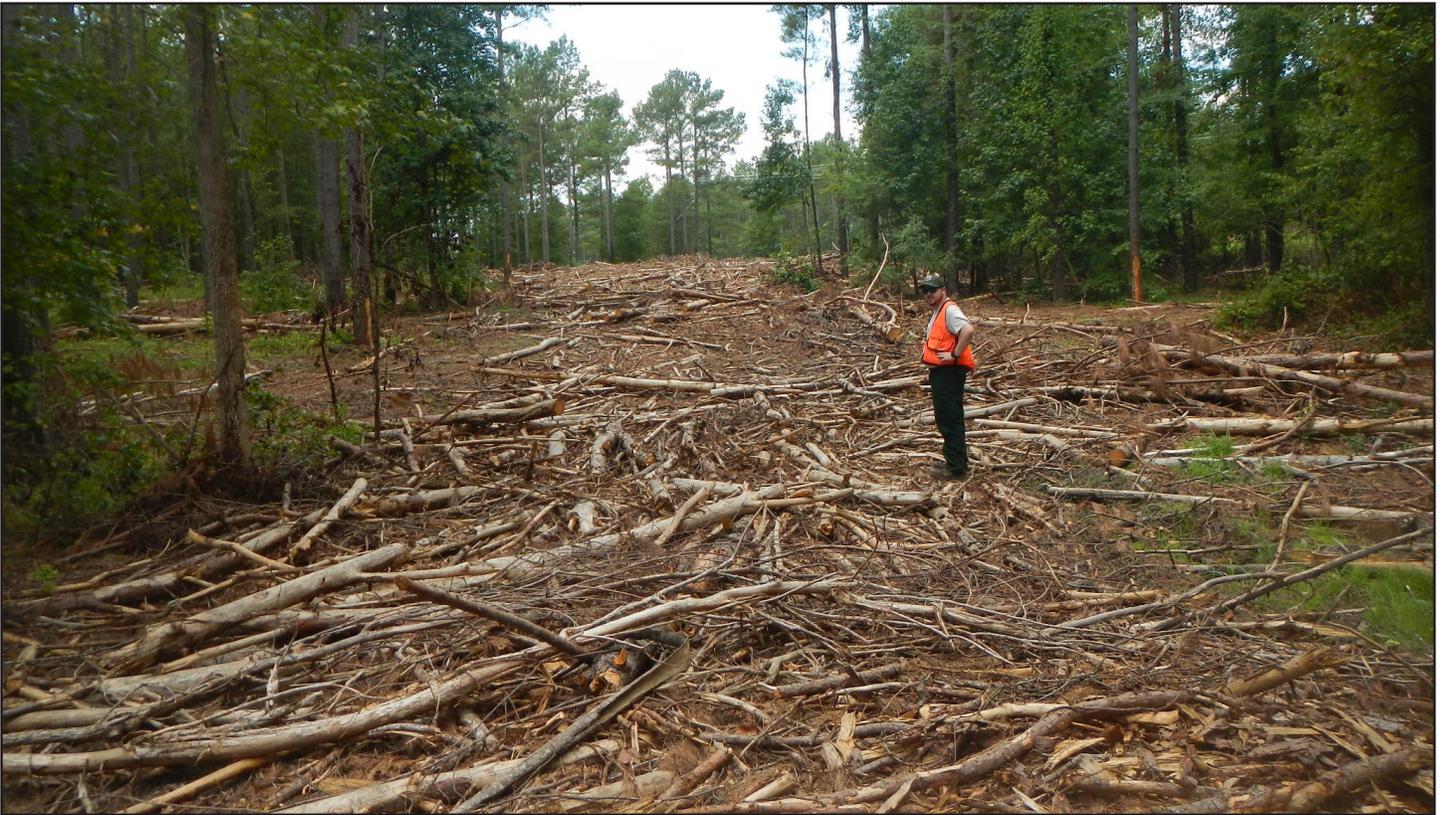
Photo 11. This main skid trail has ample logging slash (laps) applied atop of the ground surface. When applied at the onset of the harvest, and frequently added to, this material provides instant groundcover protection of exposed soil and reduces impacts to the soil.

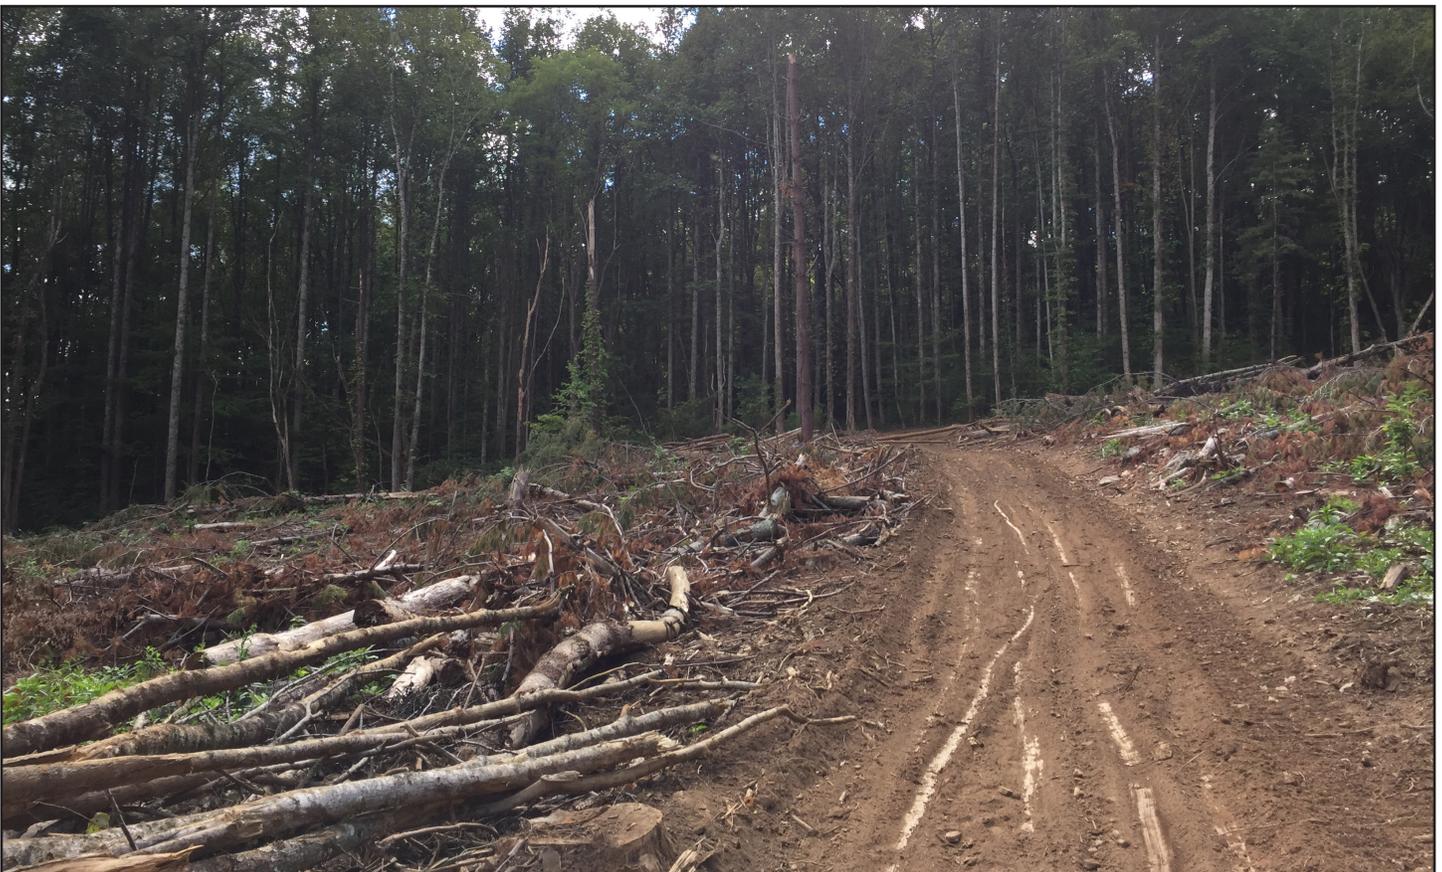
Photo 12. This skid trail generally follows the contours of the land, which helps to limit the slope of any skid trail segments. However, the leftover logging debris could be placed on top of the trail to prevent erosion and runoff.

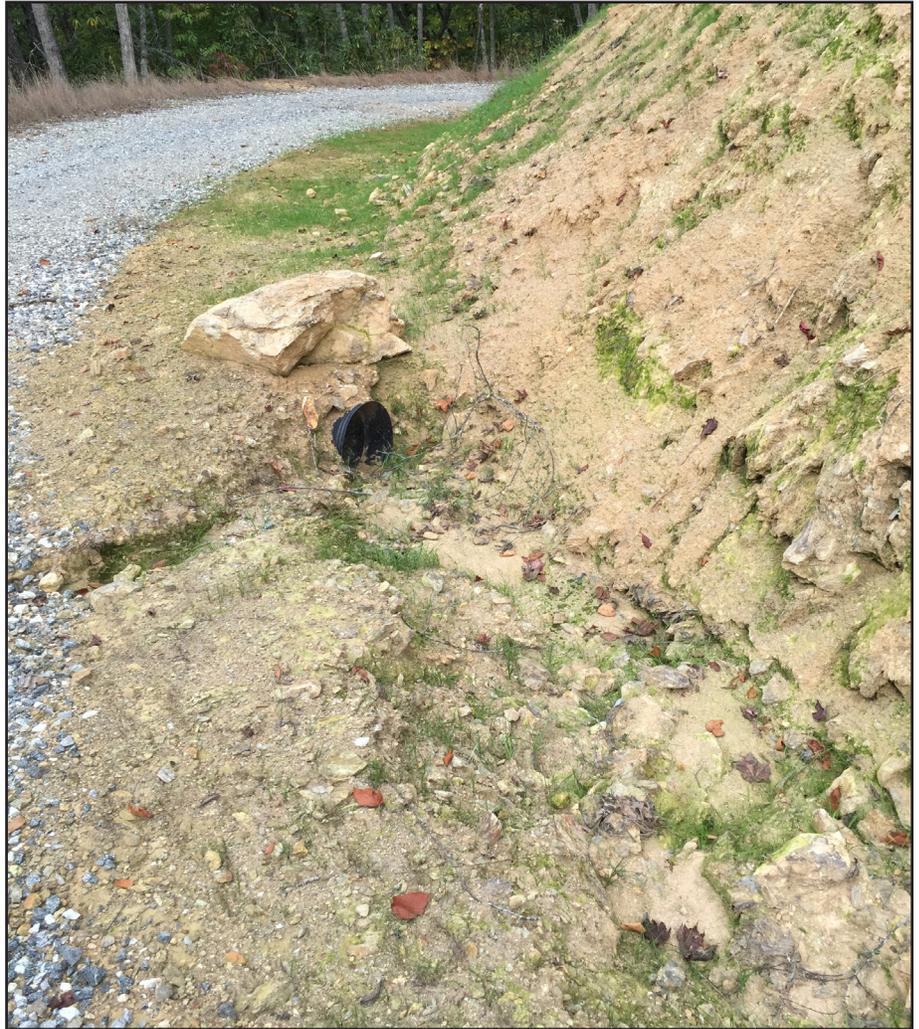
Photo 13. This cross drain collects runoff from an inside ditchline into a small pipe. The pipe runs under the road, and a brush barrier is placed under the outlet. Additionally, because the road is constructed with an inslope, water running off the road surface flows into the ditchline, and then into the cross drain. These cross drains were placed periodically down the length of the road, to prevent runoff from accumulating and overwhelming a single drain. The ditchline in this photo needed stabilization work to reduce erosion and sedimentation.

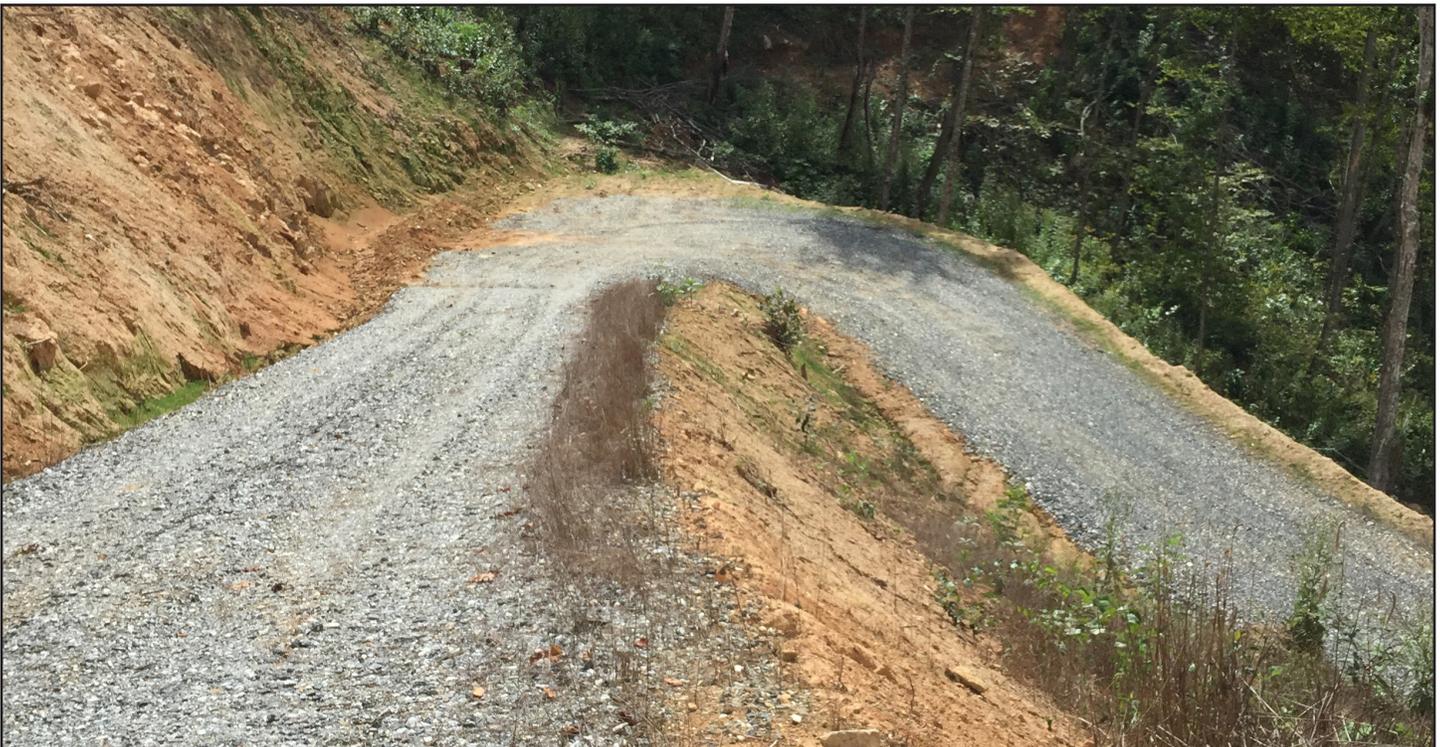
Photo 14. Example of a switchback on a steep mountain road. Gravel was applied to stabilize the surface. Additional BMP work should occur on the exposed soil of the cut banks.

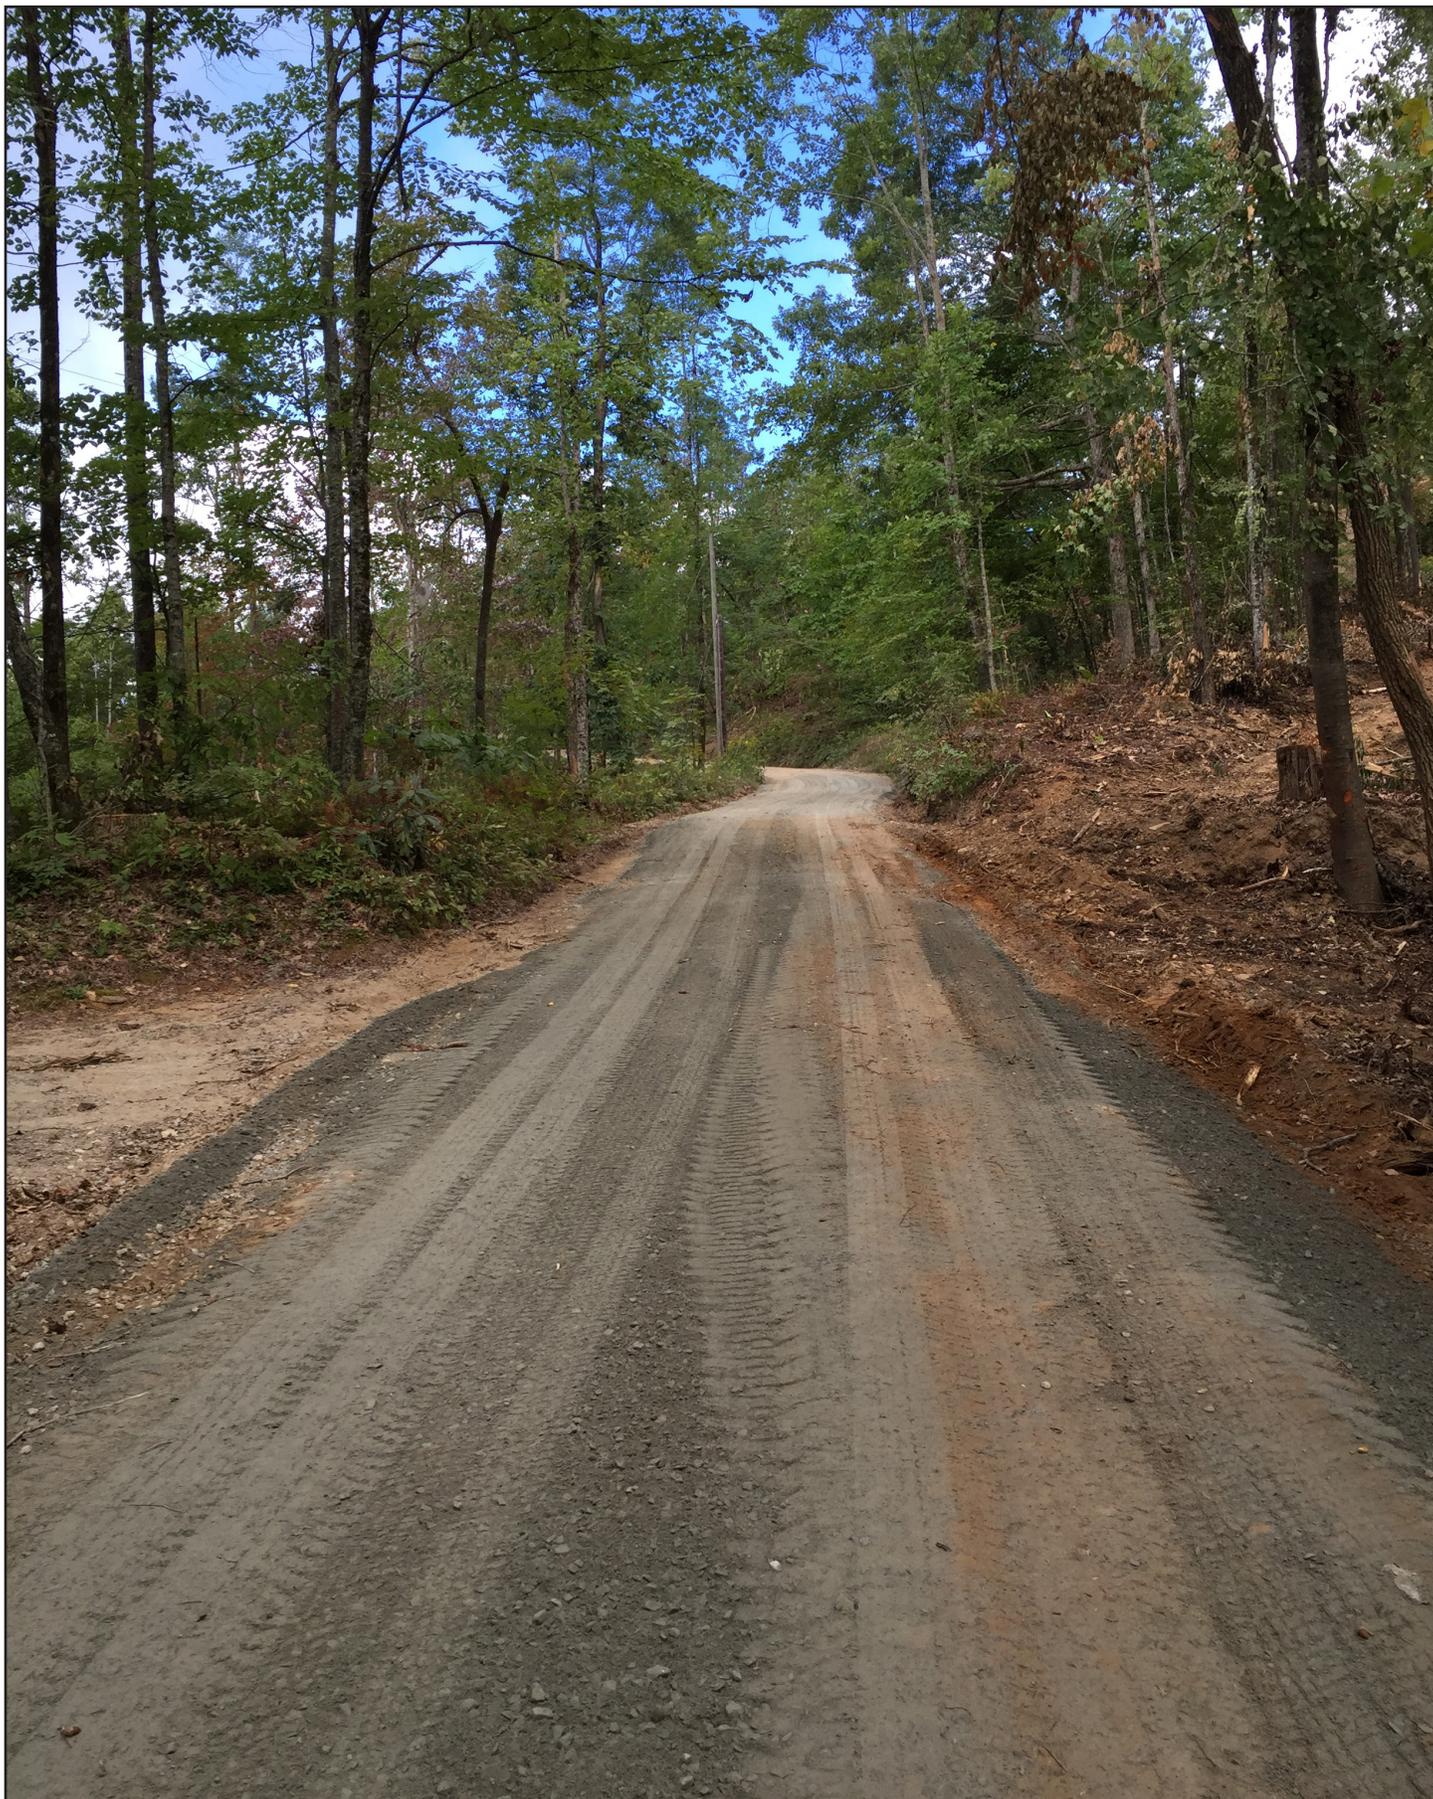
Photo 15. A well-maintained forest road. A shallow broad-based dip or similar water diversion is visible near the top of road. On sloping sections of road, it is important to frequently install diversions to control runoff and capture sediment before it can reach a waterway.
