**An Assessment
of Forestry
Best Management Practices
in North Carolina
2012-2016**

**Prepared by:
Water Resources Branch
North Carolina Forest Service**

North Carolina Department of Agriculture and Consumer Services

March - 2018

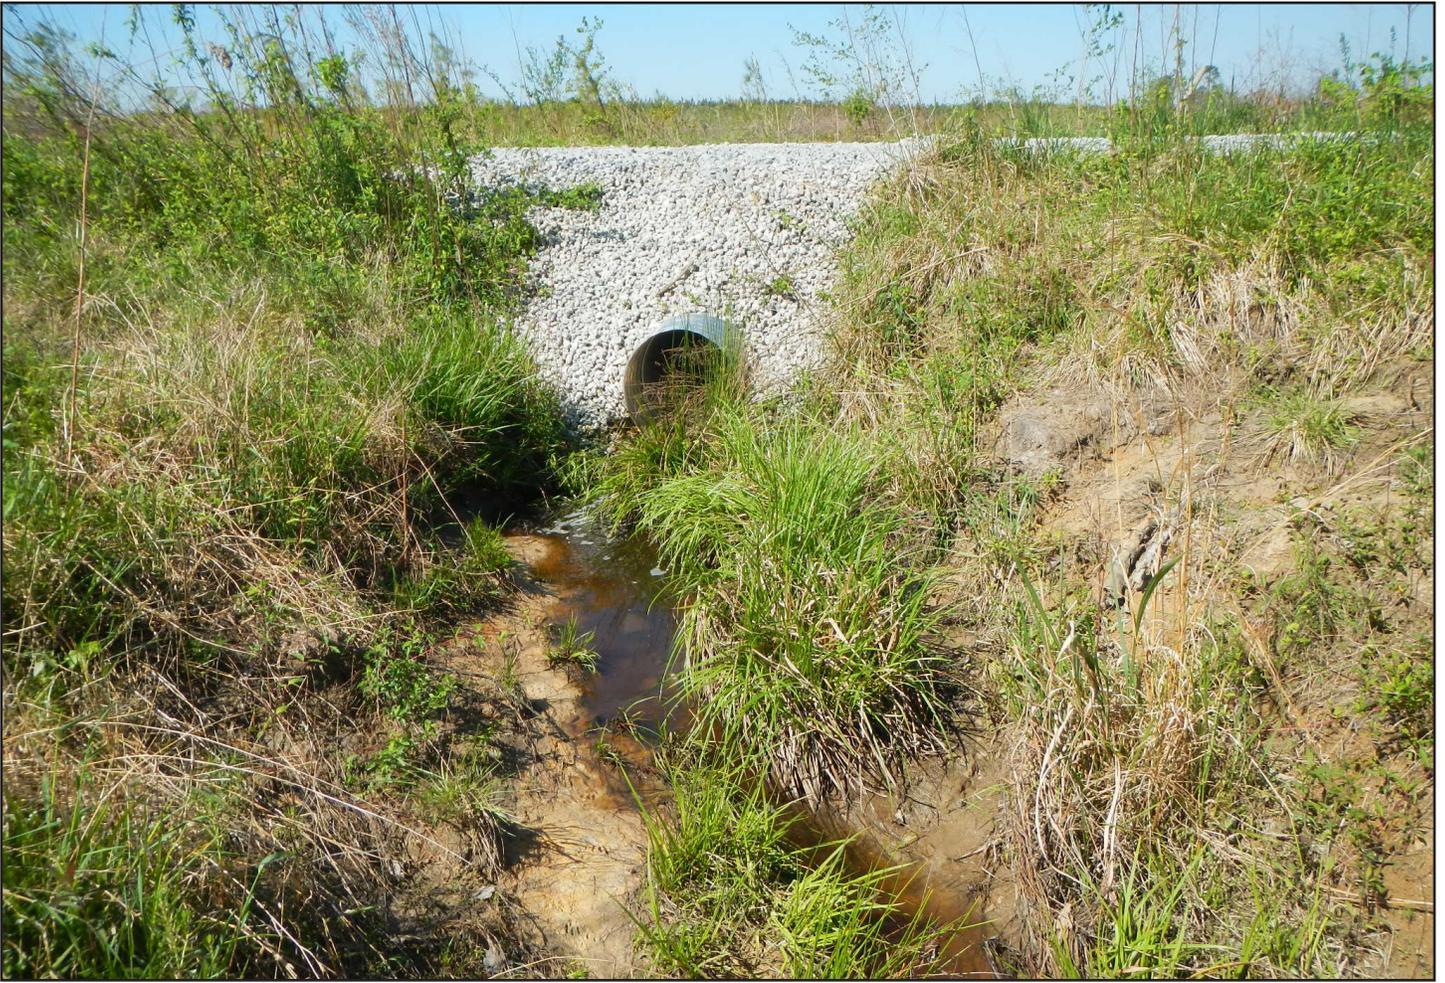
Photo 16. This culvert headwall was well stabilized, and the culvert appears large enough to handle water flow. Vegetation has been maintained on the streambanks and above the culvert, and the road above the crossing receives plenty of daylight, all measures that can help to limit erosion.

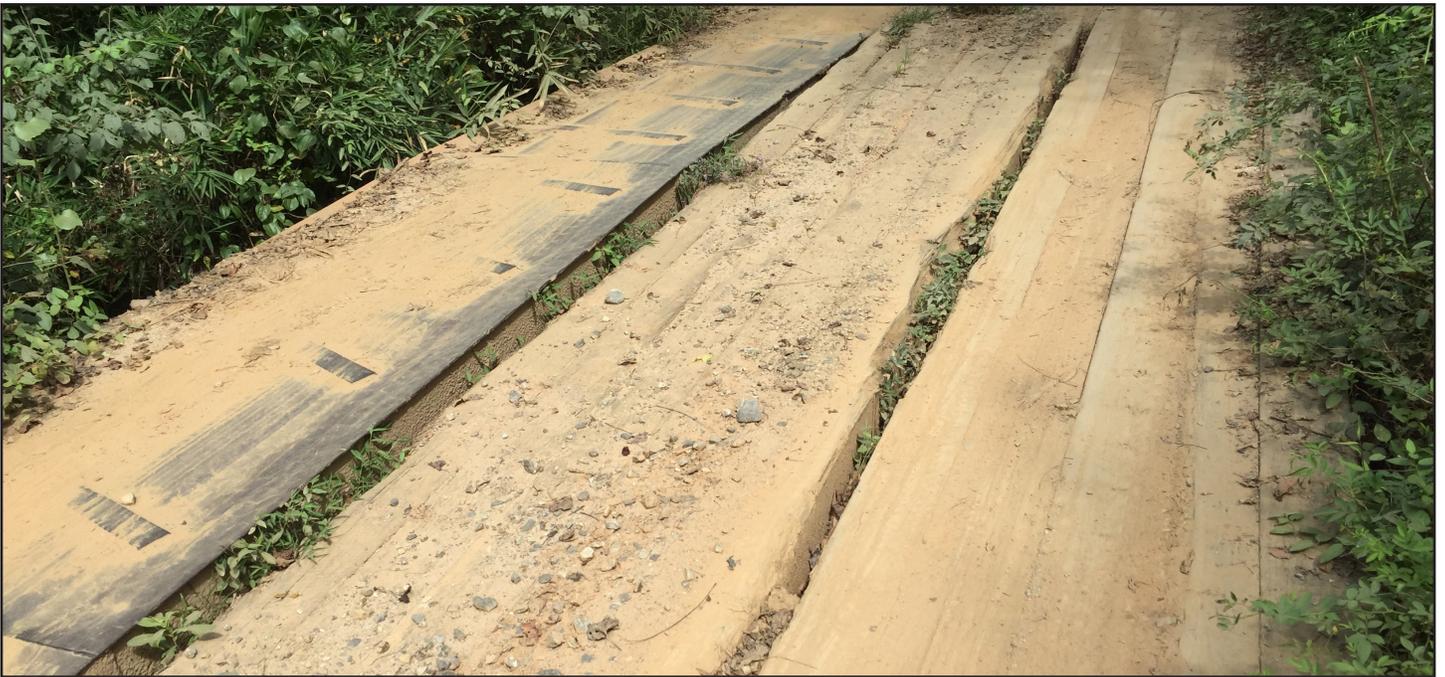
Photo 17. Though the use of bridgemats is recommended, they must be used correctly. Bridgemats must be tightly bunched together to limit gaps between them as much as possible. In the current arrangement, sediment can wash through the gaps between the mats, and enter the stream.

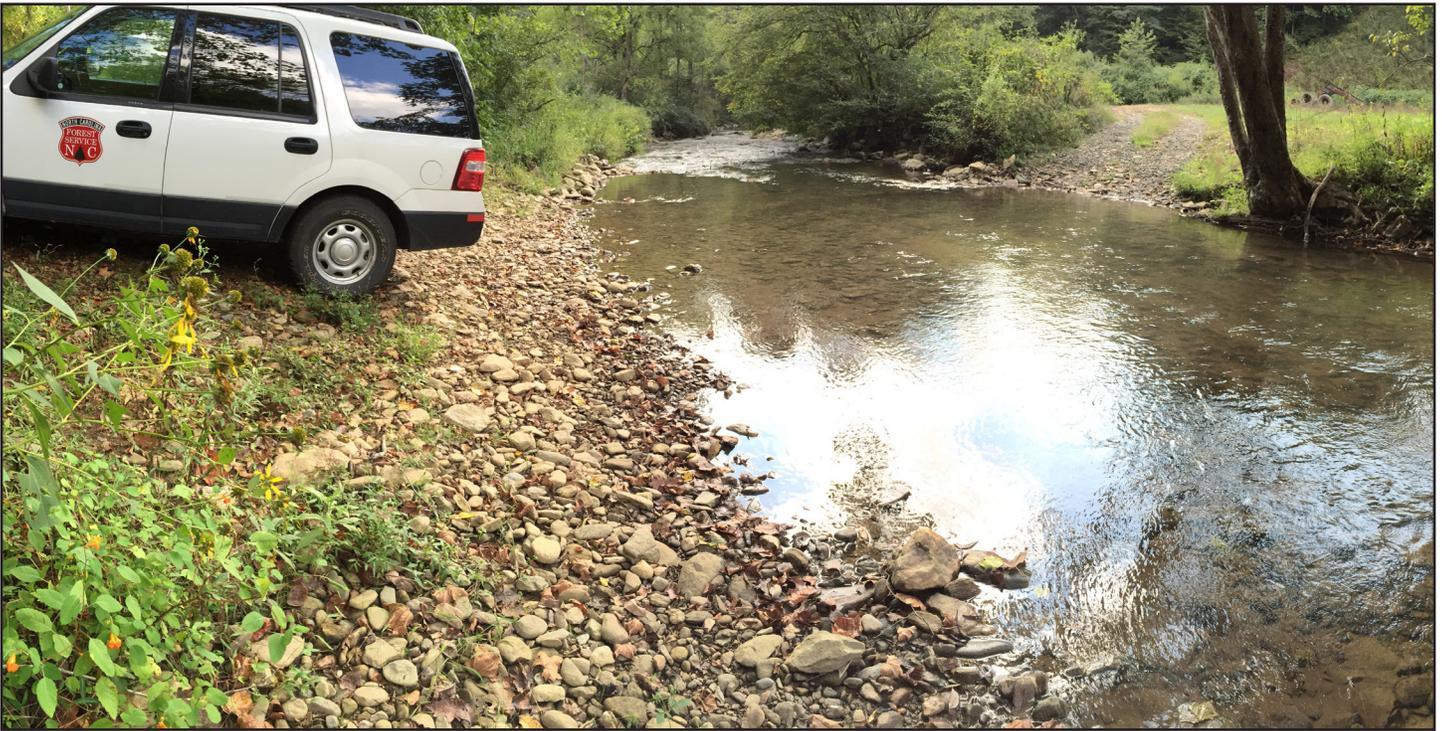
Photo 18. This is a relatively well-constructed ford crossing. The wide, stable rocky streambed and gentle approach make this a favorable location for a ford. On this harvest, the ford crossing was only used for truck access and not for skidding.

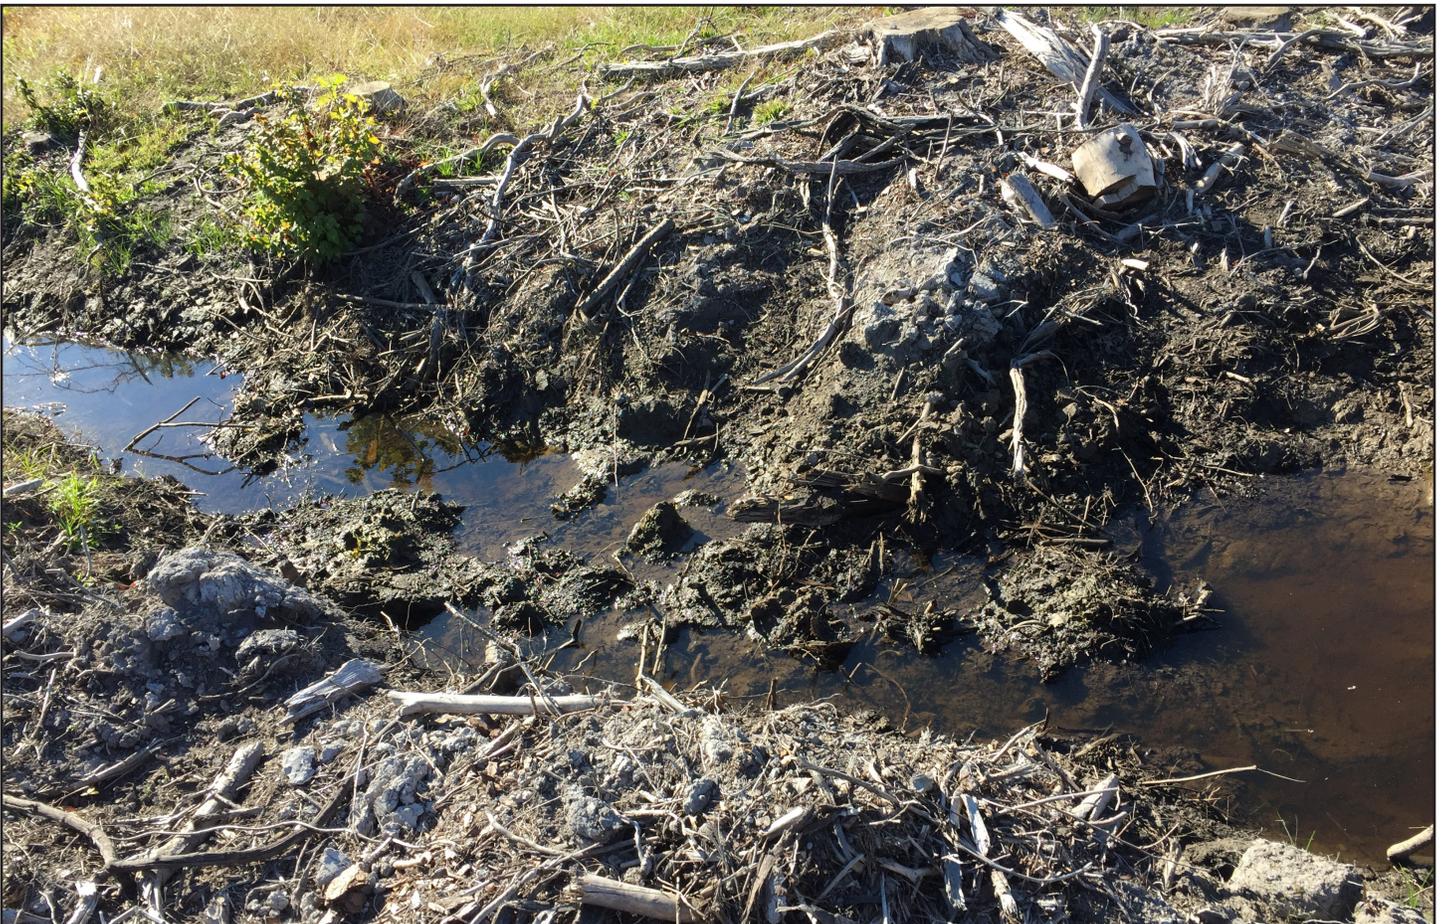
Photo 19. On this crossing in the Coastal Plain, it appears that skidders traveled directly through the waterway, disturbing the banks, and dragging sediment and debris into the waterway. This was characterized as a ford crossing by our evaluators. Fords should not be used on skid trails. A bridgemat would have likely been the best option in this example, or perhaps a temporary culvert crossing.

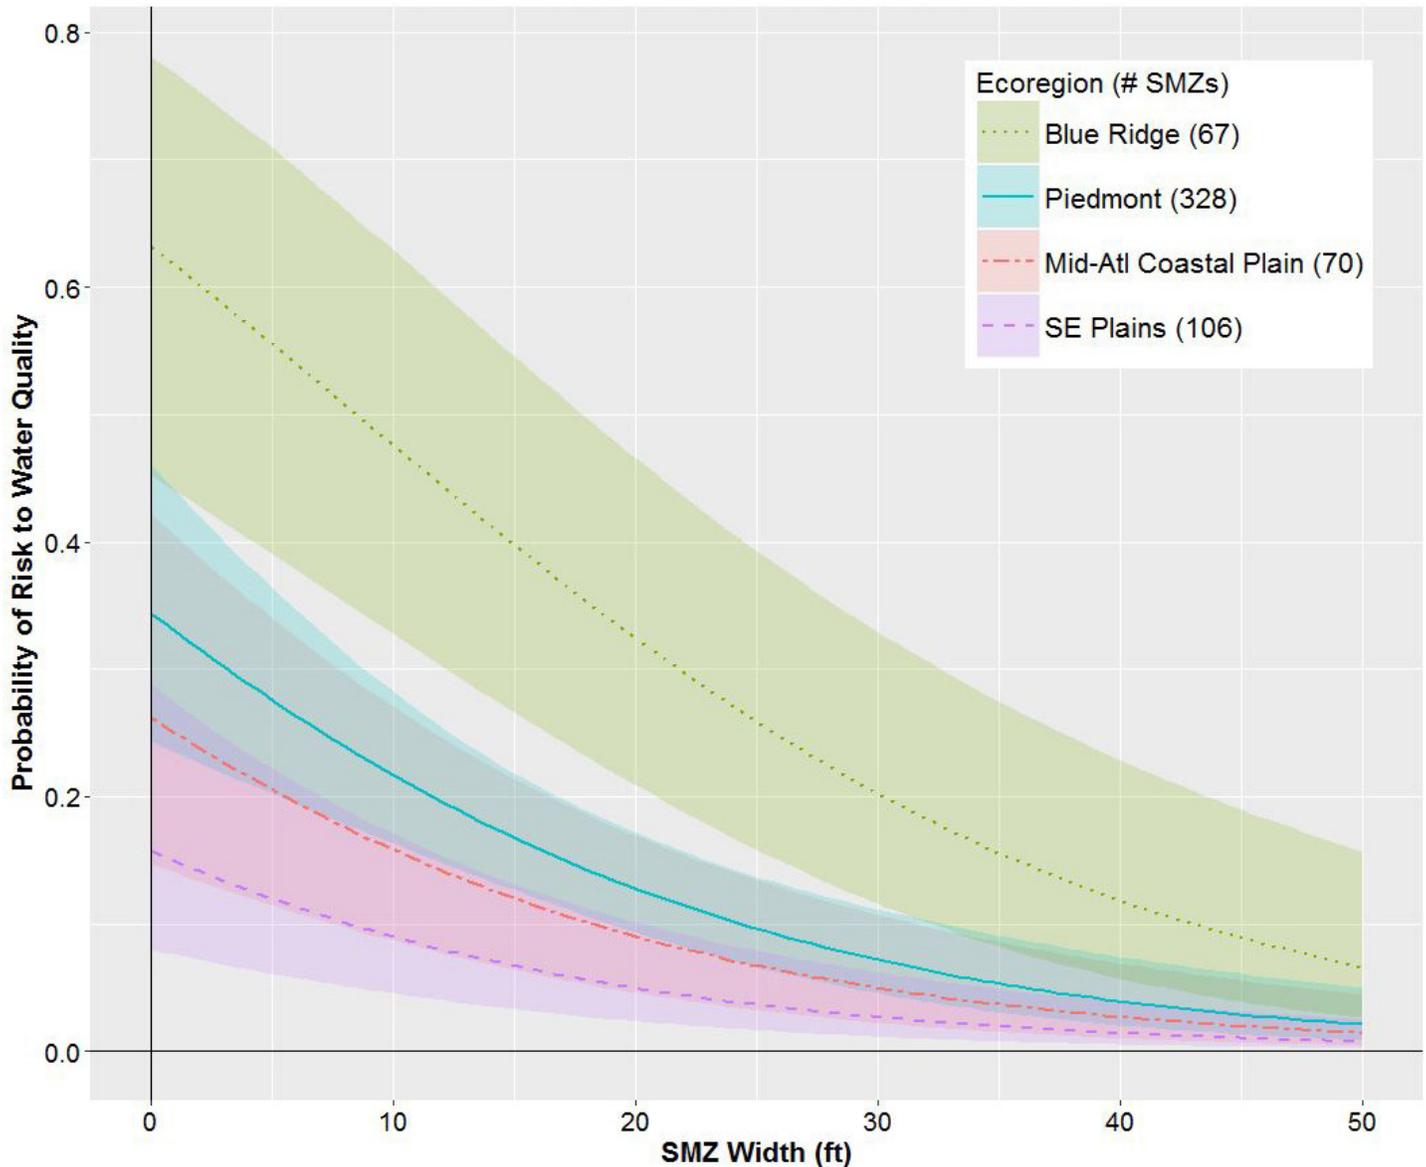
Figure 3. Model of the probability of a risk to water quality as a function of SMZ width on perennial streams and intermittent streams, by ecoregion, with 95 percent confidence interval.

Figure 3 shows the predicted probability of a risk to water quality for each ecoregion by SMZ width, with a 95 percent confidence interval. A logistic regression model was used on our dataset of 571 SMZ widths. SMZ widths (independent variable) were used to predict the presence of a risk to water quality (“Yes” or “No,” dependent variable). In our data, wider SMZs tended to be associated with fewer risks to water quality. The chi-squared test statistic of 11.6, with one degree of freedom indicates that the overall effect of SMZ width on the probability of a risk to water quality is statistically significant ($p < 0.001$). The Mountains ecoregion has a higher probability of a water quality risk than all other ecoregions, but follows a similar inversely correlated trend (i.e., less water quality risk with wider SMZ width). Confidence intervals of the other three ecoregions overlap. The probability of a risk to water quality falls below 10 percent with SMZ widths greater than 8 feet in the Southeastern Plains, 19 feet in the Mid-Atlantic Coastal Plain, 25 feet in the Piedmont, and 43 feet in the Mountains. When a SMZ is 50 feet wide, our data suggest the probability of a risk is minimal in any ecoregion. This figure supports North Carolina’s general BMP recommendation of 50 feet for a SMZ, however it should be noted that some SMZ widths less than 50 feet were found to have no risks to water quality. Therefore, this model should not be used as an exact prescription or endorsement of a specific width, particularly since failures can occur at any width. Each SMZ is unique, and may be subject to regulations requiring a certain width and/or other multiple-use objectives of the landowner.

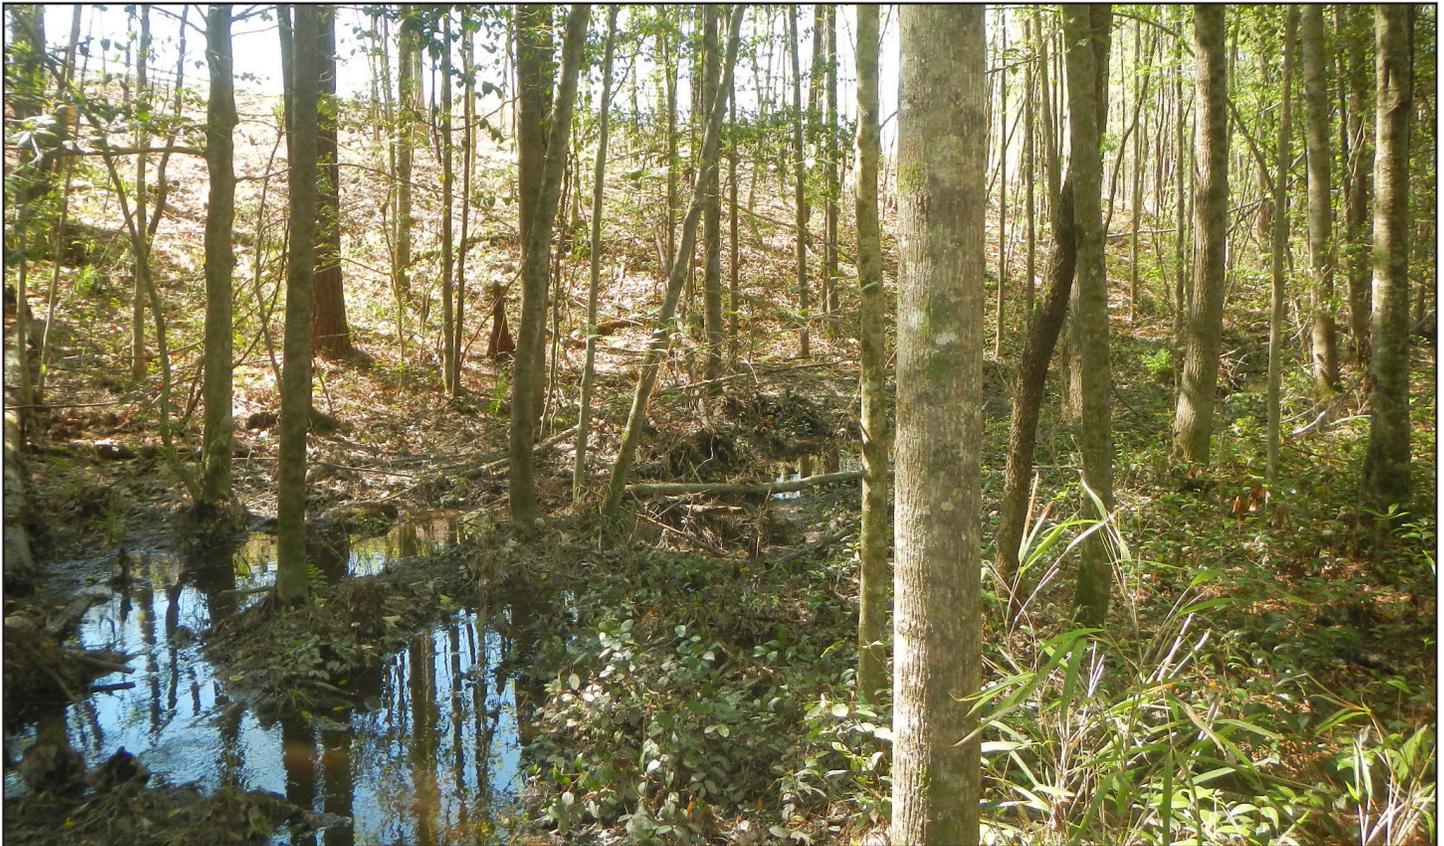
Photo 20. A SMZ with no timber removed from within it.

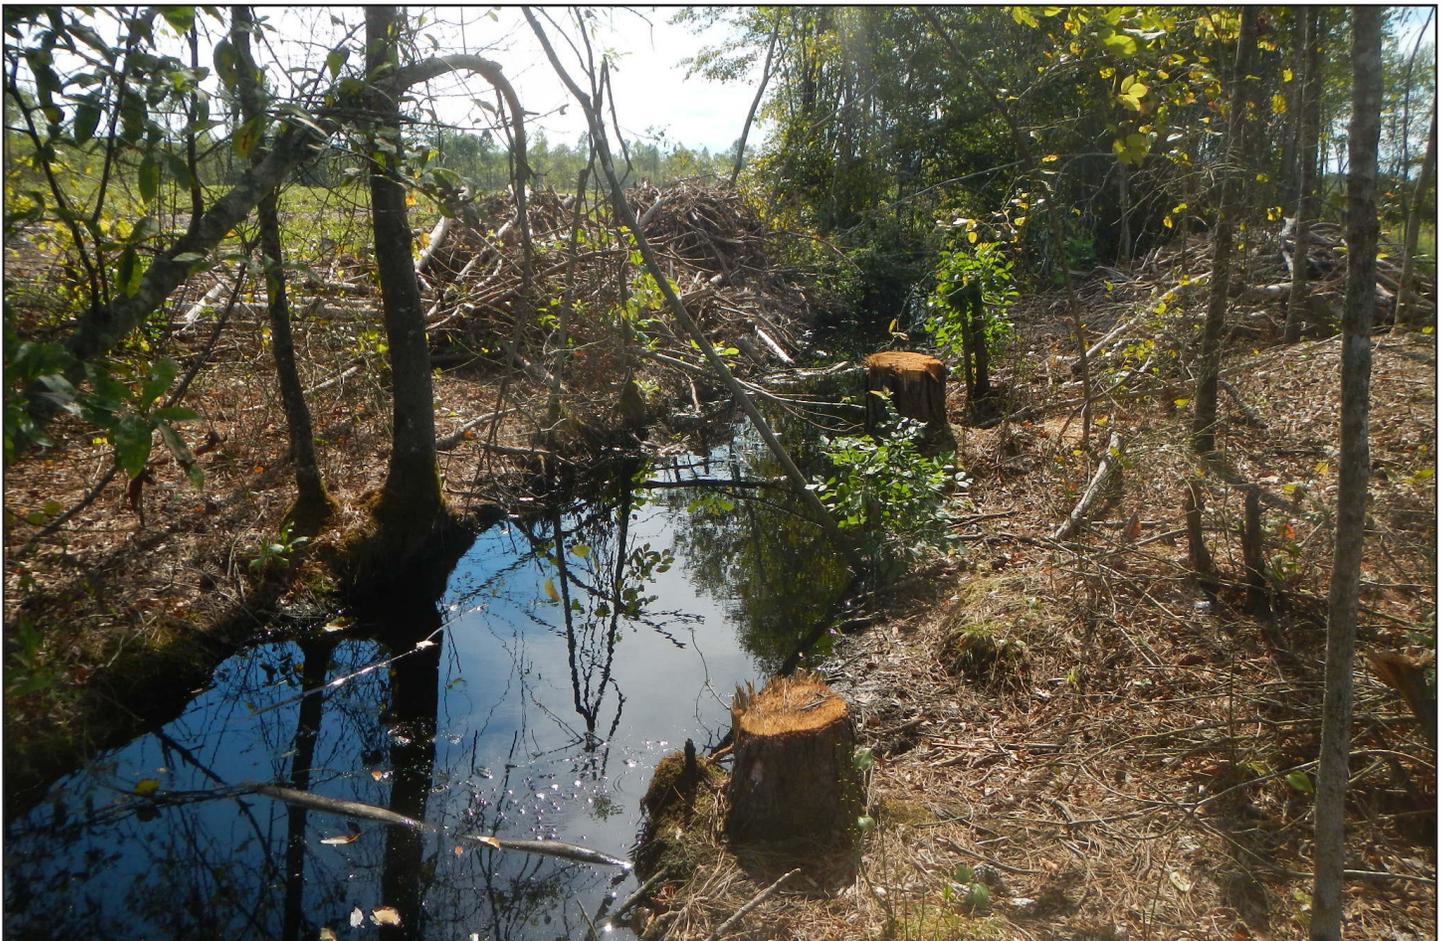
Photo 21. A SMZ that has had timber removed, but minimal disturbance to the soil or streambank.

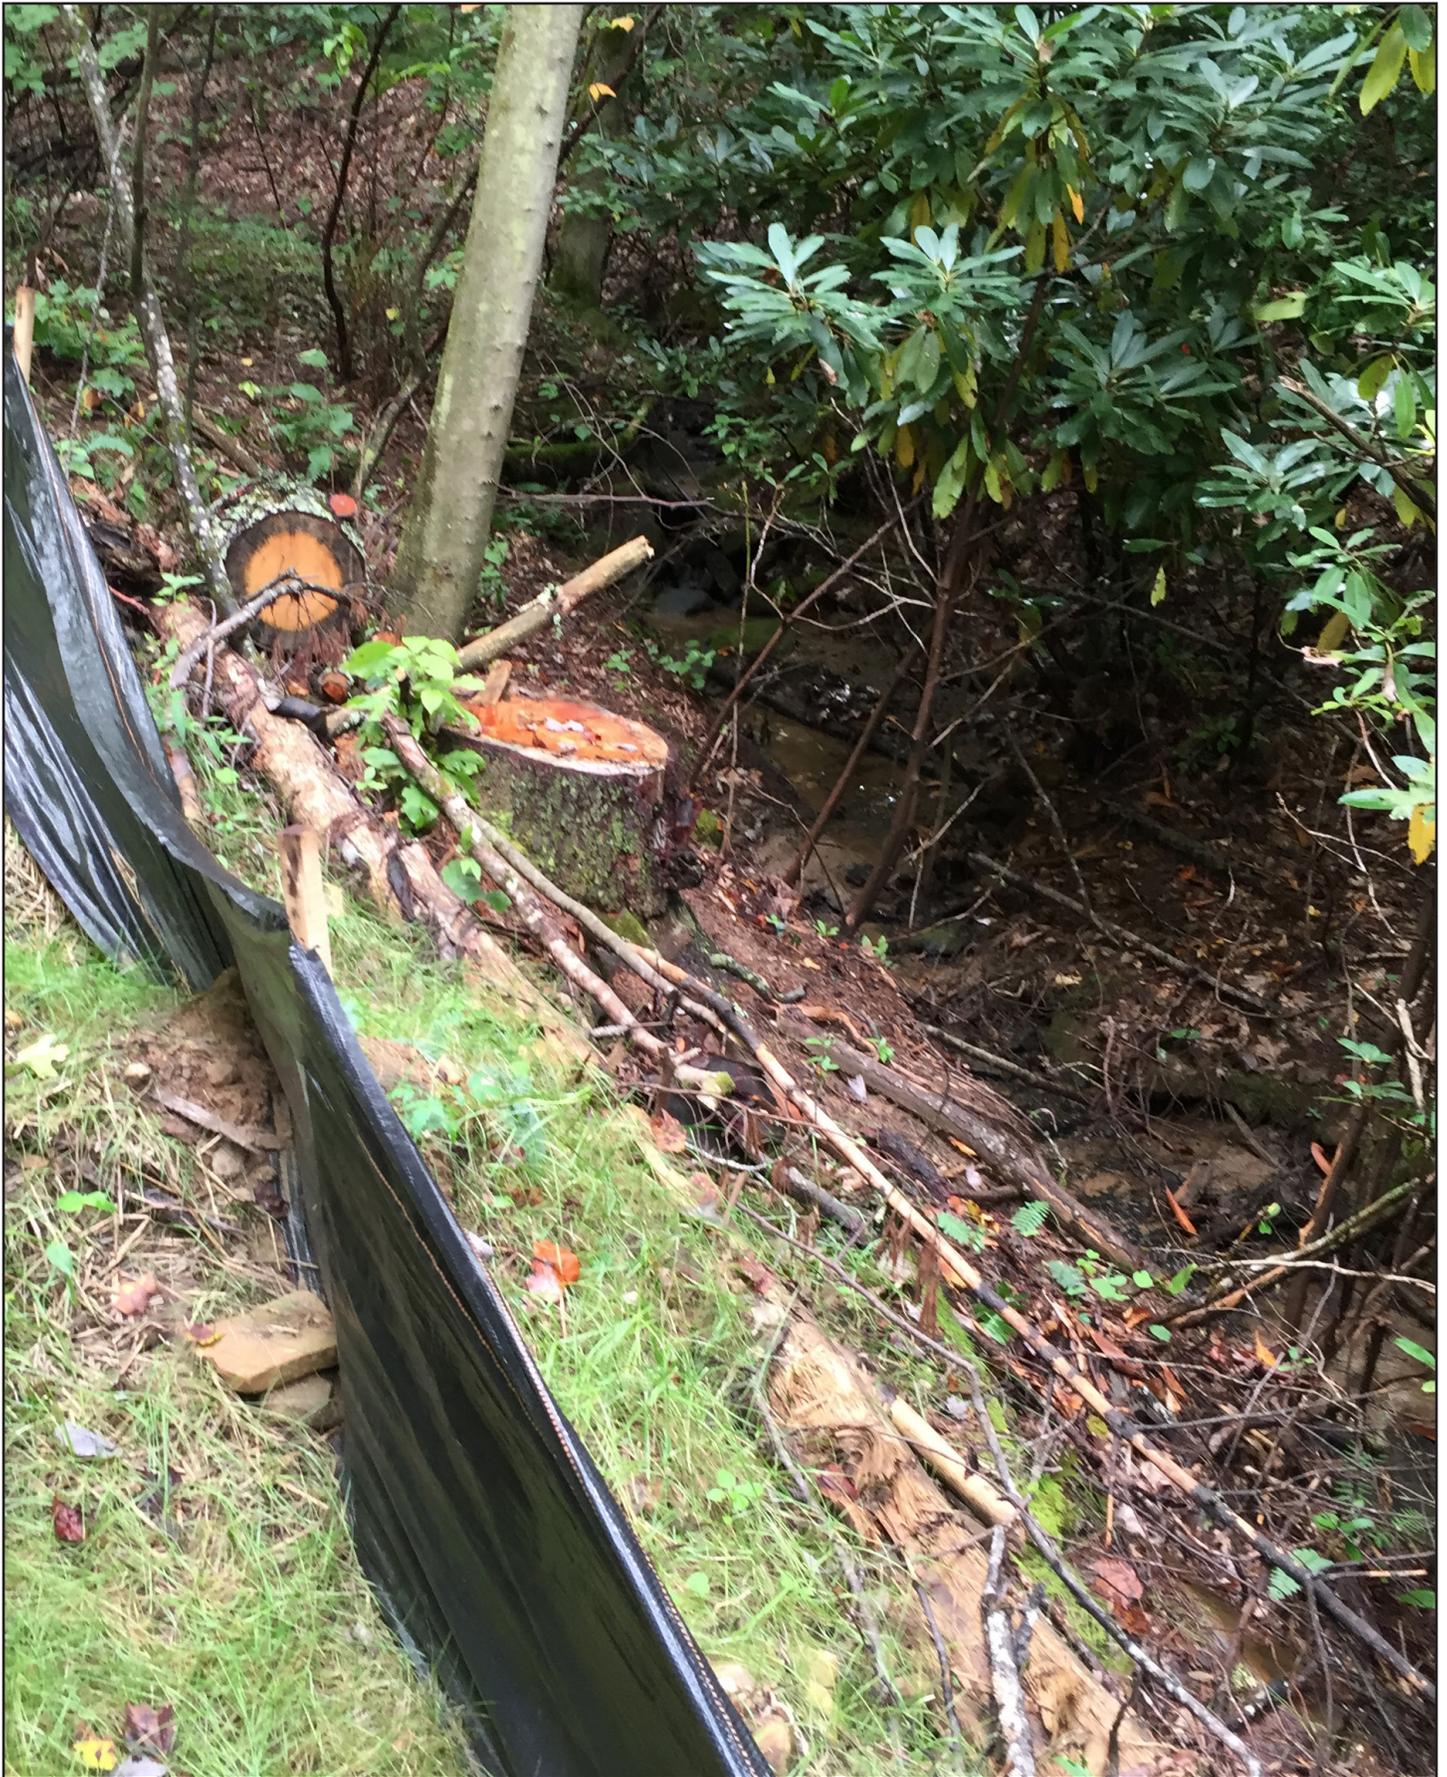
Photo 22. The forest operators installed a silt fence next to this skid trail and planted grass on the side of the trail, to prevent sediment from washing off the trail and into the SMZ. Timber was cut and removed with minimal disturbance. While this SMZ is relatively narrow, the additional BMPs that were implemented prevented visible sediment from reaching the stream.

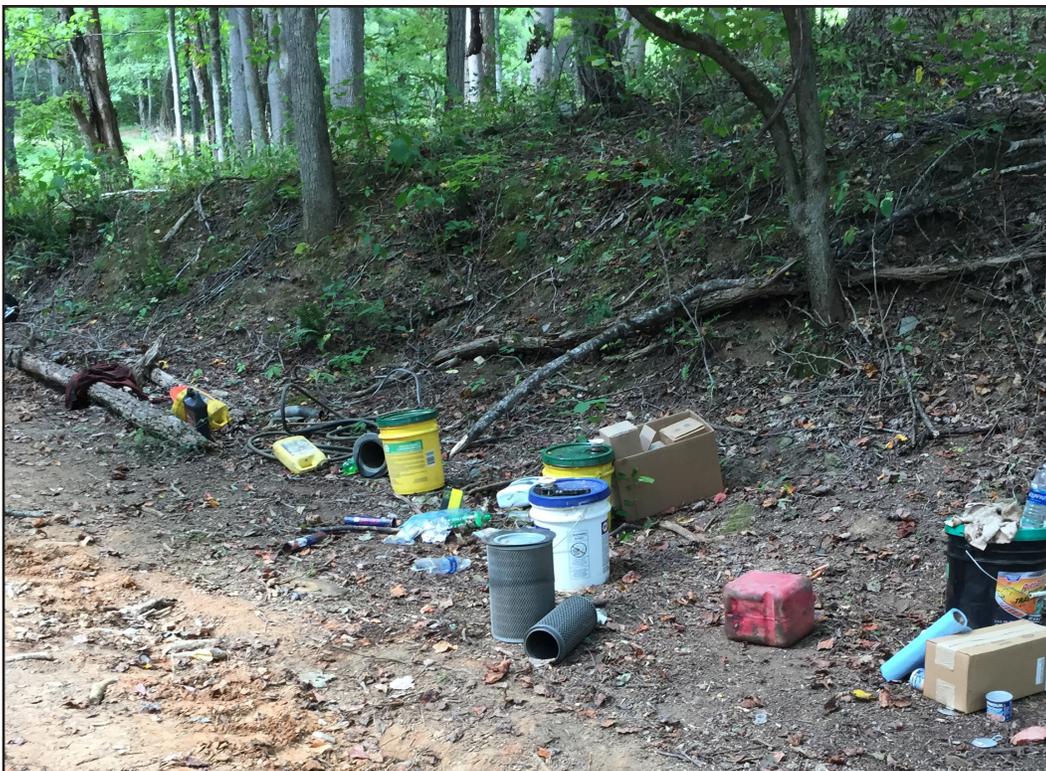
Photo 23. Though chemicals and fluids at this site are sealed in containers, some are tipped over, which creates a risk for chemicals to spill and eventually seep into groundwater or flow into streams. Leaving this type of trash on the site also diminishes the professionalism perception of logging and forestry in general.
