Area of Concern – Site: P02

Name & Location: Buckhorn Creek Road at Buckhorn Creek

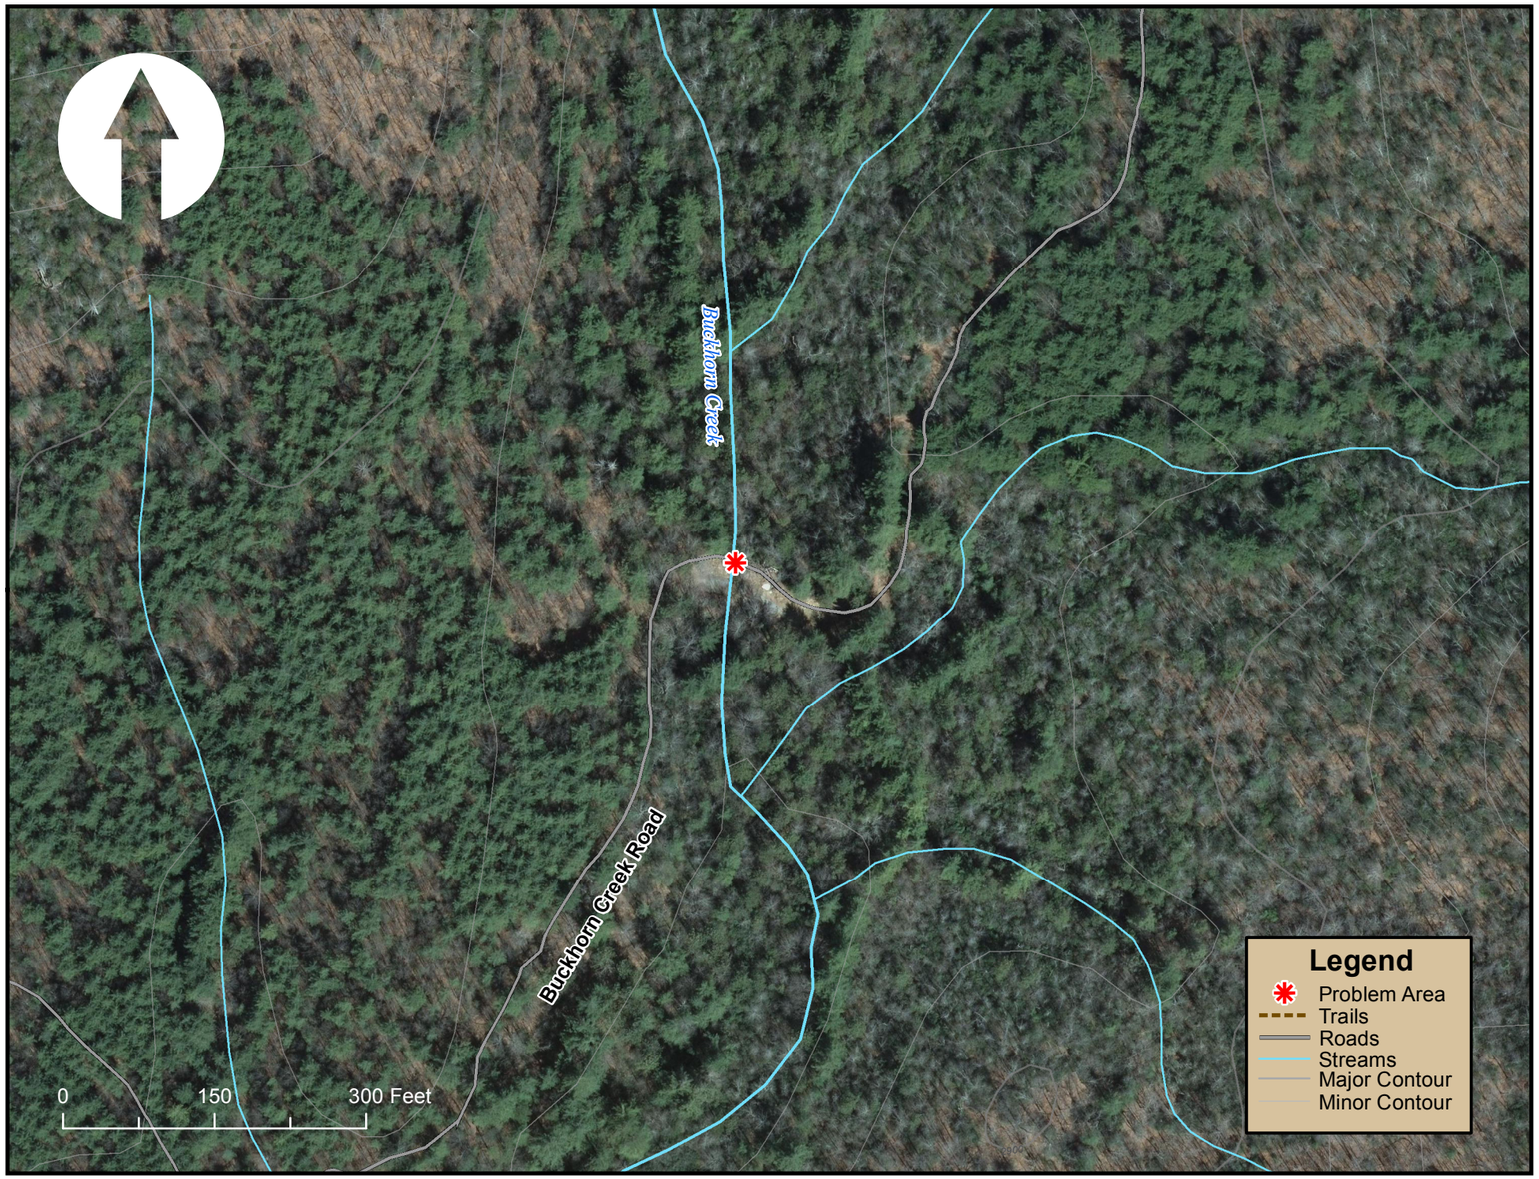
2. **Trail/ Road Impact (trail/ road name):** Buckhorn Creek Road
   - ☒ stormwater input
   - ☐ bridge
   - ☒ unstable trail crossing
   - ☐ safety hazard
   - ☒ missing vegetation
   - ☒ sediment input
   - ☐ utilities
   - ☐ erosion
   - ☒ human impact (hiking/biking)
   - ☐ equine/dog impacts

Road crossing of creek appears to be overwide and contributing fine sediment. Re-design of crossing could improve water quality.

- ☐ relocate trail/close trail/road
- ☒ vegetation/ shoreline planting
- ☐ stormwater treatment
- ☐ human/ animal exclusion
- ☐ signs
- ☐ maintenance
- ☒ trail/road crossing improvement
- ☐ mechanical grading
- ☐ animal watering
- ☐ culvert rehabilitation/ replacement
- ☐ culvert daylighting
- ☐ bridge replacement/improvement
