Area of Concern – Site: P06

Name & Location: Bridge/ crossing near Little River

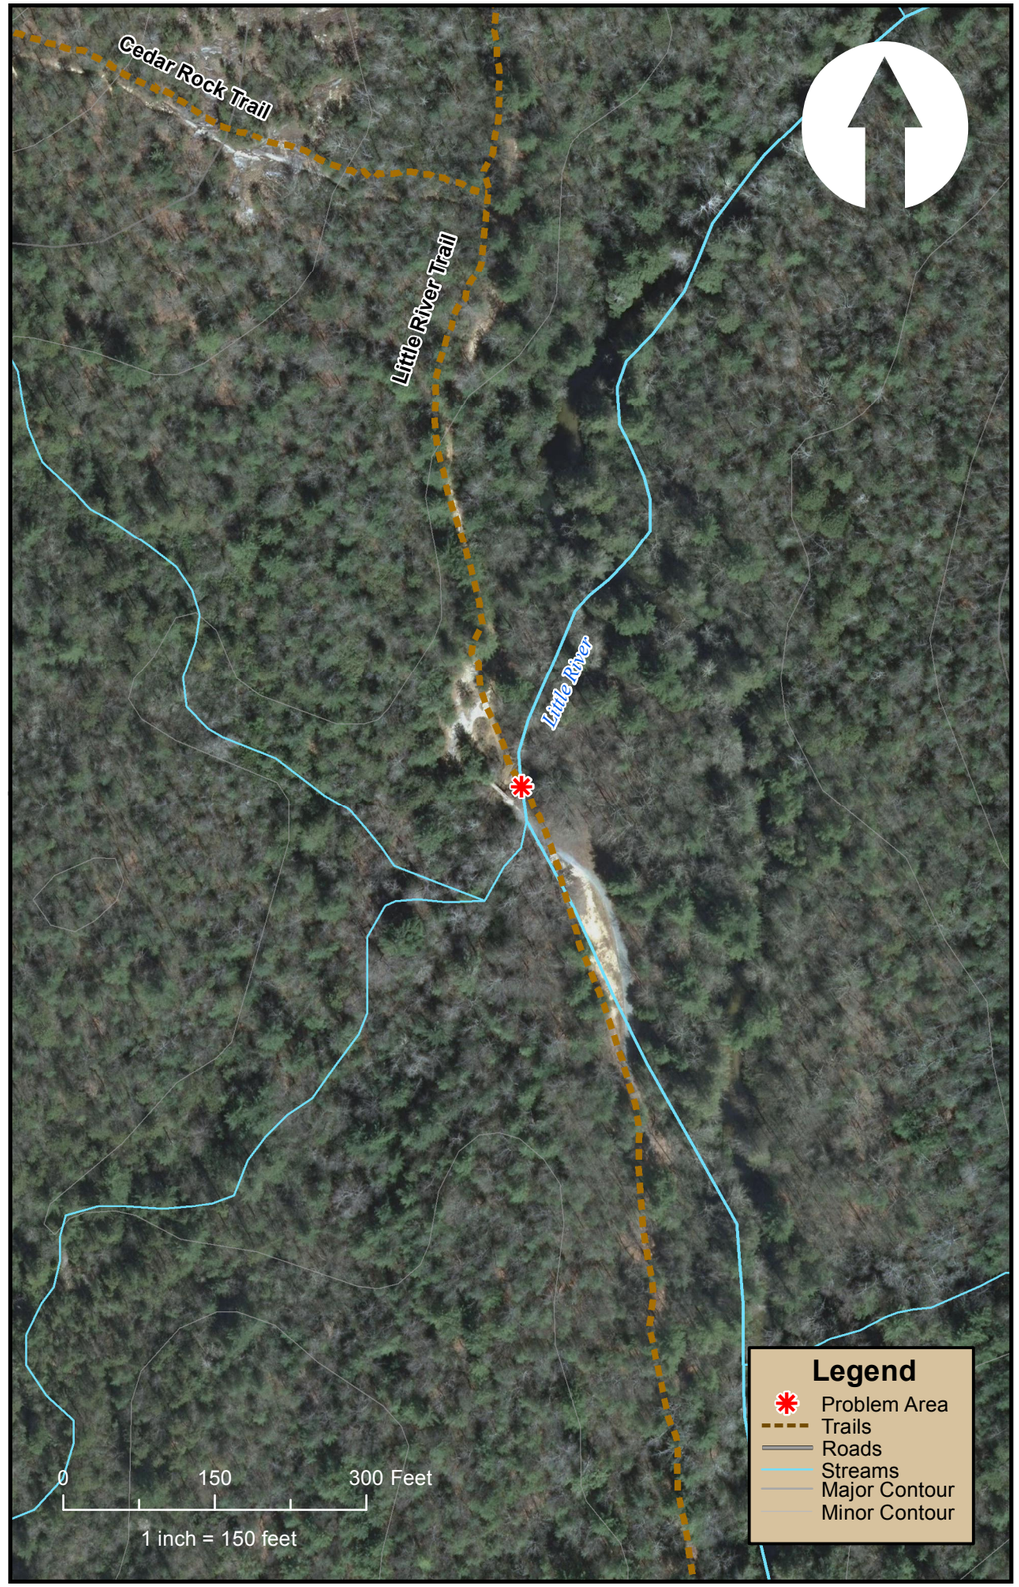
☒stormwater input ☒sediment input
☒bridge ☐utilities
☒unstable trail crossing ☐erosion
☒safety hazard ☒human impact (hiking/biking)
☒missing vegetation ☒equine/dog impacts

Tributary to Little River is crossed by bridge and ford. Bridge is in poor condition. Ford is over widened with fine sediment in streambed. Entire crossing could be reconstructed for increased stability/ safety.

☒relocate trail/close trail/road ☒trail/road crossing improvement
☒vegetation/ shoreline planting ☐mechanical grading
☐stormwater treatment ☐animal watering
☐human/ animal exclusion ☐culvert rehabilitation/ replacement
☐signs ☐culvert daylighting
☐maintenance ☒bridge replacement/improvement
