Area of Concern – Site: P42

Name & Location: Stone Mountain Trail

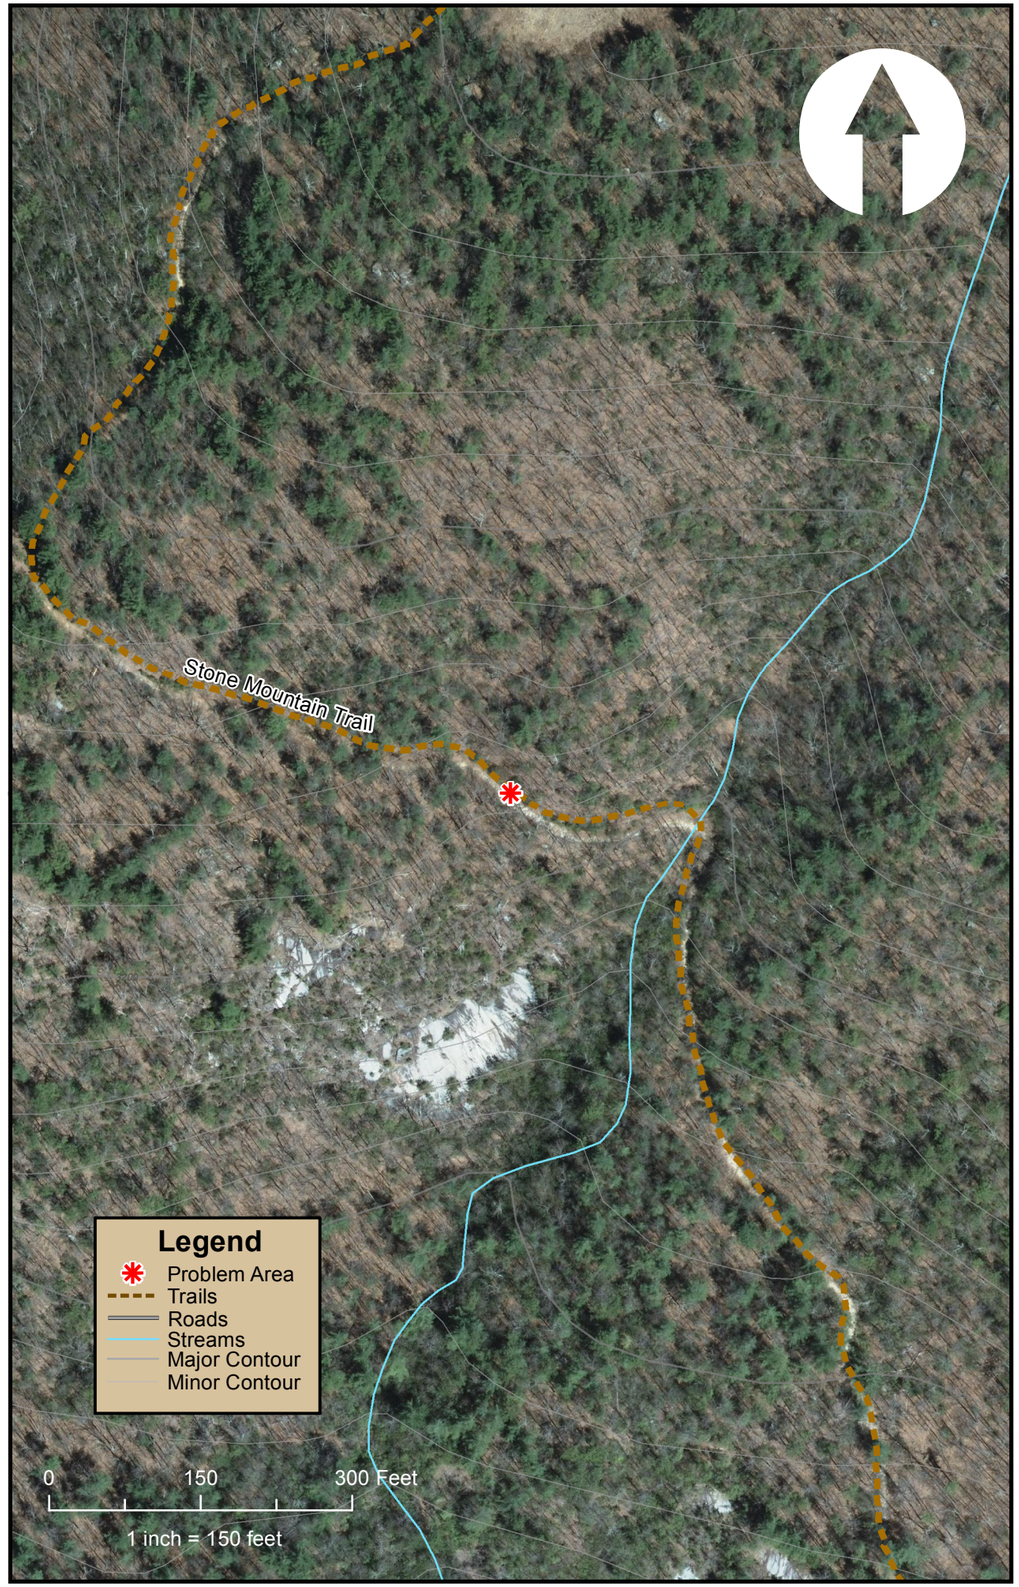
2. **Trail/ Road Impact (trail/ road name):** Stone Mountain Trail
   - ☐stormwater input
   - ☐bridge
   - ☐unstable trail crossing
   - ☐safety hazard
   - ☐missing vegetation
   - ☒sediment input
   - ☐utilities
   - ☒erosion
   - ☒human impact (hiking/biking)
   - ☐equine/dog impacts

3. **Upland/ Stormwater**
   - ☒nonpoint source pollution
   - ☐pollutant point source
   - ☒upland erosion
   - ☐unvegetated upland area

Significant upland erosion along much of Stone Mountain Trail.

- ☒relocate trail/close trail/road
- ☒vegetation/ shoreline planting
- ☐stormwater treatment
- ☐human/ animal exclusion
- ☐signs
- ☒maintenance
- ☐trail/road crossing improvement
- ☐mechanical grading
- ☐animal watering
- ☐culvert rehabilitation/ replacement
- ☐culvert daylighting
- ☐bridge replacement/improvement
