# Supplemental Report: 2011 Stream Restoration of the Lake Julia Outfall (Reasonover Creek) at DuPont State Forest

Compiled by Tom Gerow, Jr.  
BMP Staff Forester, Nonpoint Source Branch  
NCDA&CS - North Carolina Forest Service (NCFS)  
Raleigh, NC  
December 2011

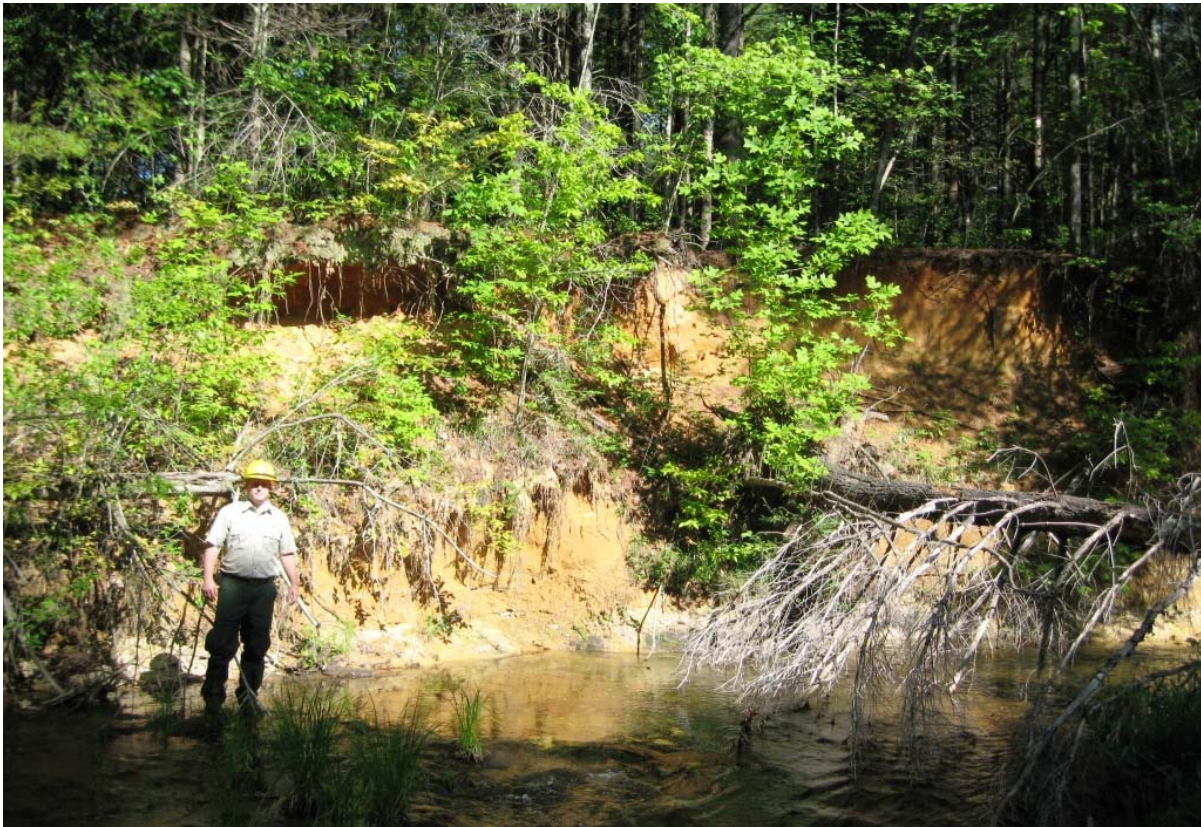
After a series of significant rainfall events in the mid-to-late 2000's, this embankment exhibited a considerable increase in the frequency of soil loss and subsequent slumping of large trees that were atop the embankment. This eroding and collapsing embankment also began migrating downstream and upstream towards the permanent bridge on Conservation Road that is a vital travel route on DuPont State Forest.

Two photos of the stream's eroding and collapsing right-bank escarpment: Above taken May 2009. Below taken Sept.2009. Note the safety vest hung on a limb to show relative height of the escarpment (circled).
