APPENDIX F

Area of Concern Assessments

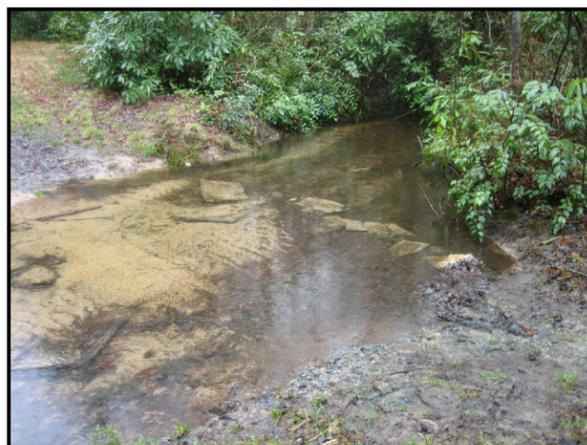
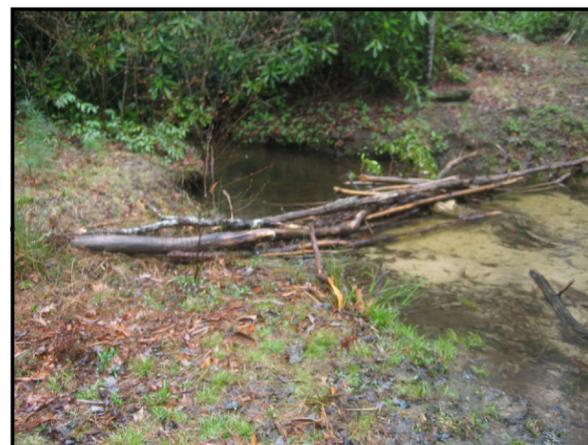
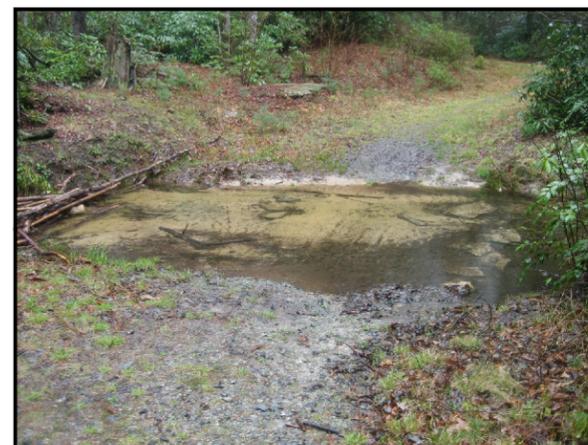
Area of Concern – Site: P02

Road crossing of creek appears to be overwide and contributing fine sediment. Re-design of crossing could improve water quality.

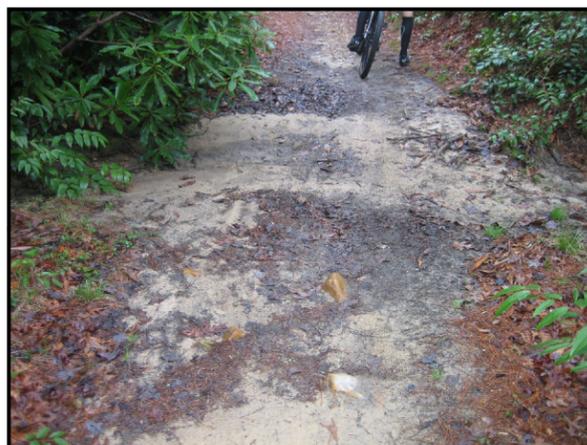
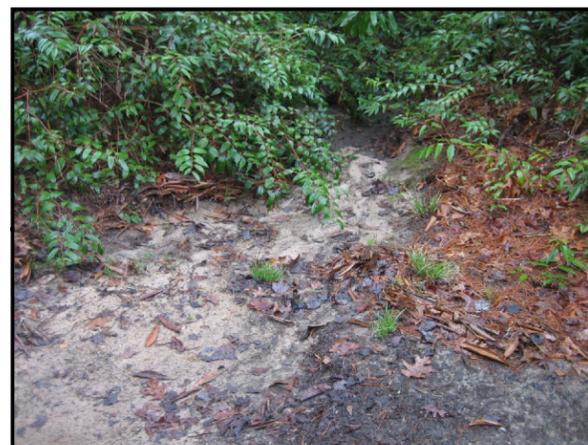
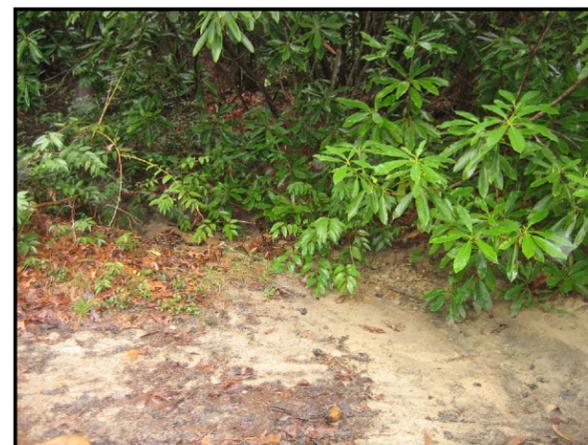
Area of Concern – Site: P04

Stormwater drainage crosses Little River Trail, with trail serving as sediment source to Little River.

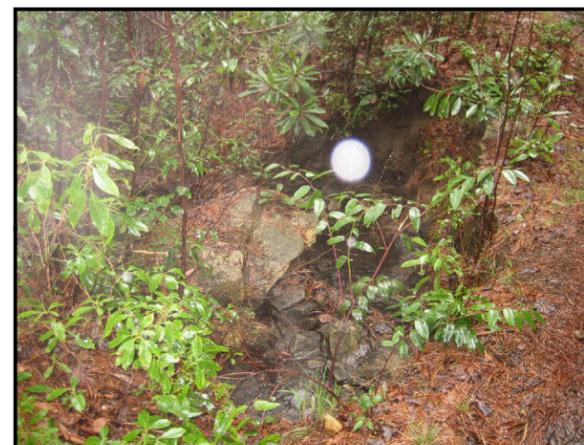
Area of Concern – Site: P10

Stream banks eroded upstream/ downstream of culvert. Trail currently intact.

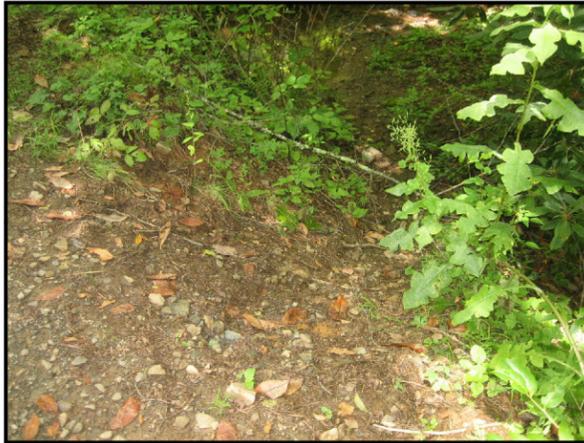
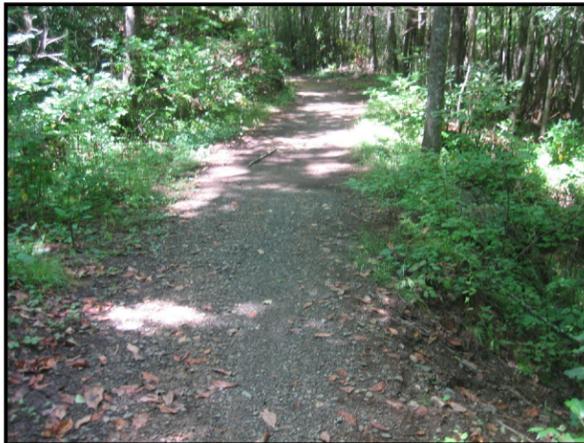
Area of Concern – Site: P14

Culvert exists and appears to be in good condition. Bare area between trail and stream caused/ exacerbated by human access and stormwater.

| <input checked="" type="checkbox"/> human/ animal exclusion | <input type="checkbox"/> culvert rehabilitation/ replacement |

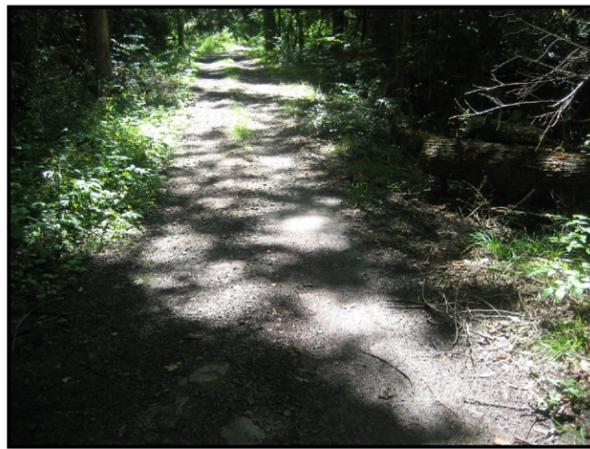
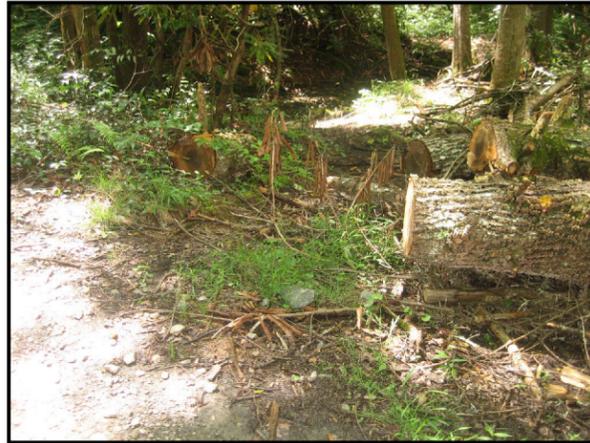
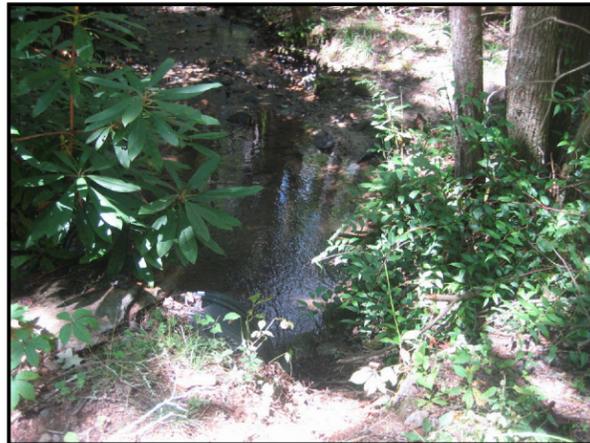
Area of Concern – Site: P15

Comments
 Culvert exists and appears to be in good condition. Bare area between trail and stream caused/ exacerbated by human access and stormwater.

| <input checked="" type="checkbox"/> human/ animal exclusion | <input type="checkbox"/> culvert rehabilitation/ replacement |

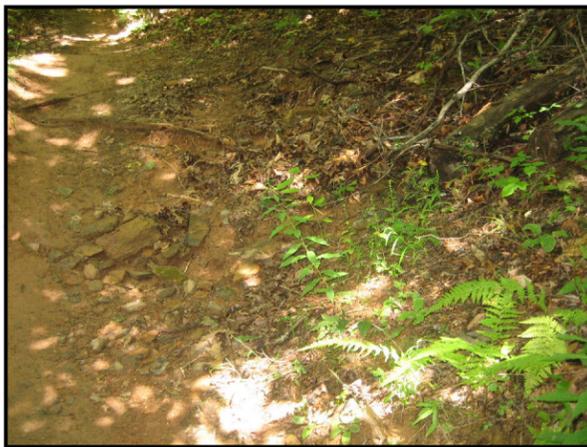
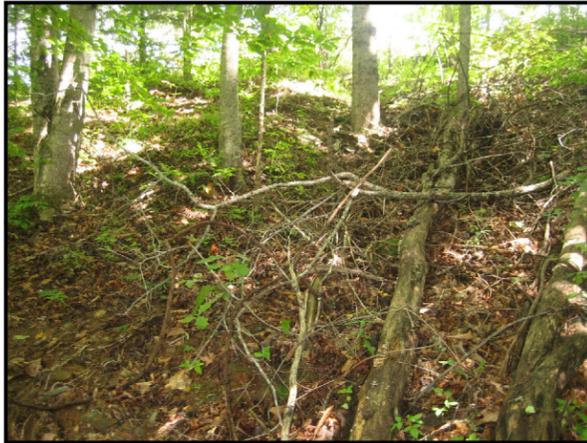
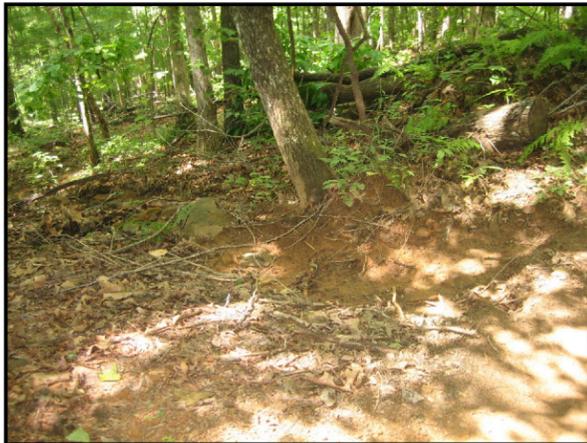
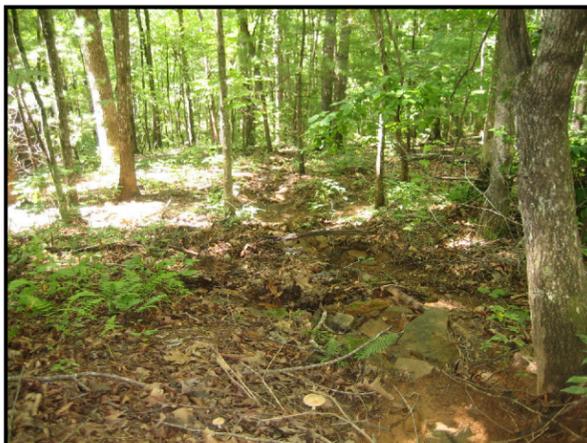
Area of Concern – Site: P17

Airstrip Trail is in good condition. However, runoff from impervious airstrip has formed gully crossing Airstrip Trail in multiple locations. Potential solution includes treating stormwater at its source.

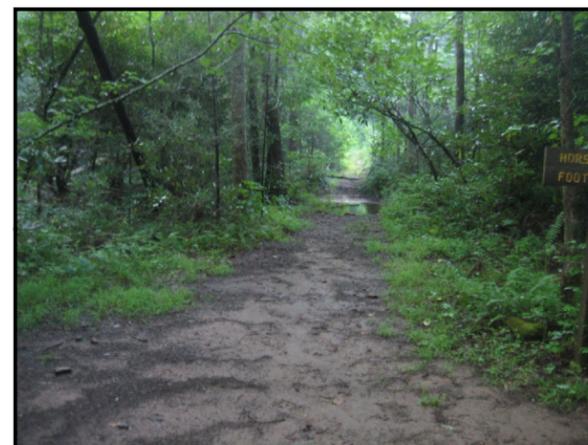
Area of Concern – Site: P21

Fine sediment entering creek as result of trail crossing. Potentially improve to harden crossing.

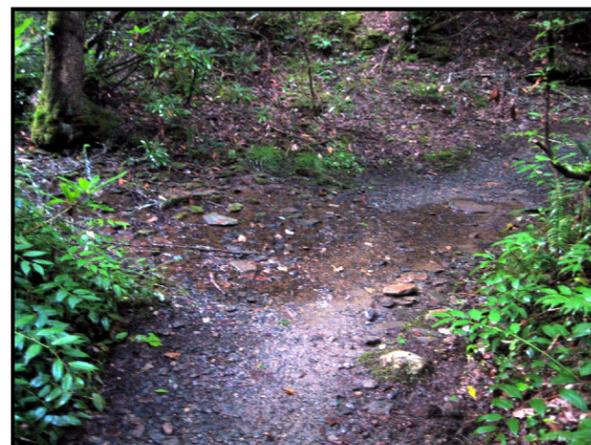
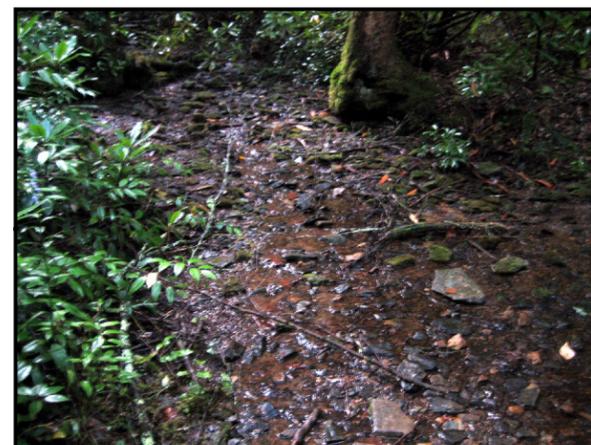
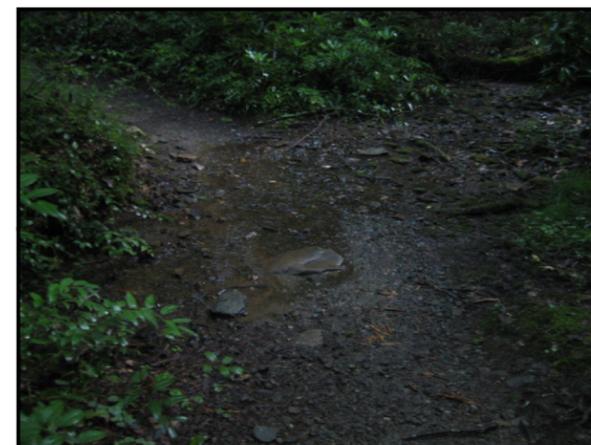
Area of Concern – Site: P22

Tributary over widened and unvegetated at trail crossing.

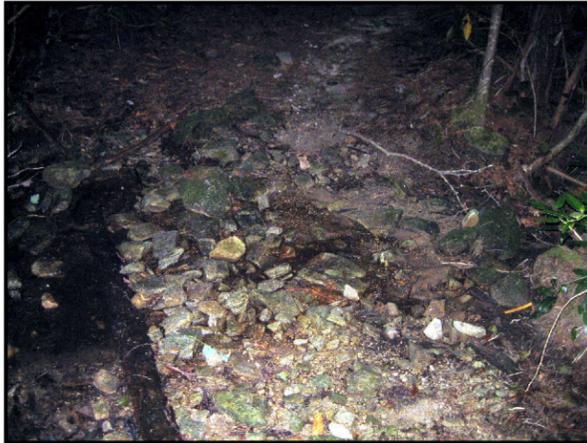
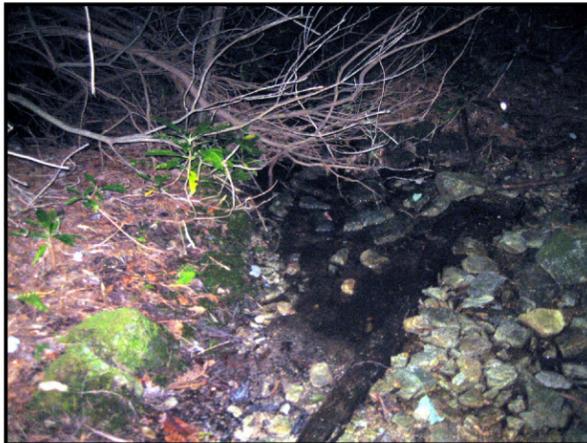
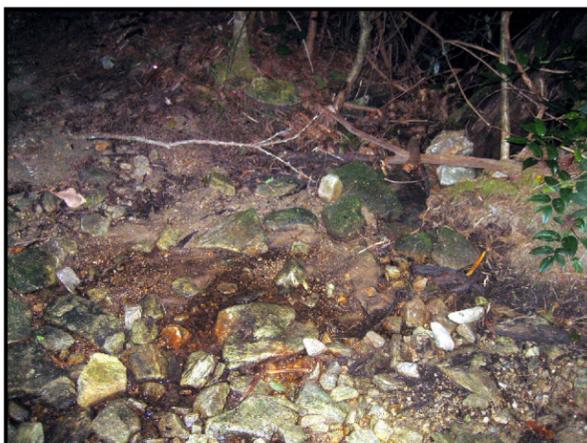
Area of Concern – Site: P25

| <input type="checkbox"/> safety hazard | <input checked="" type="checkbox"/> human impact (hiking/biking) |

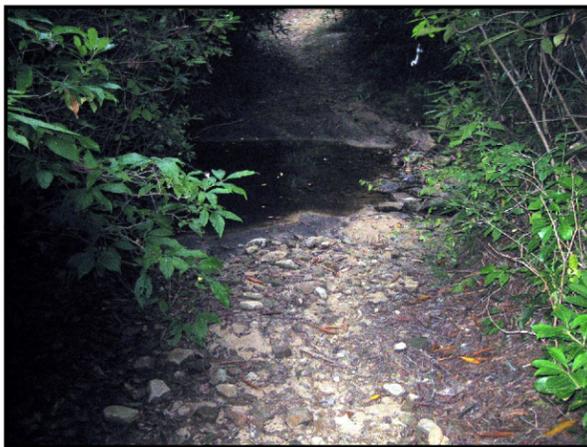
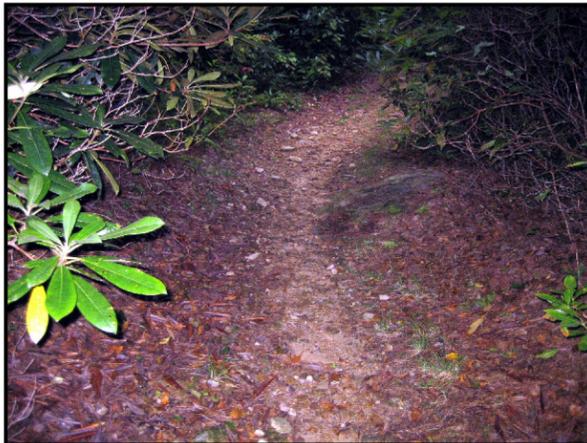
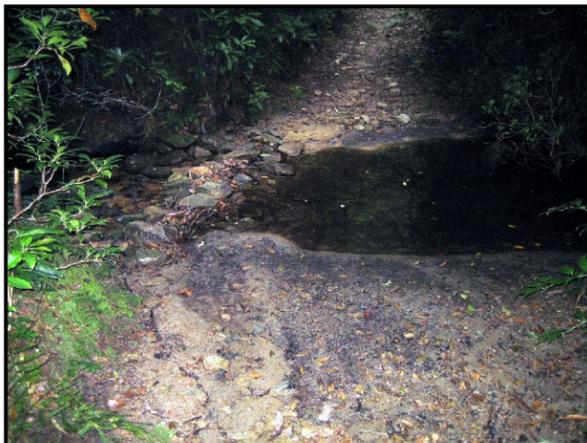
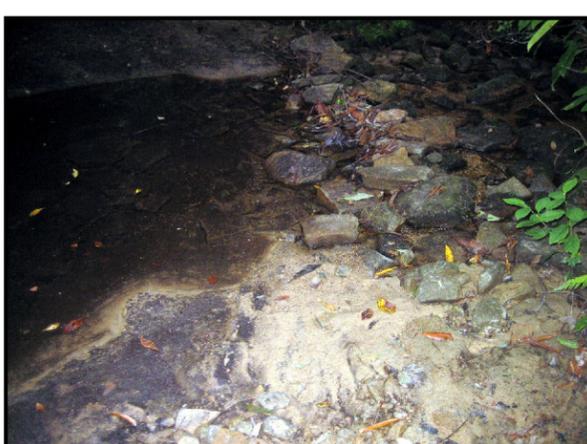
Area of Concern – Site: P28

| <input type="checkbox"/> safety hazard | <input checked="" type="checkbox"/> human impact (hiking/biking) |

Comments
 Trail crossing serves as source of fine sediment. Potentially install sediment traps/ diversions on trail.

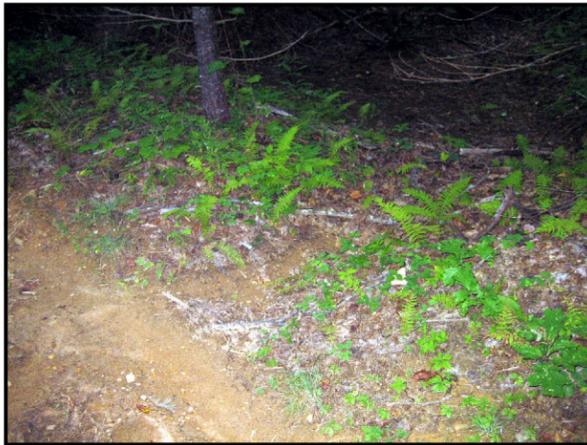
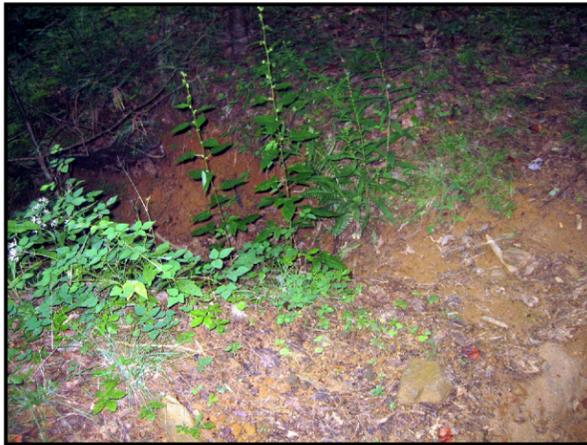
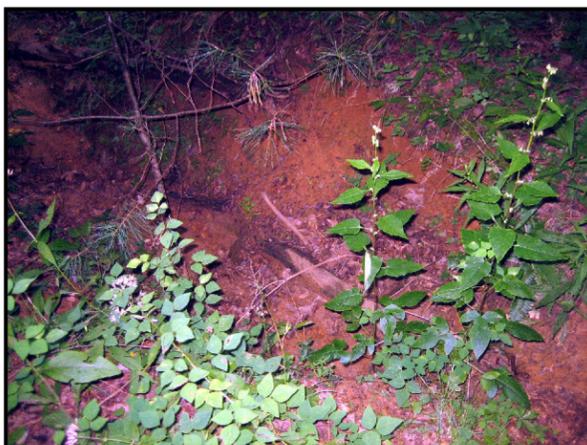
Area of Concern – Site: P29

Trail serves as source of sediment. Eroding banks and head cut in channel downstream of trail are sediment source and may threaten trail.

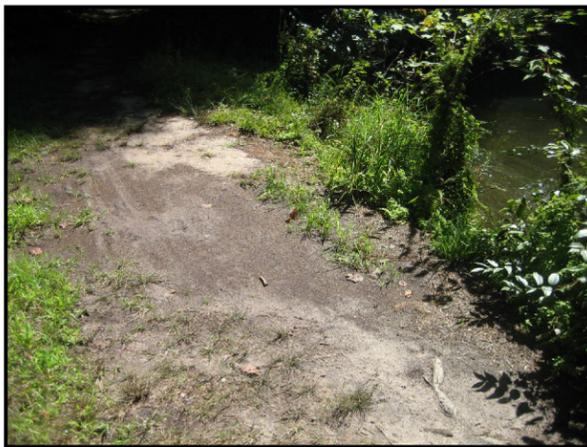
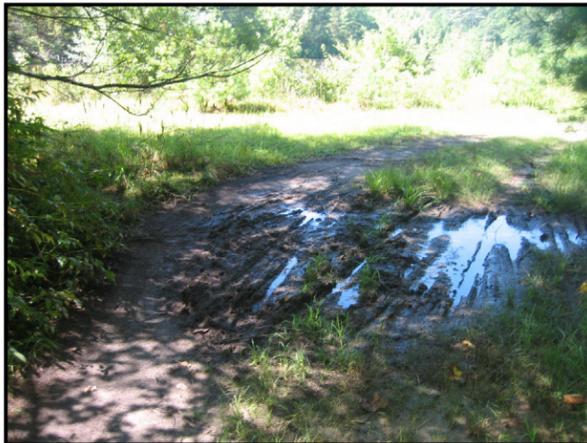
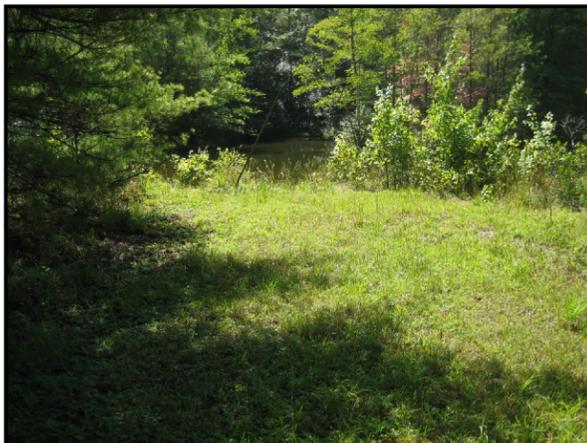
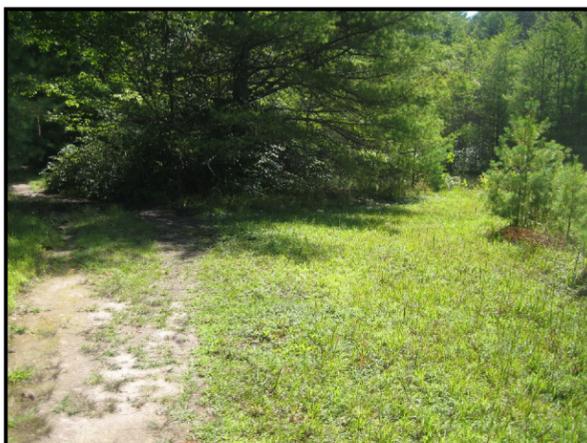
Comments
 At trail crossing, creek is over widened with fine sediment input. A small tributary coincides with the trail.

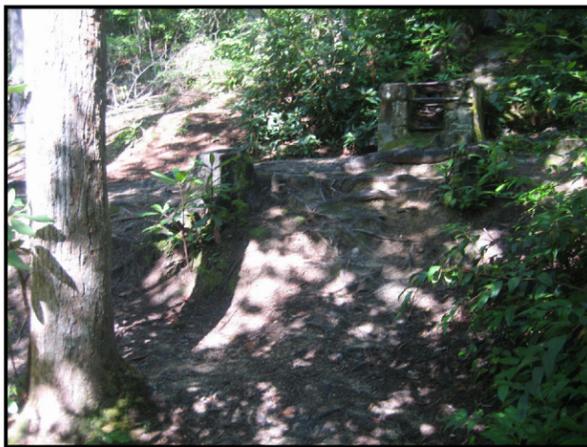
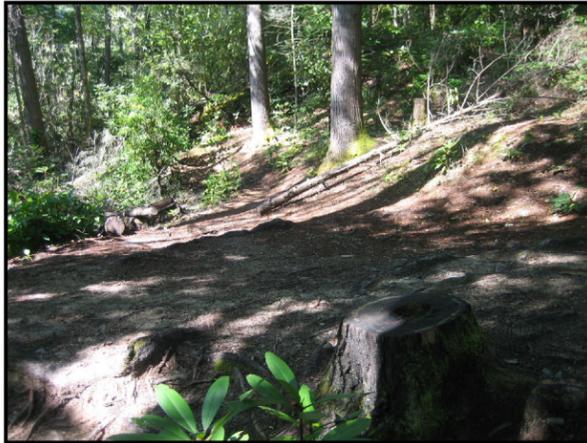
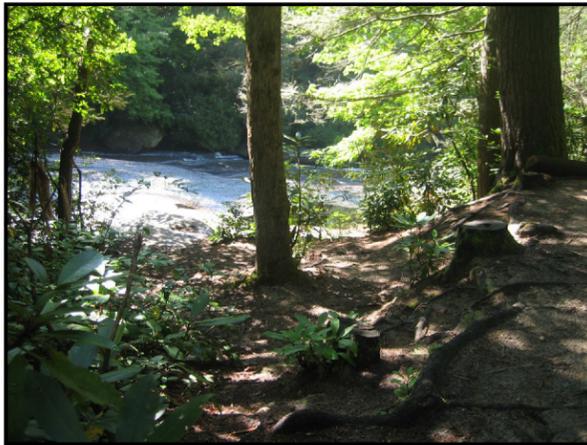
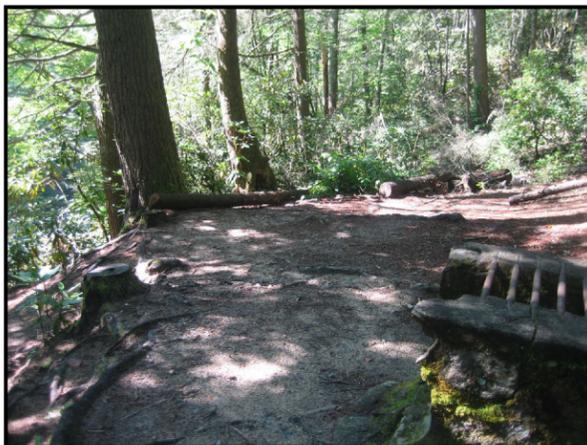
Comments
 Upland sediment source on eroding, over widened trail. Trail serves as stormwater drainage to receiving water.

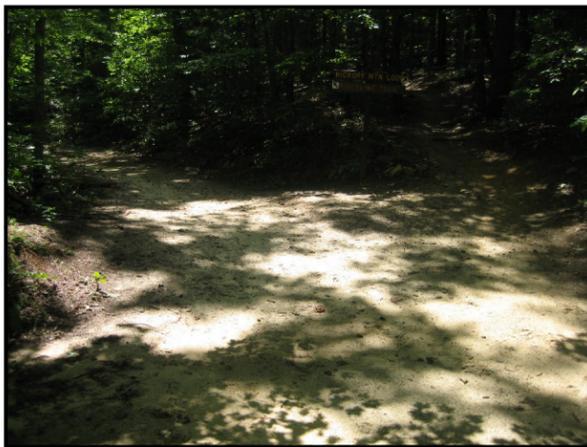
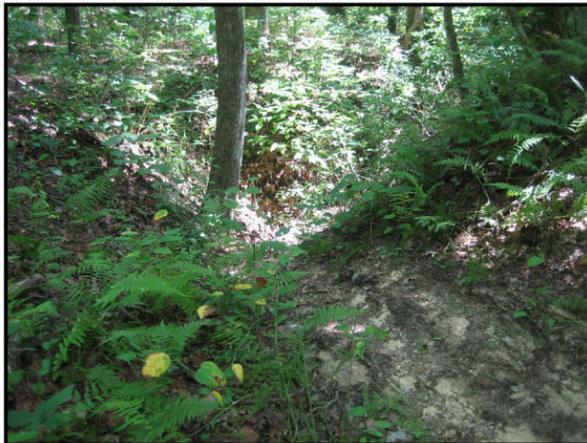
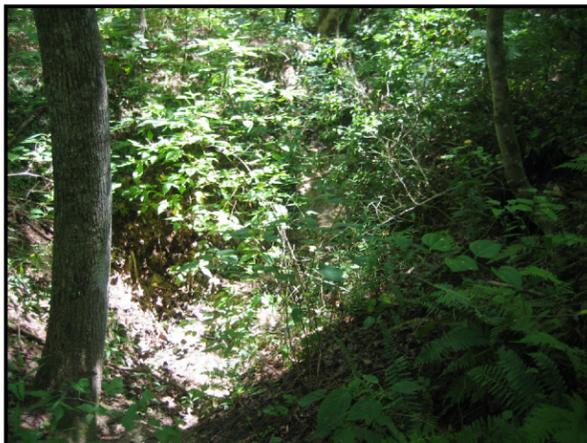
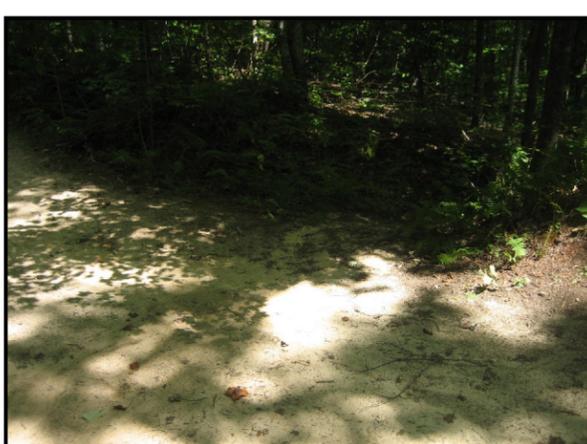
Barc areas along viewing area below Hooker Falls.

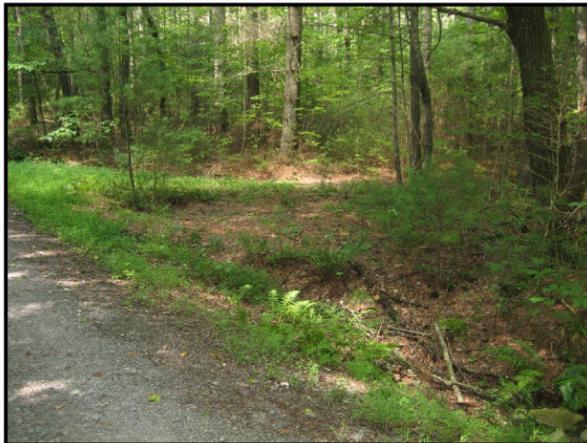
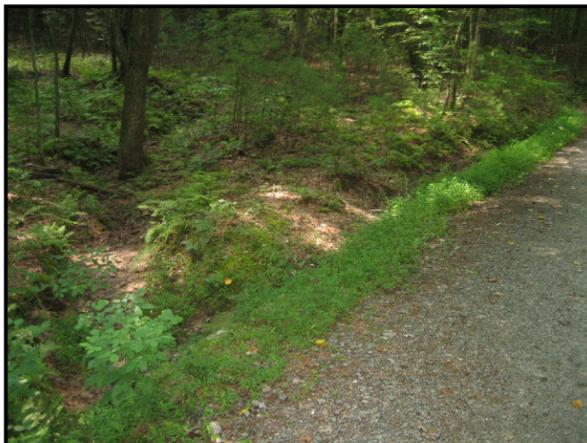
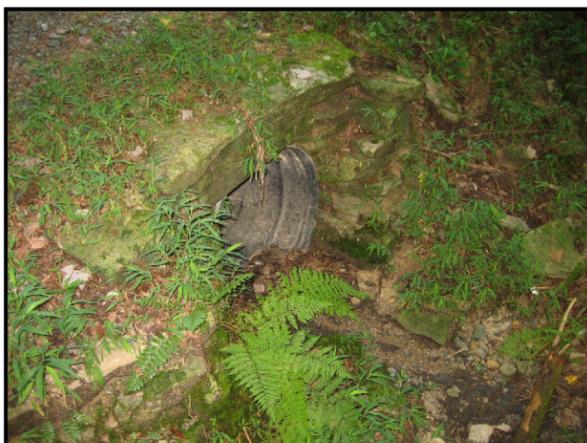
Comments
 Hardened trail crossing, though trail still serves as sediment source. Minor bank erosion in channel just downstream of crossing.

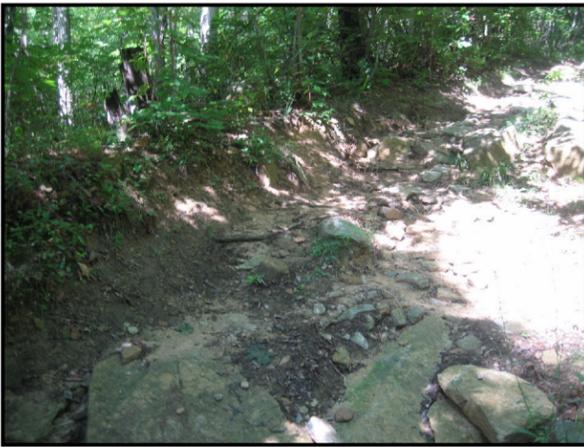
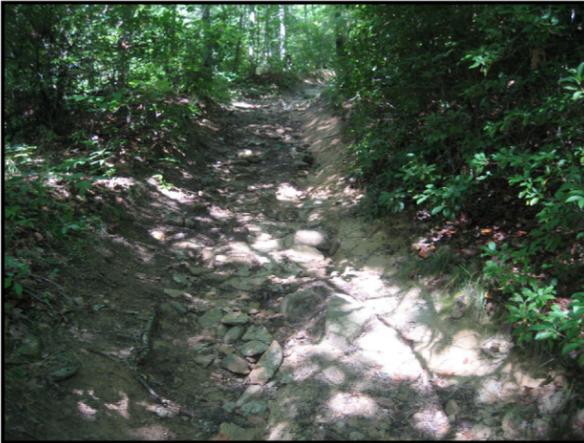
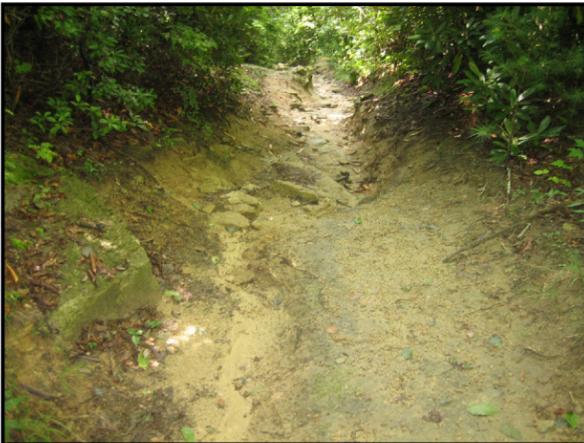
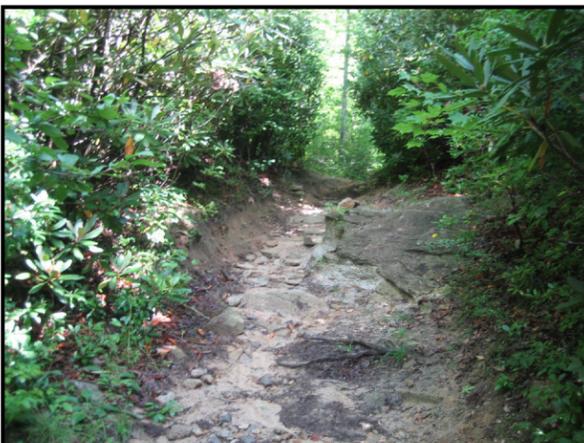
Comments
 Farmhouse Trail is steep on both sides of the creek crossing, leading to trail erosion. Sediment traps are full, resulting in fine sediment input to creek. Consider short-term maintenance and/or long-term trail relocation upvalley.

| <input checked="" type="checkbox"/> maintenance | <input type="checkbox"/> bridge replacement/improvement |

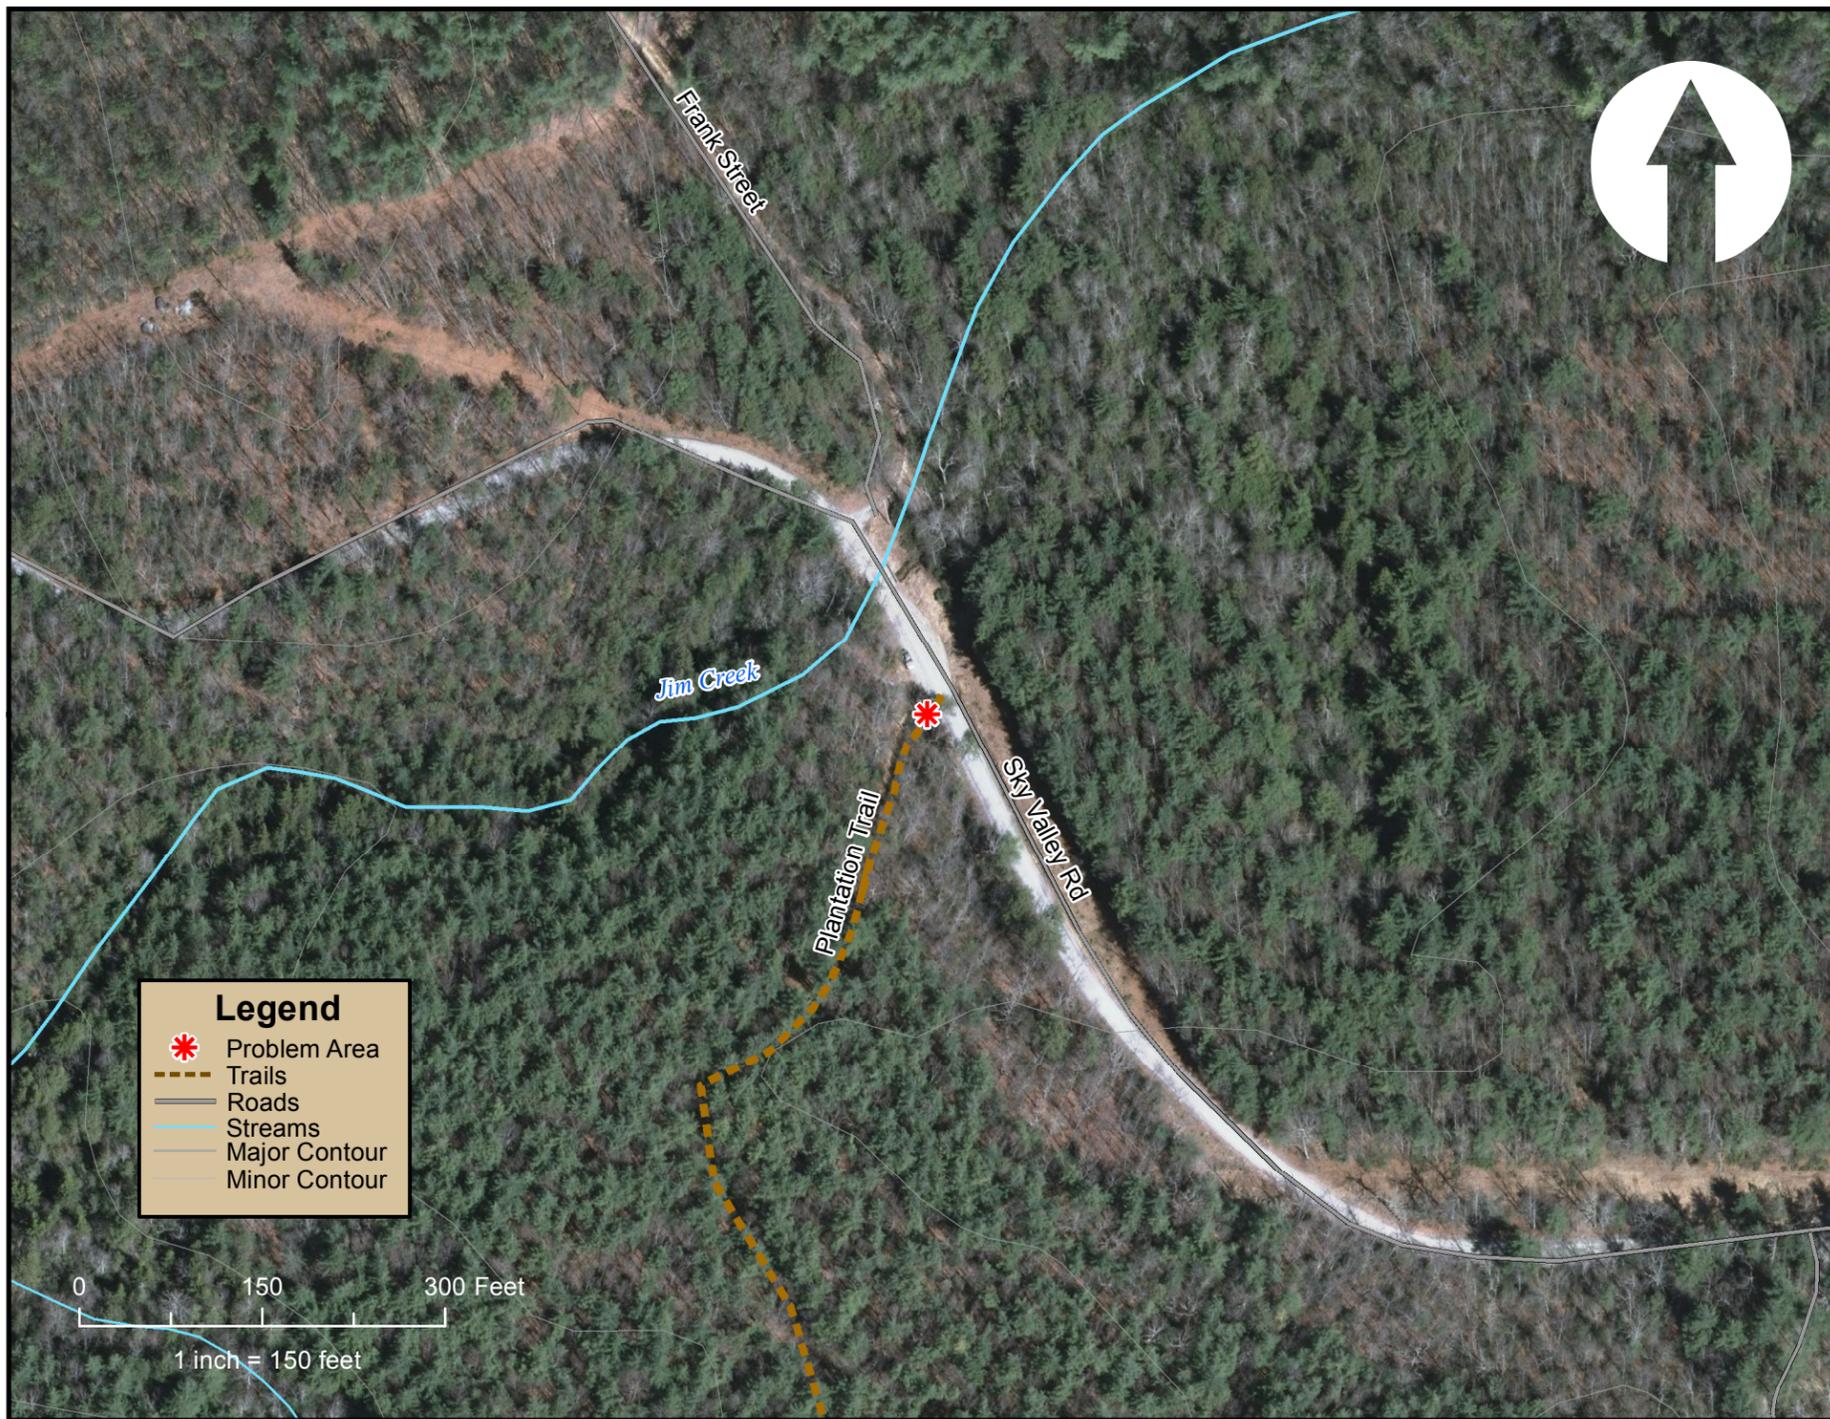
Comments
 Culvert under Plantation Trail filled with road sediment and perhaps crushed.

| <input type="checkbox"/> human/ animal exclusion | <input checked="" type="checkbox"/> culvert rehabilitation/ replacement |
