Water Resources Restoration Master Plan

DuPont State Recreational Forest
North Carolina

Prepared for:
North Carolina Forest Service

November 9, 2015

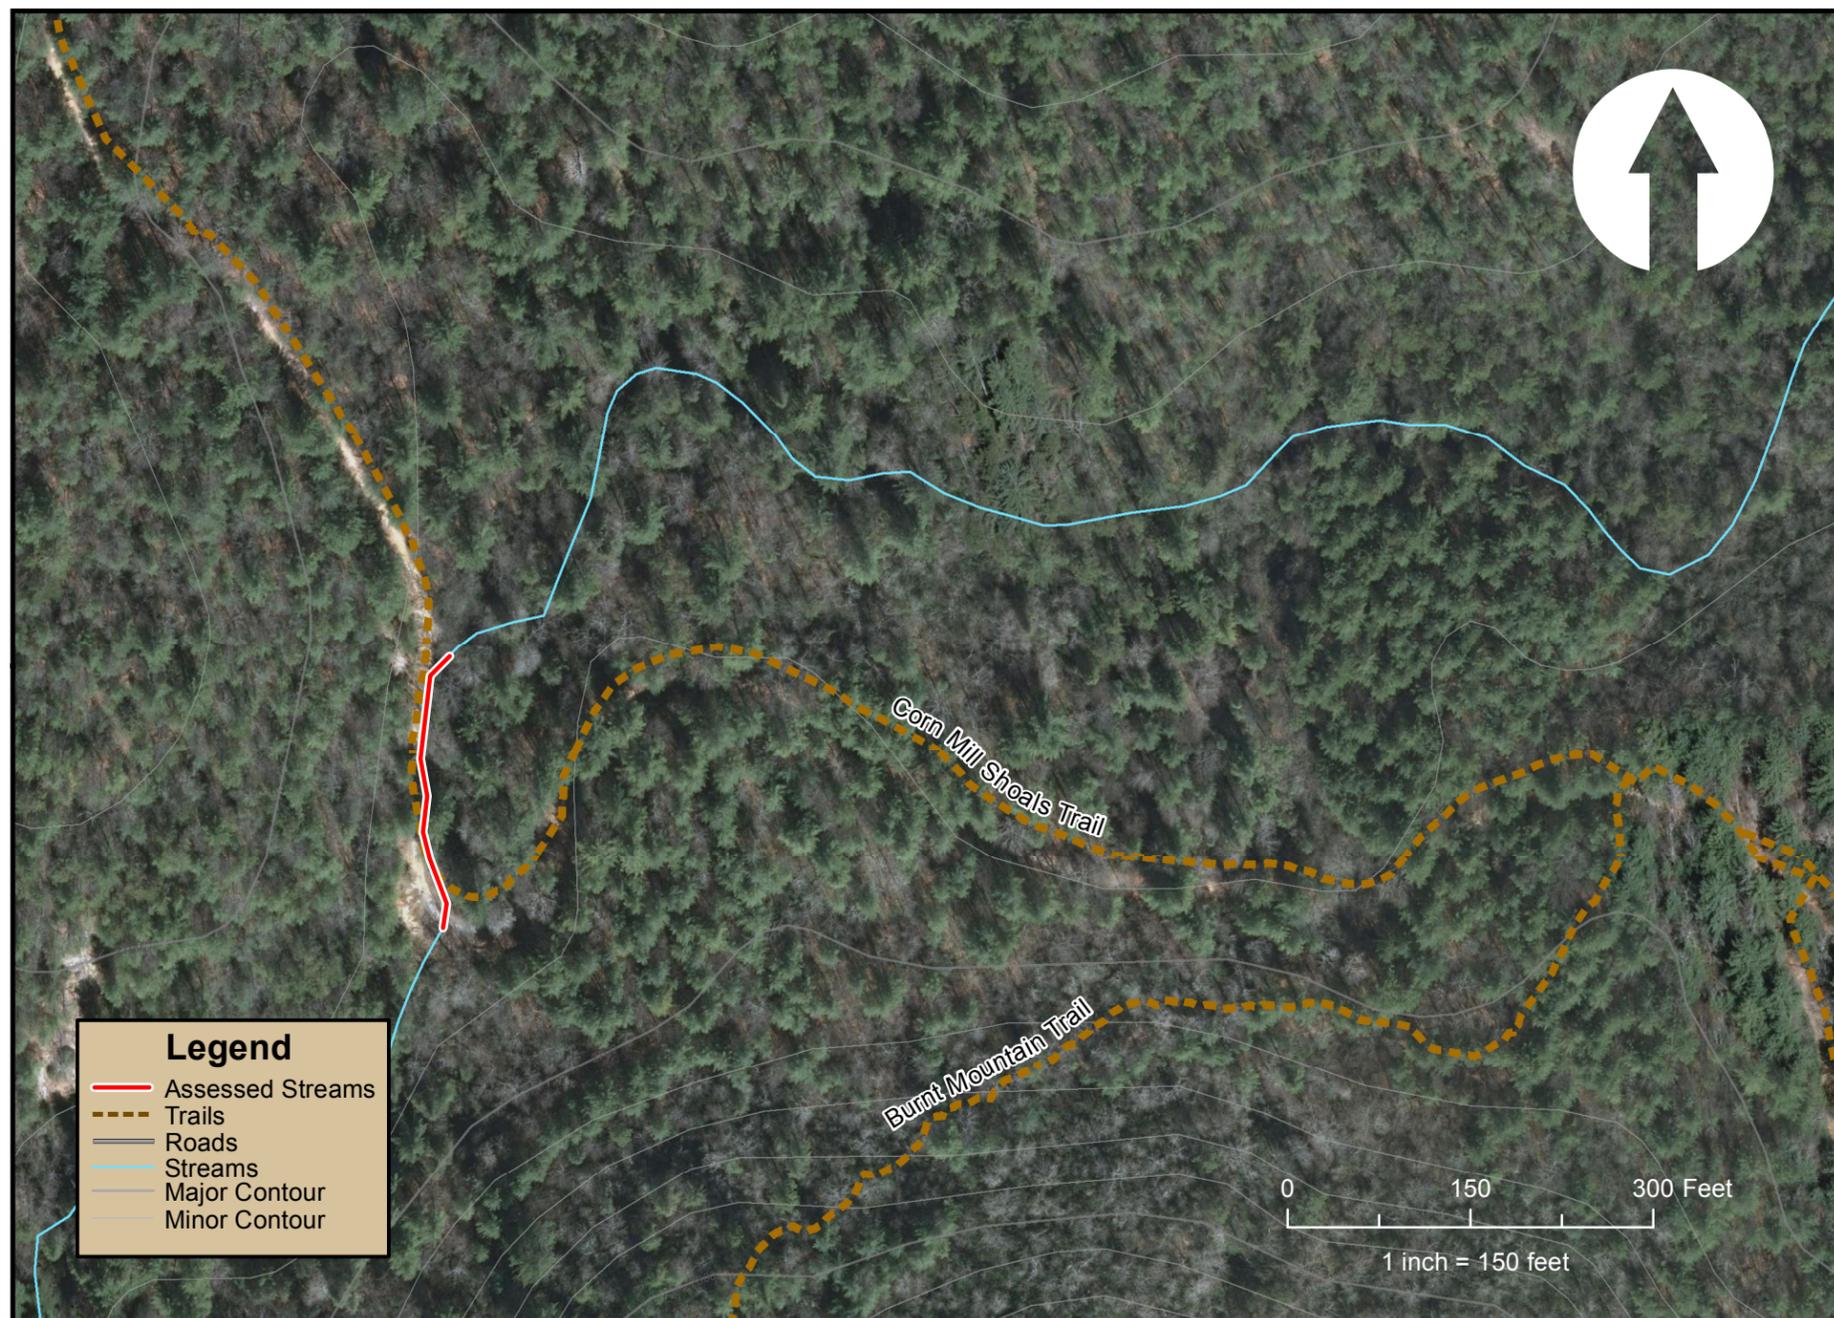
See also P07; Corn Mill Shoals Trail in buffer, providing sediment/ stormwater source.

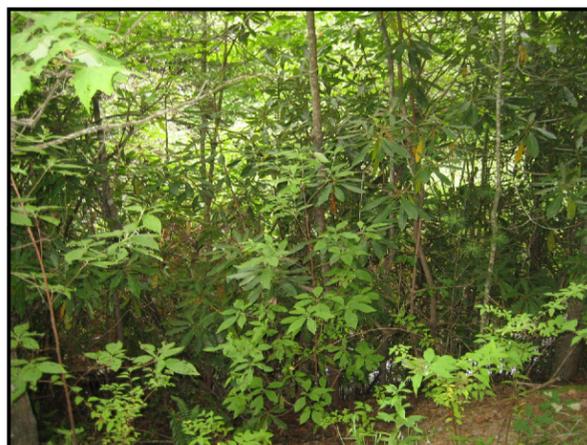
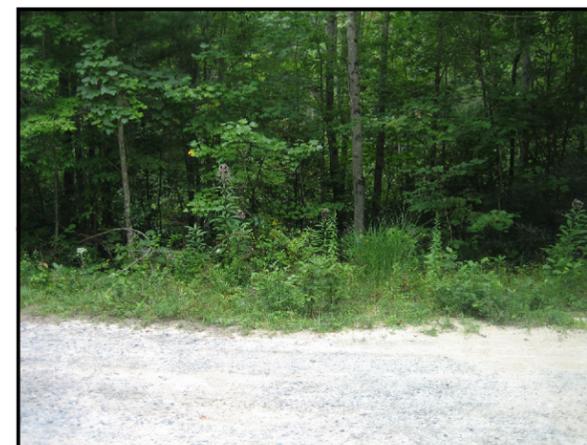
Culvert clogged upstream of Conservation Road, creating large area of backwater in channel; woody vegetation has died as a result.

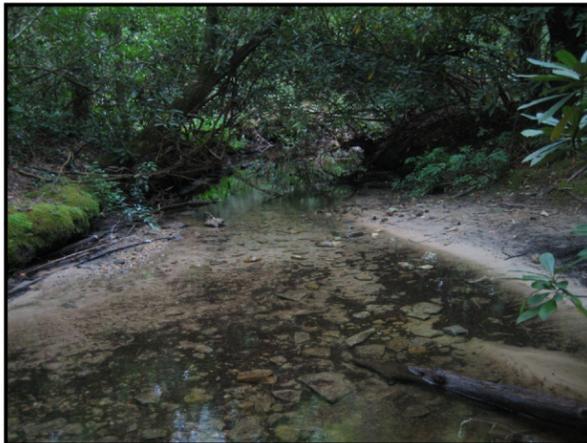
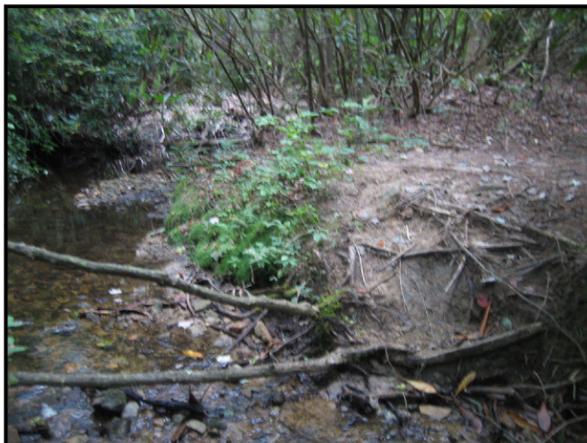
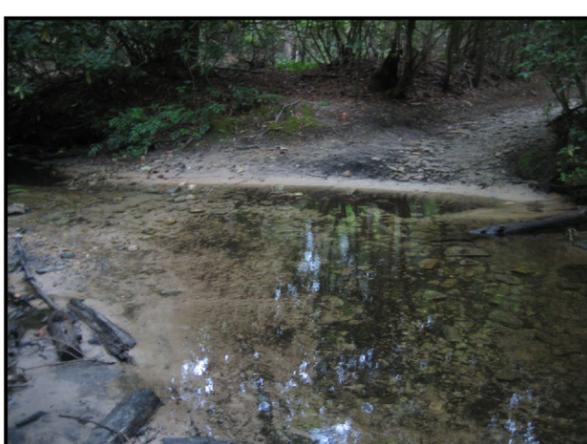
Eroding left bank just downstream of bedrock grade control, fine sediment deposition in channel; trail near channel serves as sediment source.

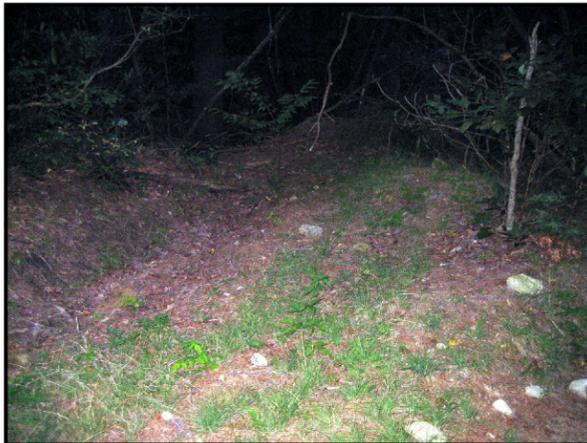
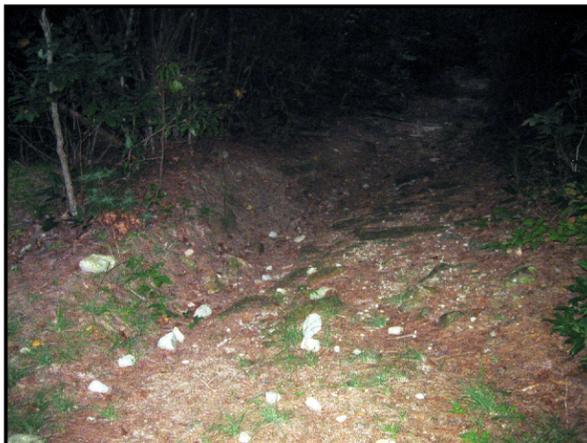
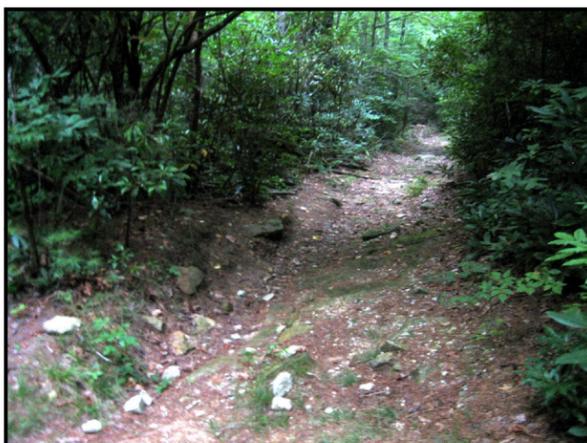
Trail in buffer with unstable crossing (croding banks, overwide channel, sediment deposition).

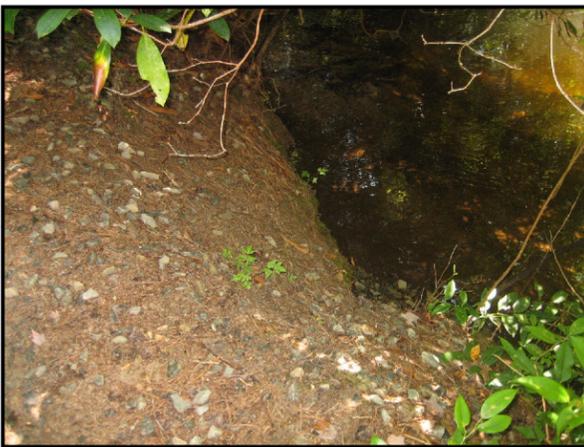
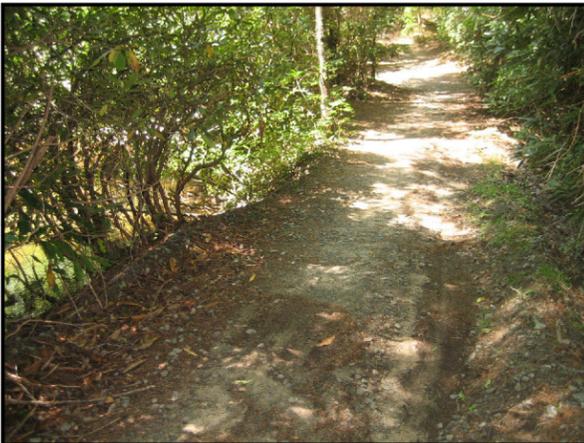
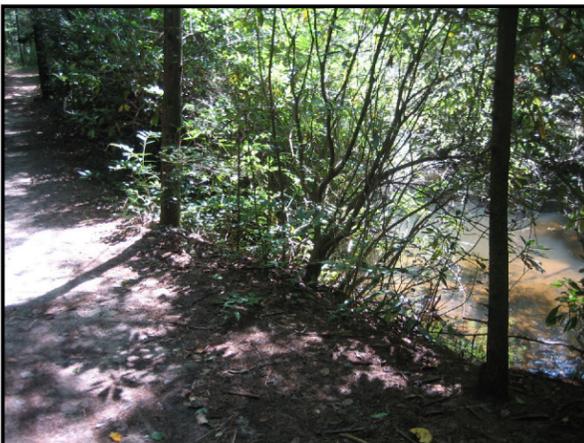
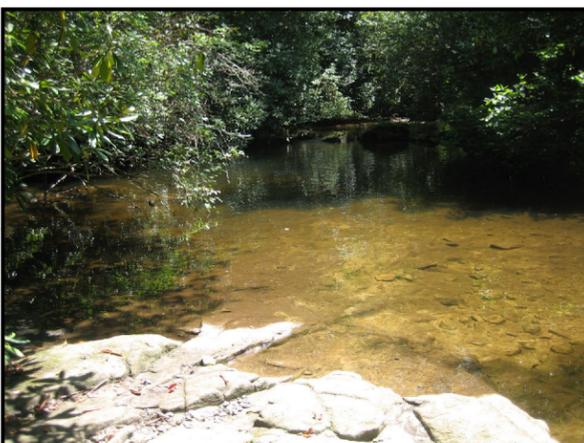
Joanna Road within buffer of stream is serving as sediment source.

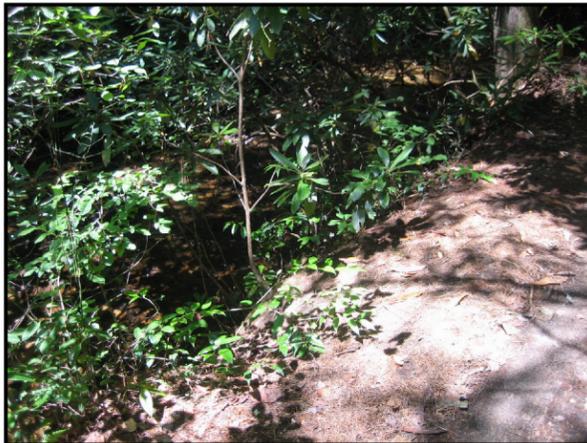
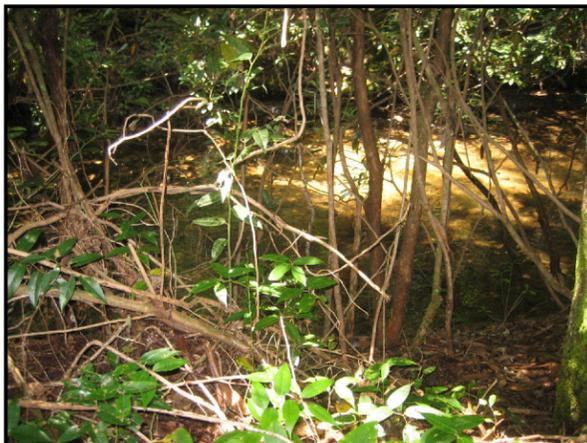
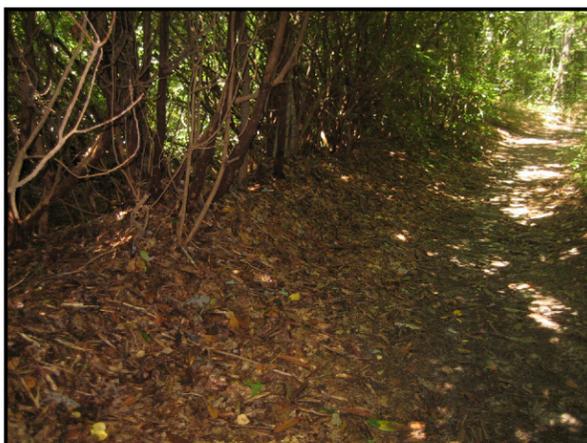
Comments
Trail crossing stable. However, trail in buffer with minor stream bank erosion.

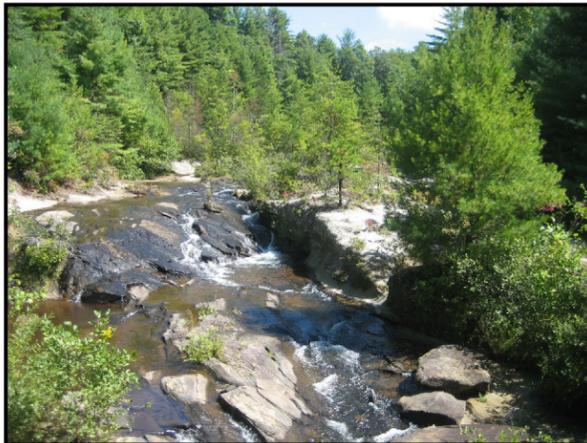
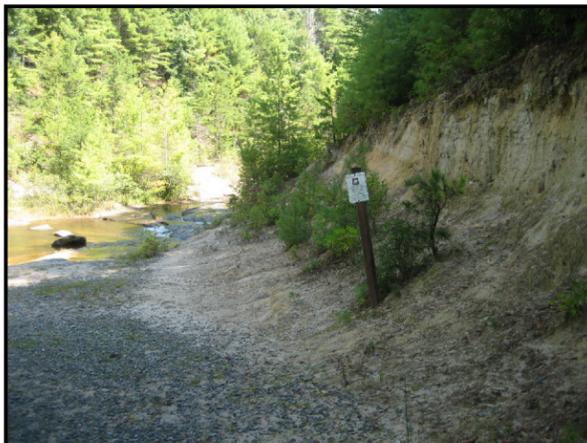
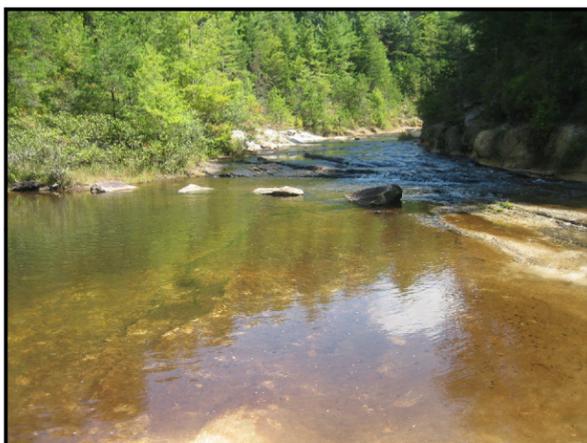
Stream generally stable, though trail and levee in buffer are detrimental.

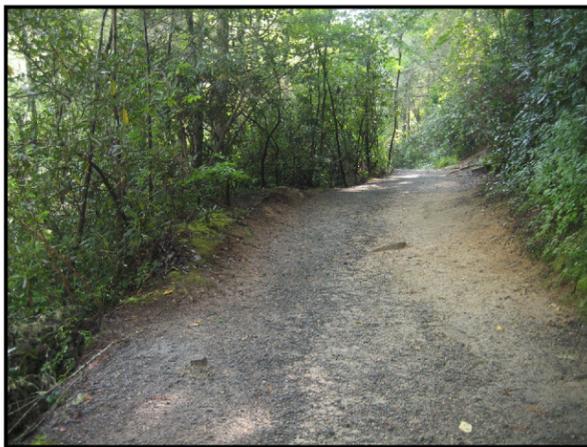
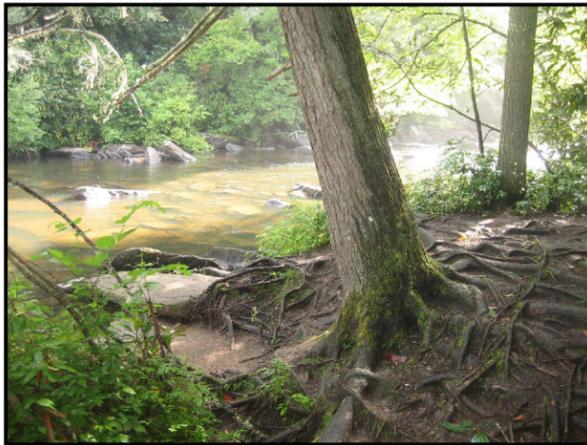
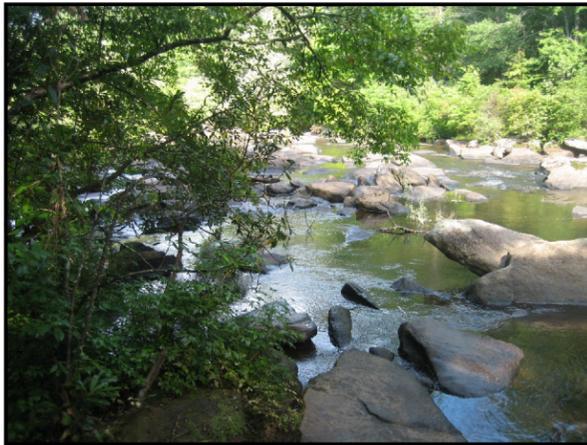
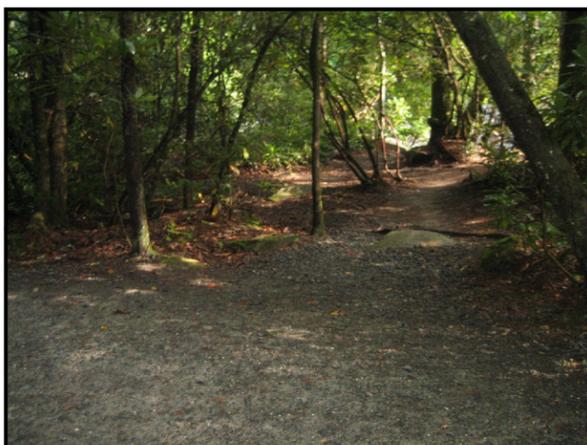
Trail along river leads to sediment and stormwater input. Some croding banks and fine scdiment in river. BMPs exist on road, but require maintenance.

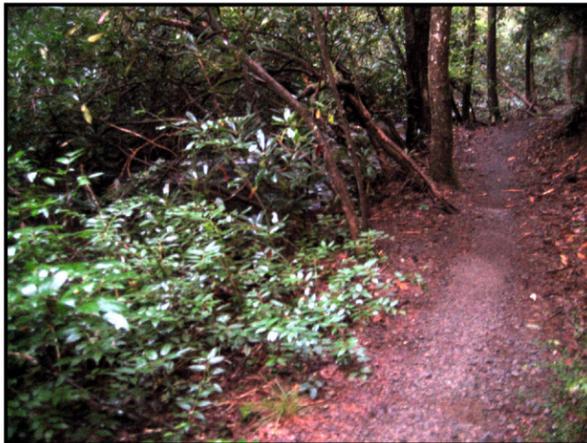
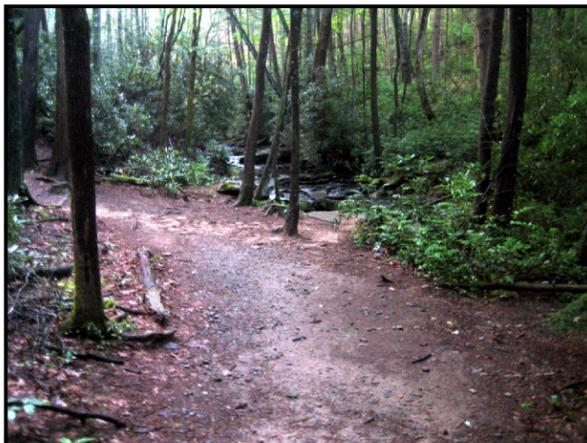
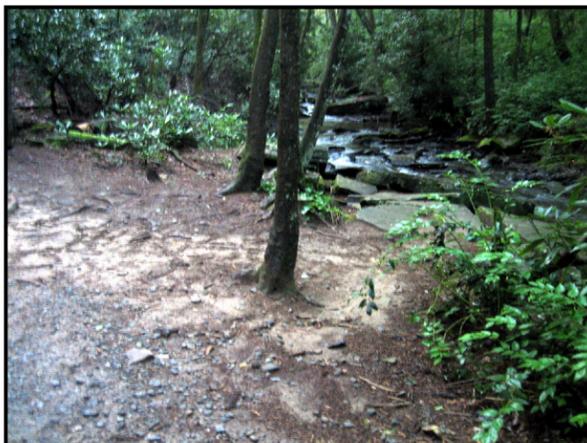
Power line through watershed, trail and old road/ trail in buffer. Head-cut at top of reach, some bank erosion throughout reach.

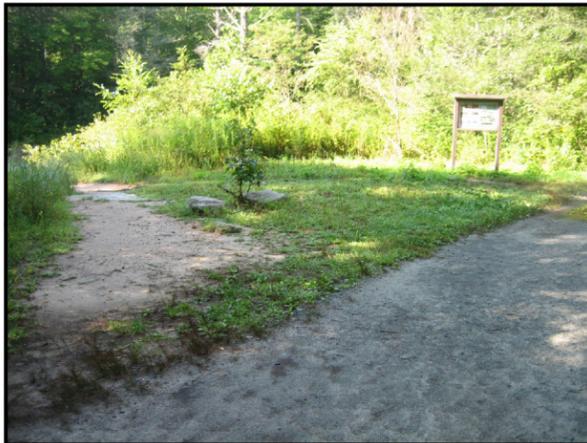
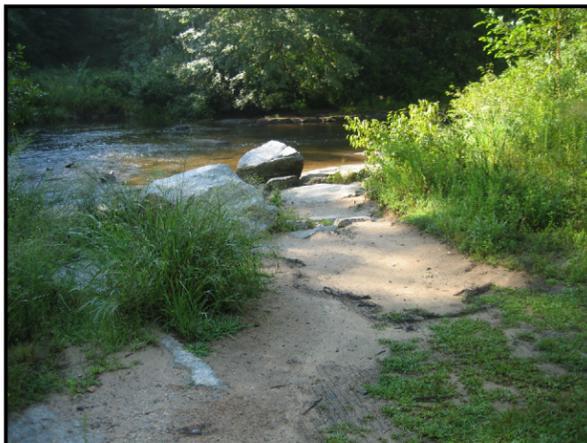
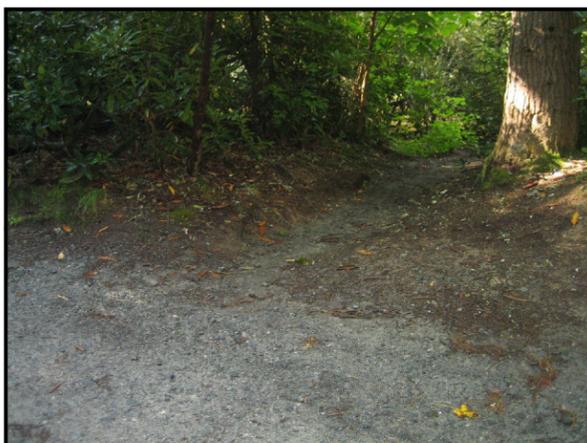
Trail within buffer, resulting in reduced vegetation and sediment input.

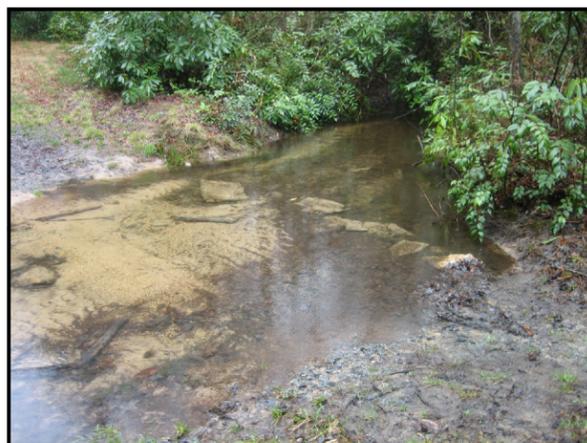
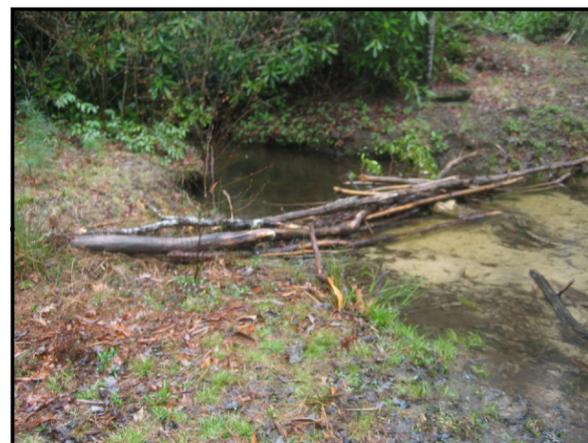
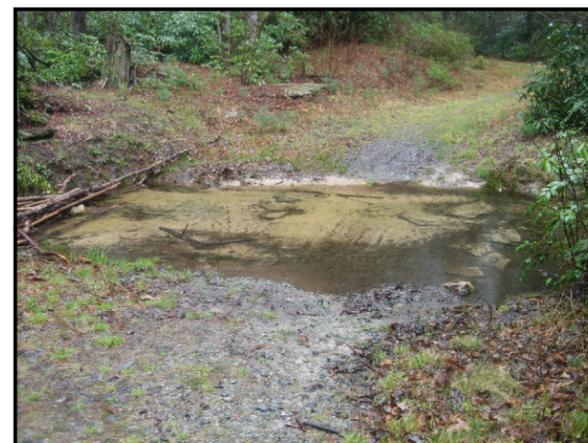
Road crossing of creek appears to be overwide and contributing fine sediment. Re-design of crossing could improve water quality.

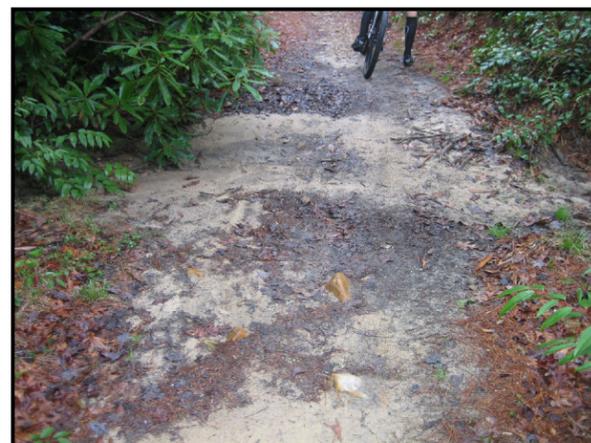
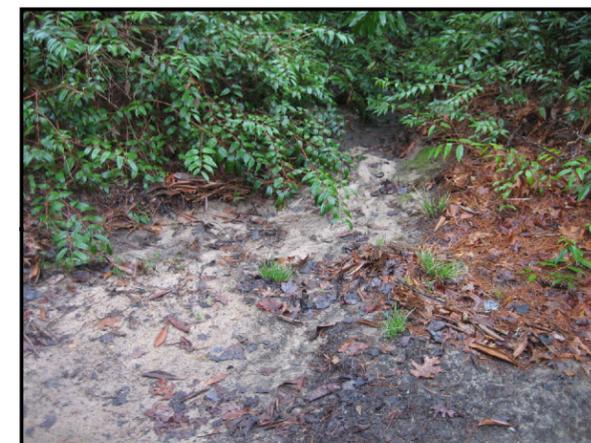
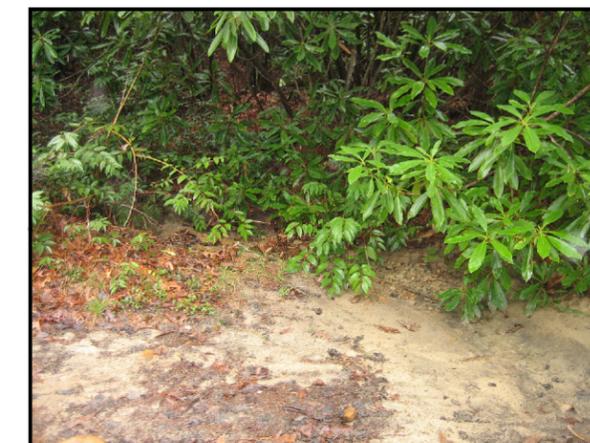
Comments
 Stormwater drainage crosses Little River Trail, with trail serving as sediment source to Little River.

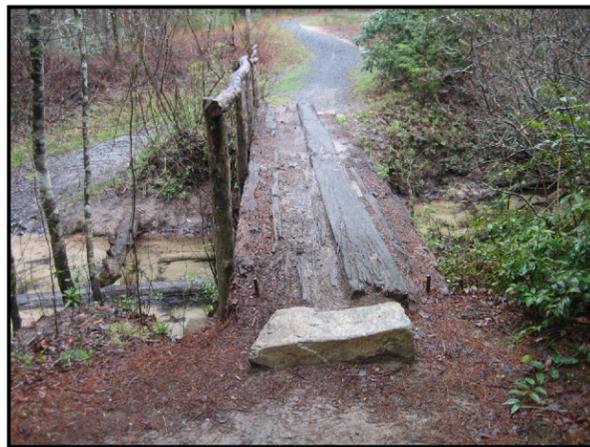
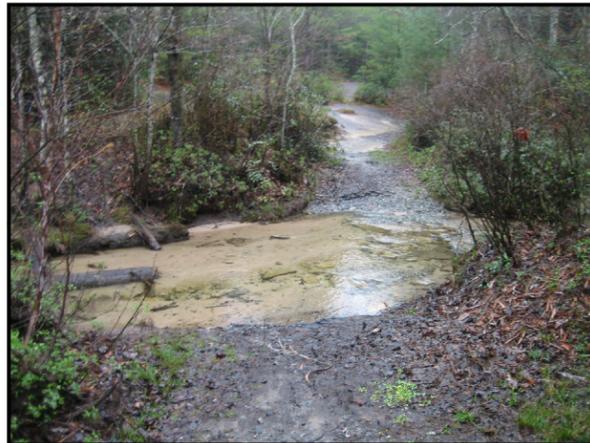
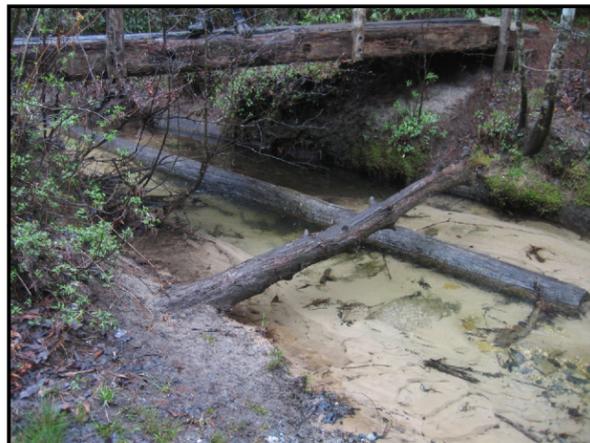
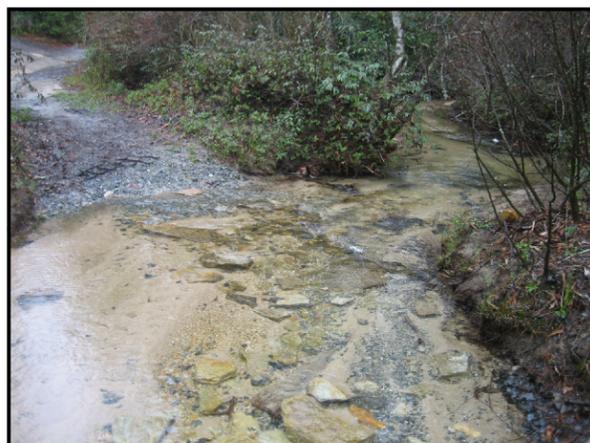
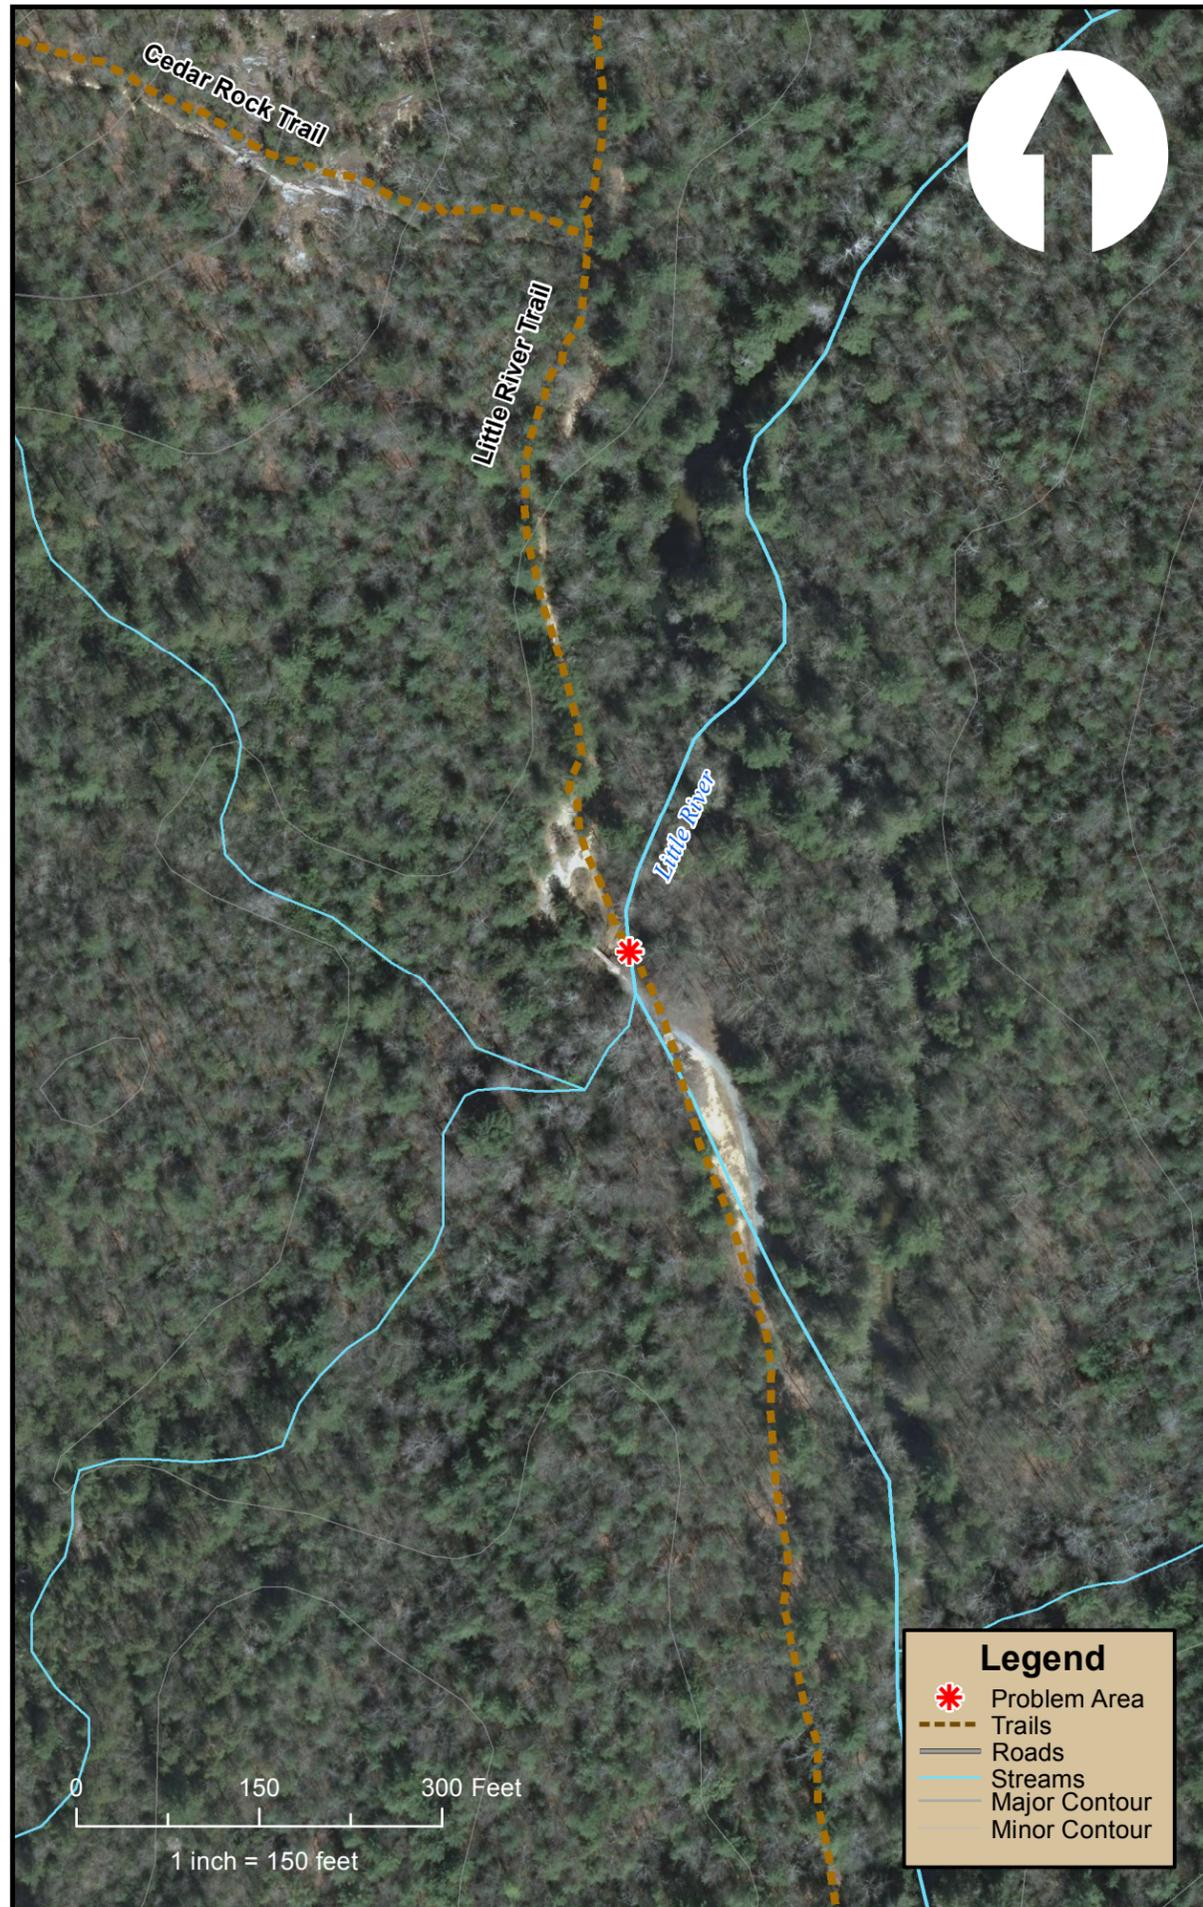
Area of Concern – Site: P06

Comments
 Tributary to Little River is crossed by bridge and ford. Bridge is in poor condition. Ford is over widened with fine sediment in streambed. Entire crossing could be reconstructed for increased stability/ safety.

| <input type="checkbox"/> maintenance | <input checked="" type="checkbox"/> bridge replacement/improvement |

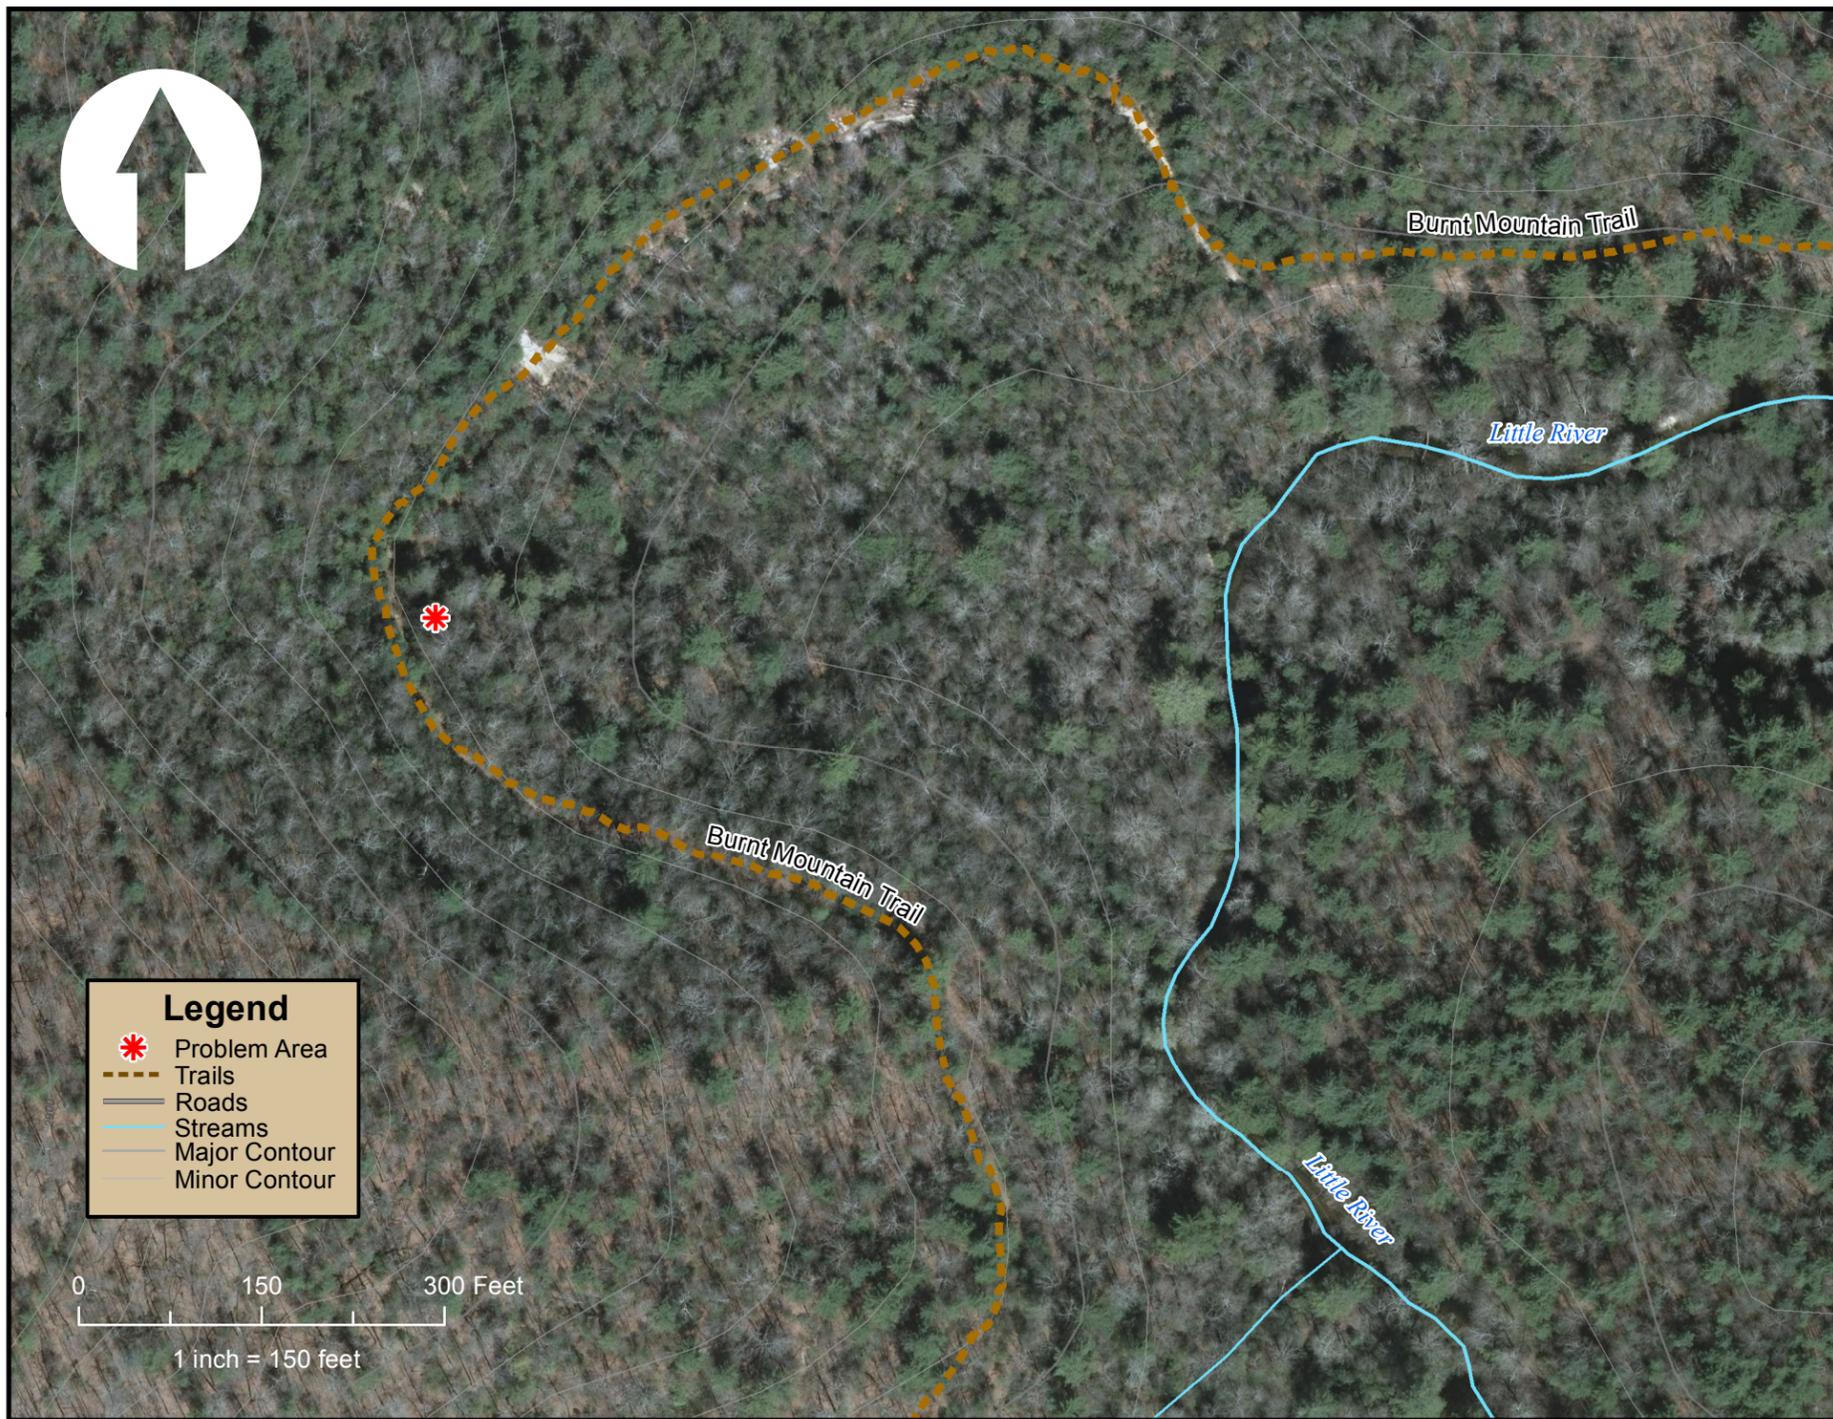
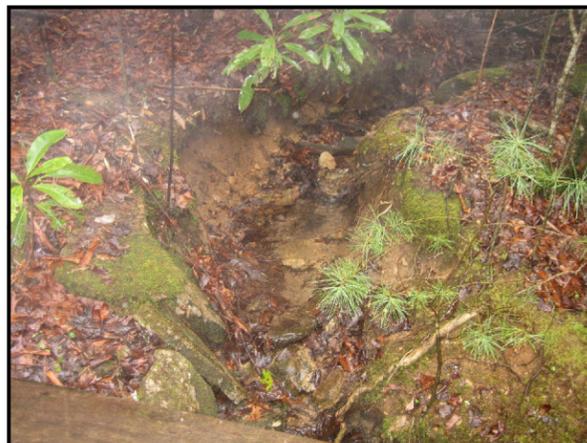
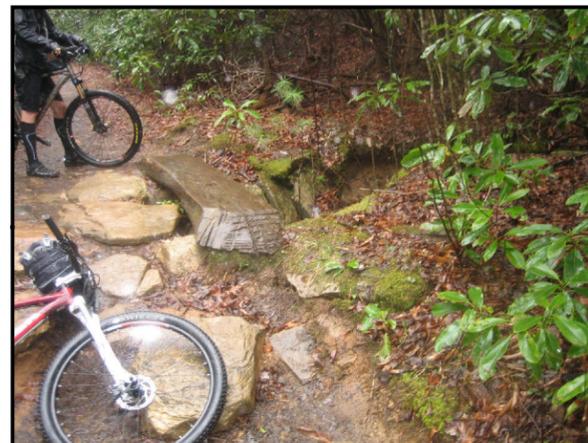
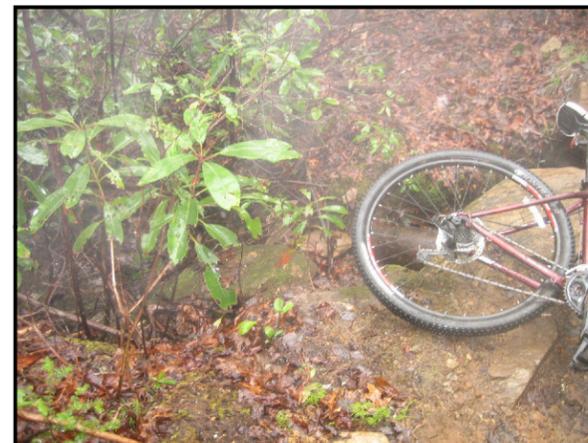
Area of Concern – Site: P09

Stream banks eroded upstream/ downstream of culvert. Trail currently intact.

| <input type="checkbox"/> human/ animal exclusion | <input checked="" type="checkbox"/> culvert rehabilitation/ replacement |

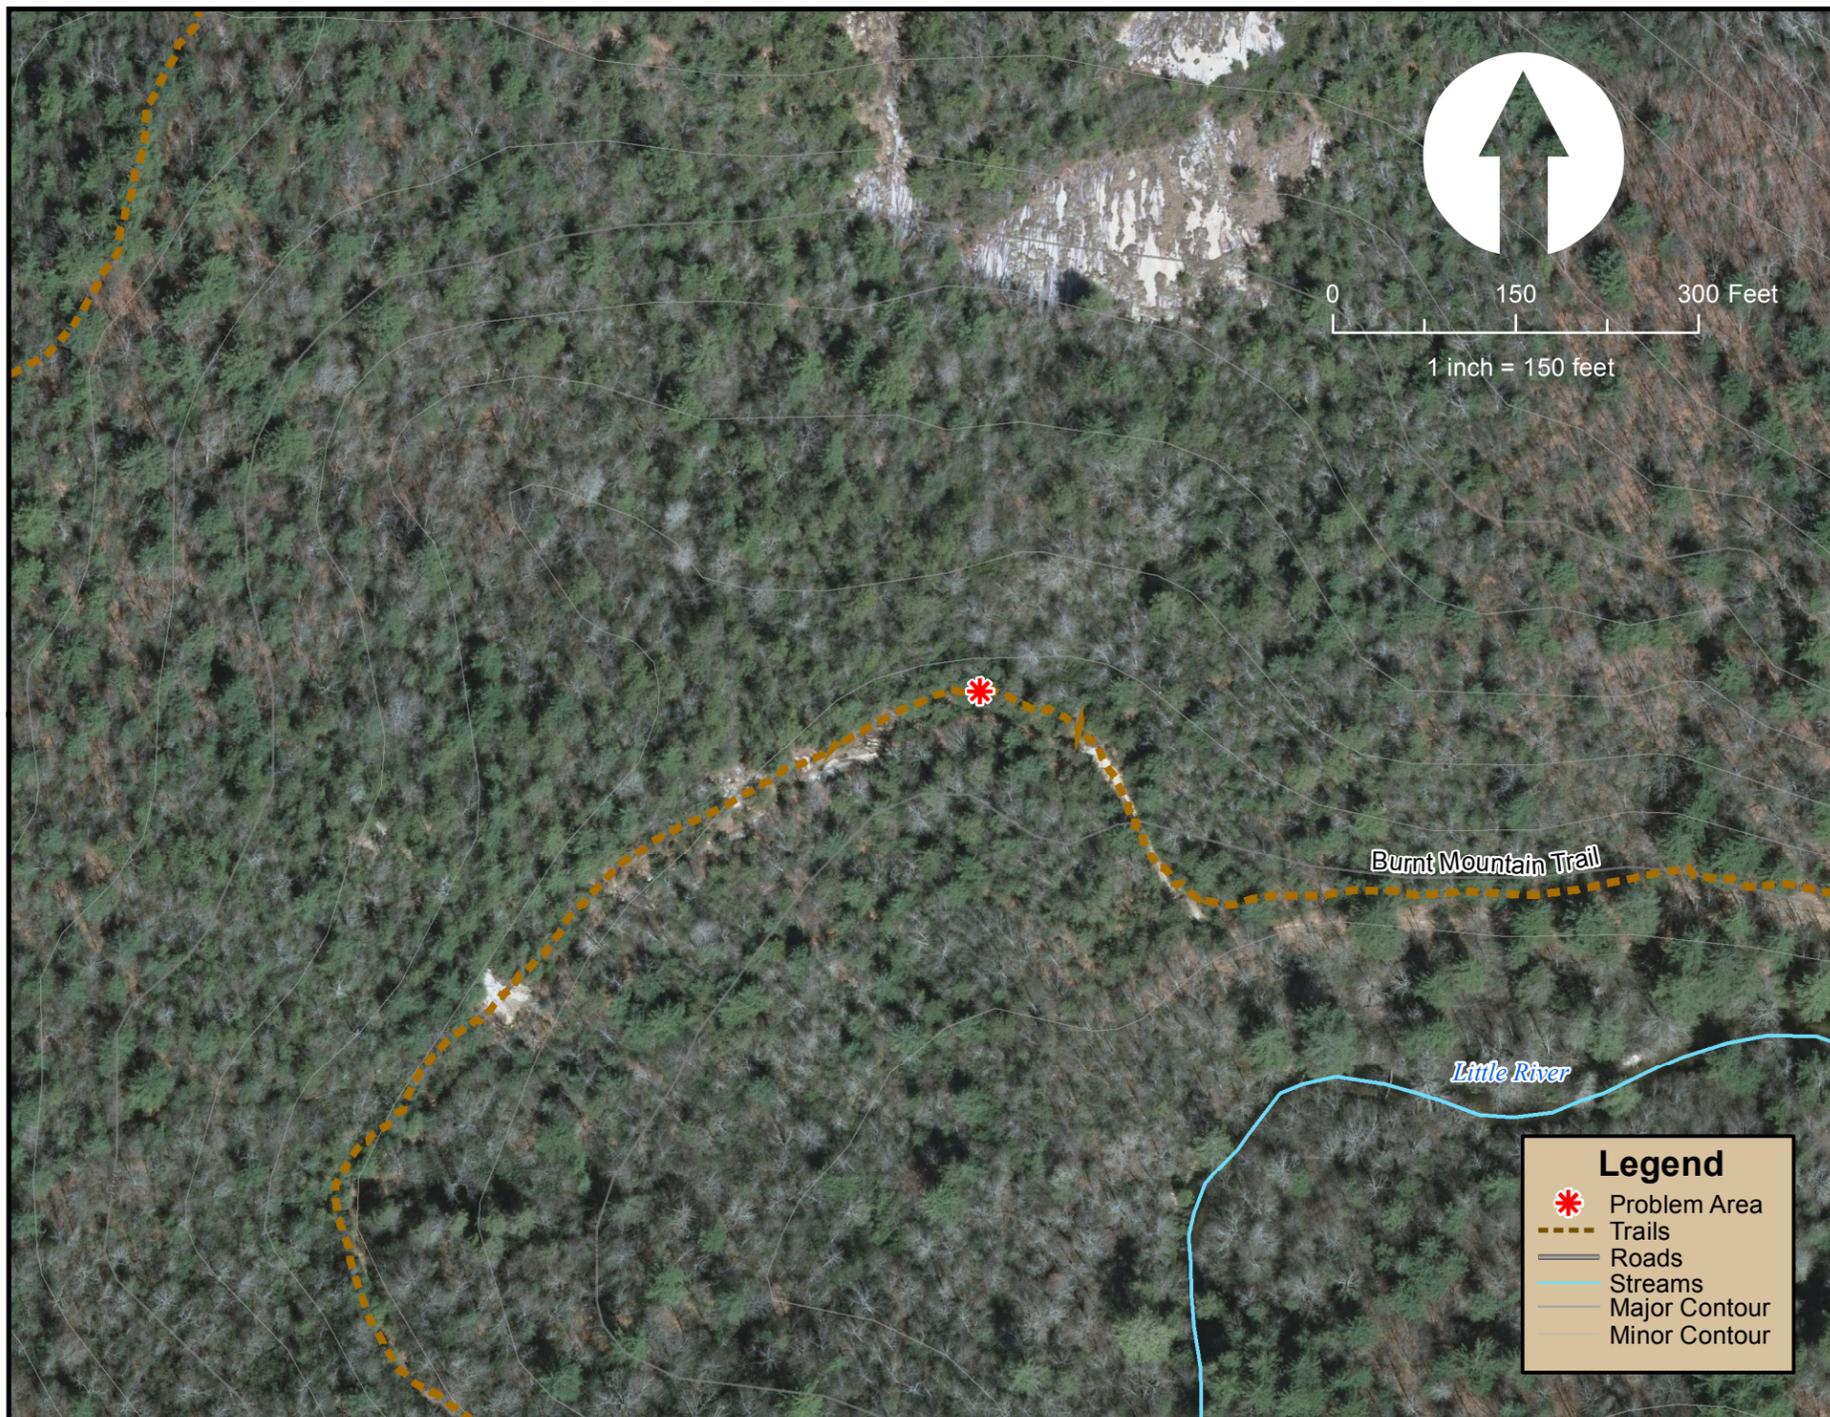
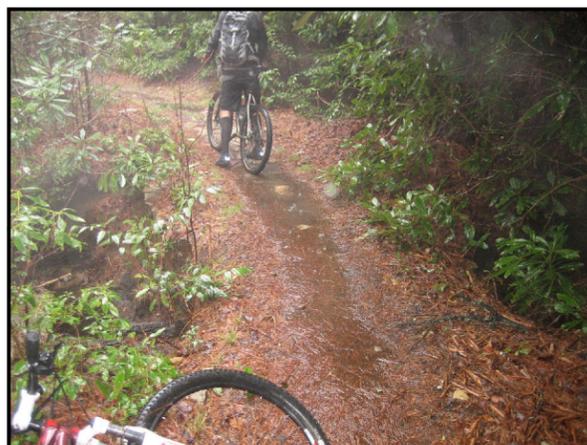
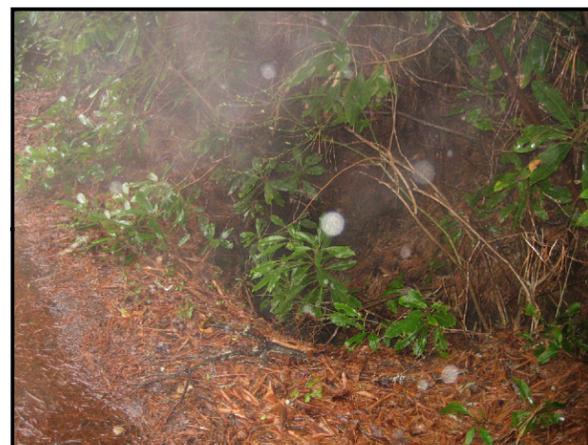
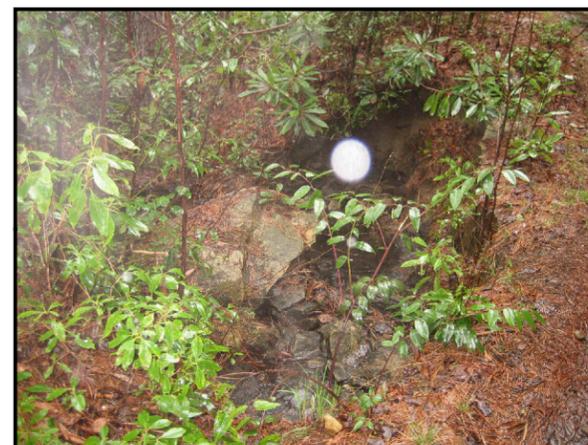
Area of Concern – Site: P10

Stream banks eroded upstream/ downstream of culvert. Trail currently intact.

| <input type="checkbox"/> human/ animal exclusion | <input checked="" type="checkbox"/> culvert rehabilitation/ replacement |
