Water Resources Restoration Master Plan

DuPont State Recreational Forest
North Carolina

Prepared for:
North Carolina Forest Service

November 9, 2015

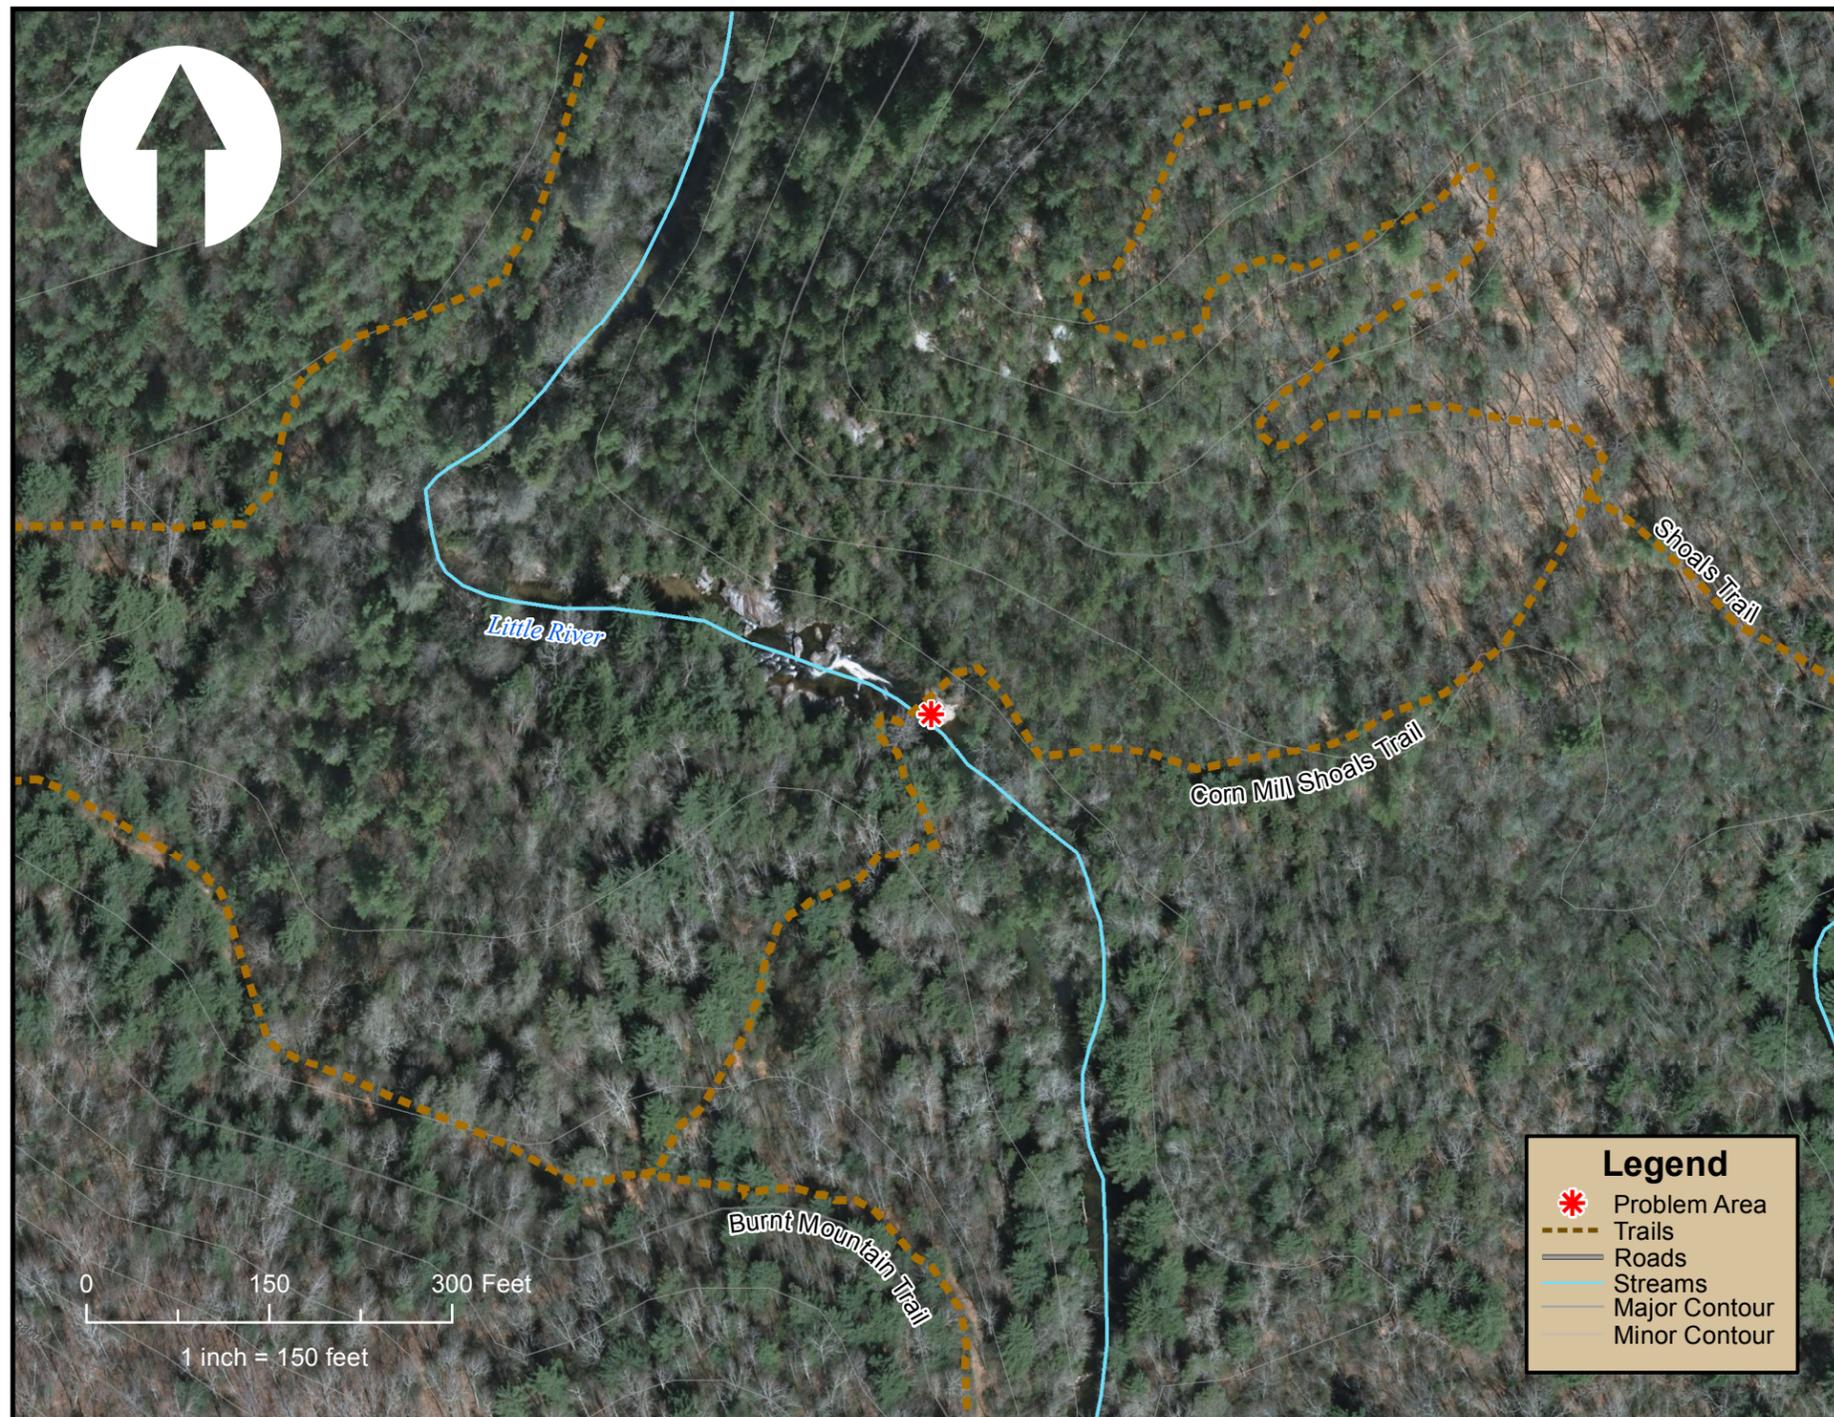
Area of Concern – Site: P11

Comments
 Trail over widened and missing vegetation in vicinity of crossing. Actual crossing stable due to bedrock in riverbed.

| <input checked="" type="checkbox"/> human/ animal exclusion | <input type="checkbox"/> culvert rehabilitation/ replacement |

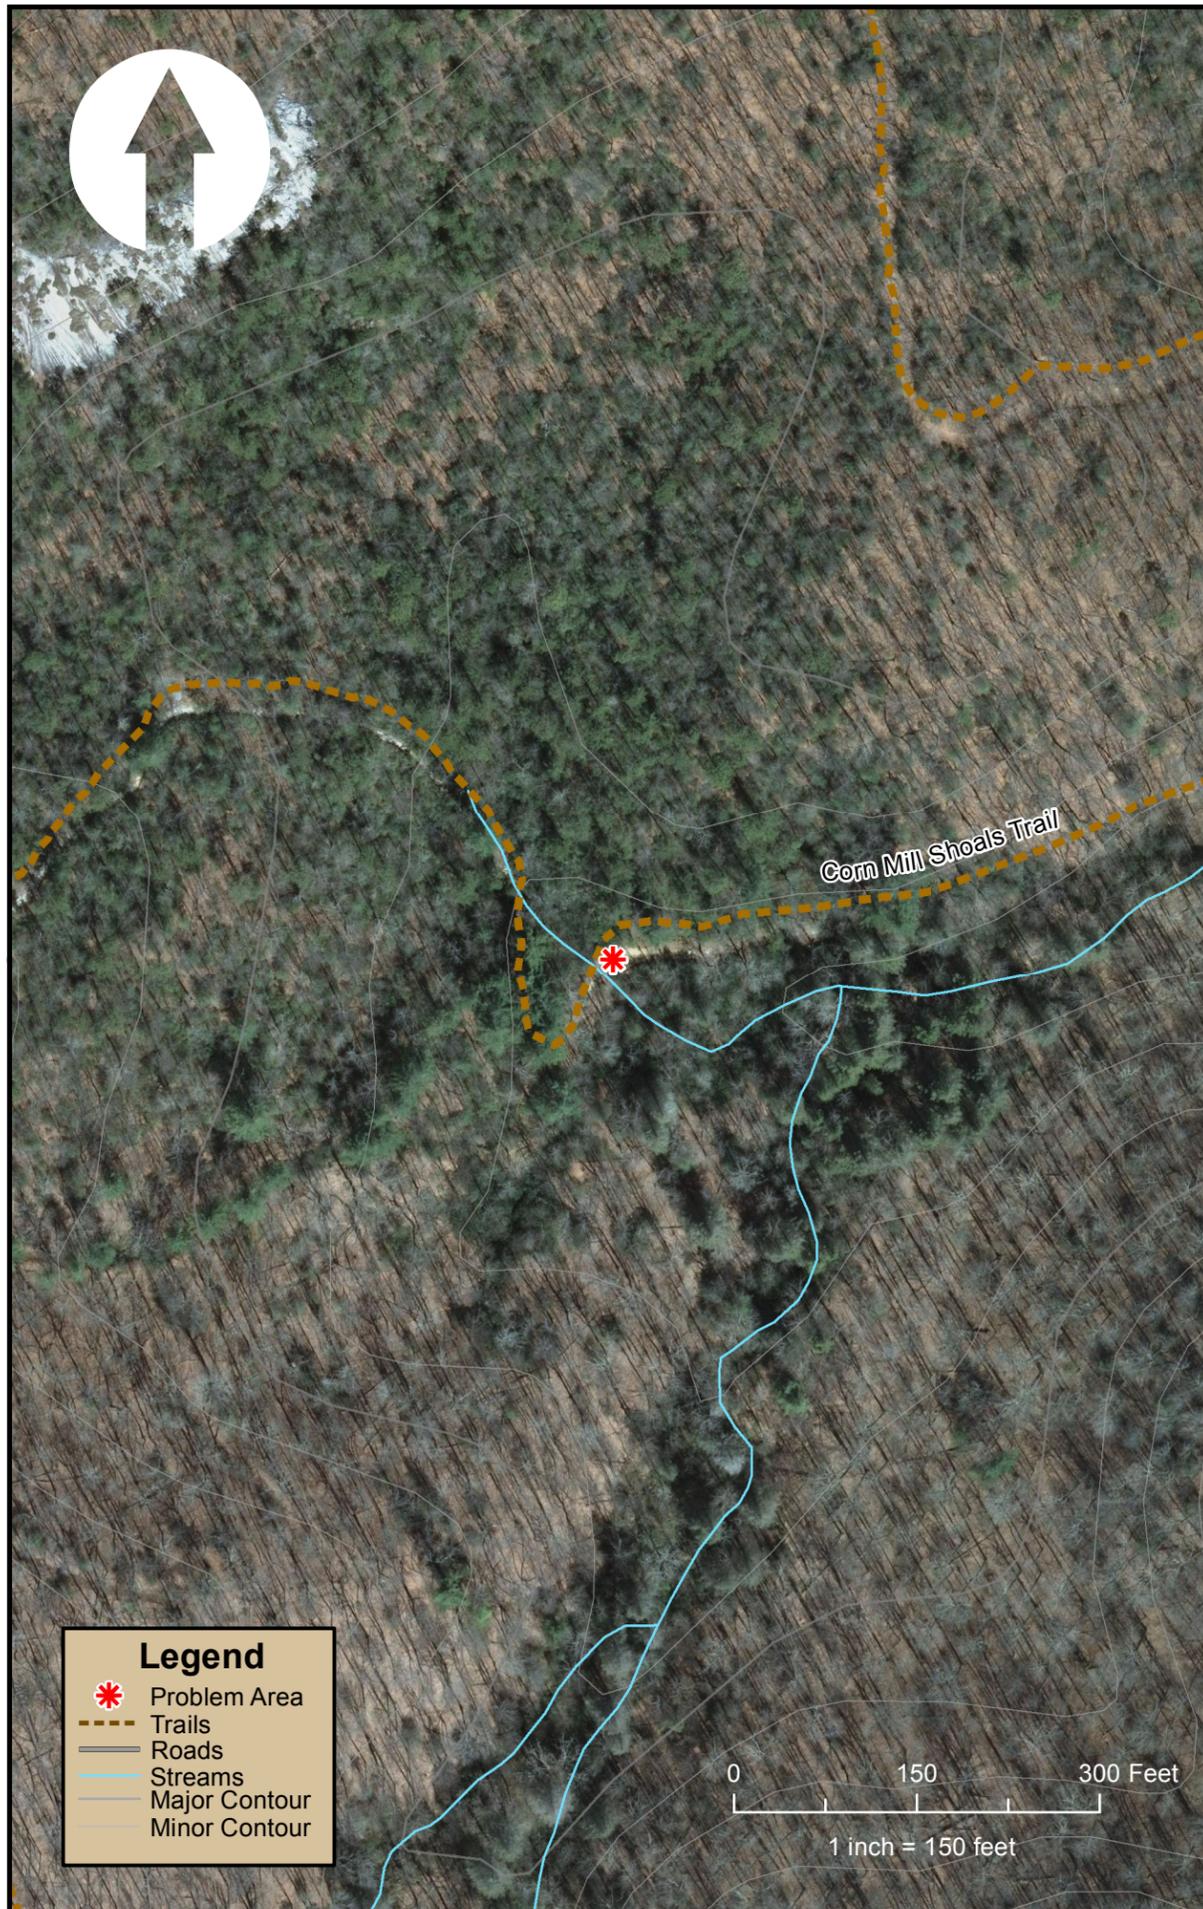
Area of Concern – Site: P12

Culvert appears to be in good condition, though perched at downstream end. Trail serves as sediment source to stream, with sediment traps full.

| <input checked="" type="checkbox"/> maintenance | <input type="checkbox"/> bridge replacement/improvement |

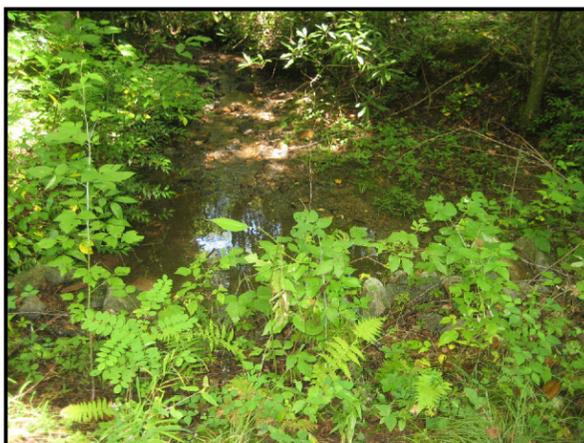
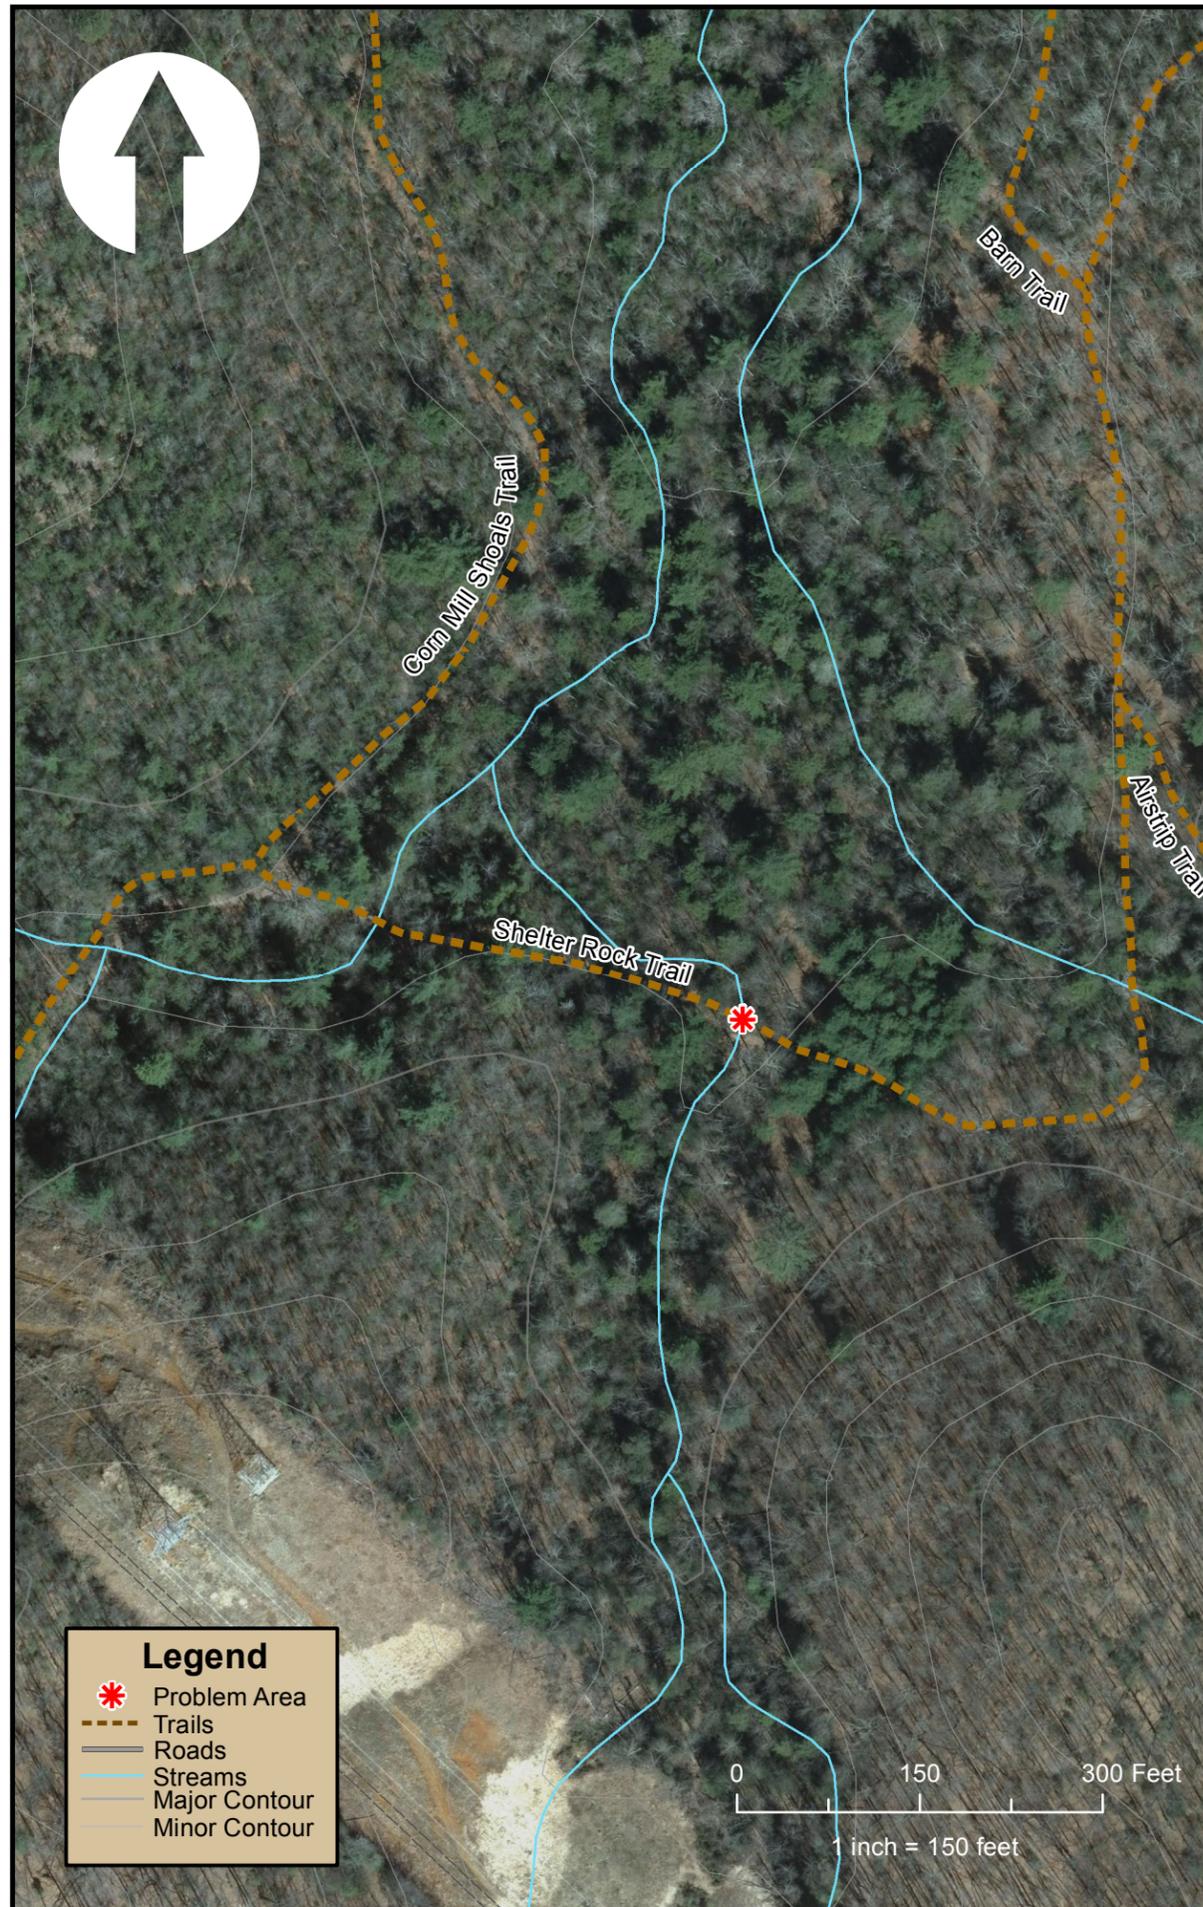
Area of Concern – Site: P14

Comments
 Culvert exists and appears to be in good condition. Bare area between trail and stream caused/ exacerbated by human access and stormwater.

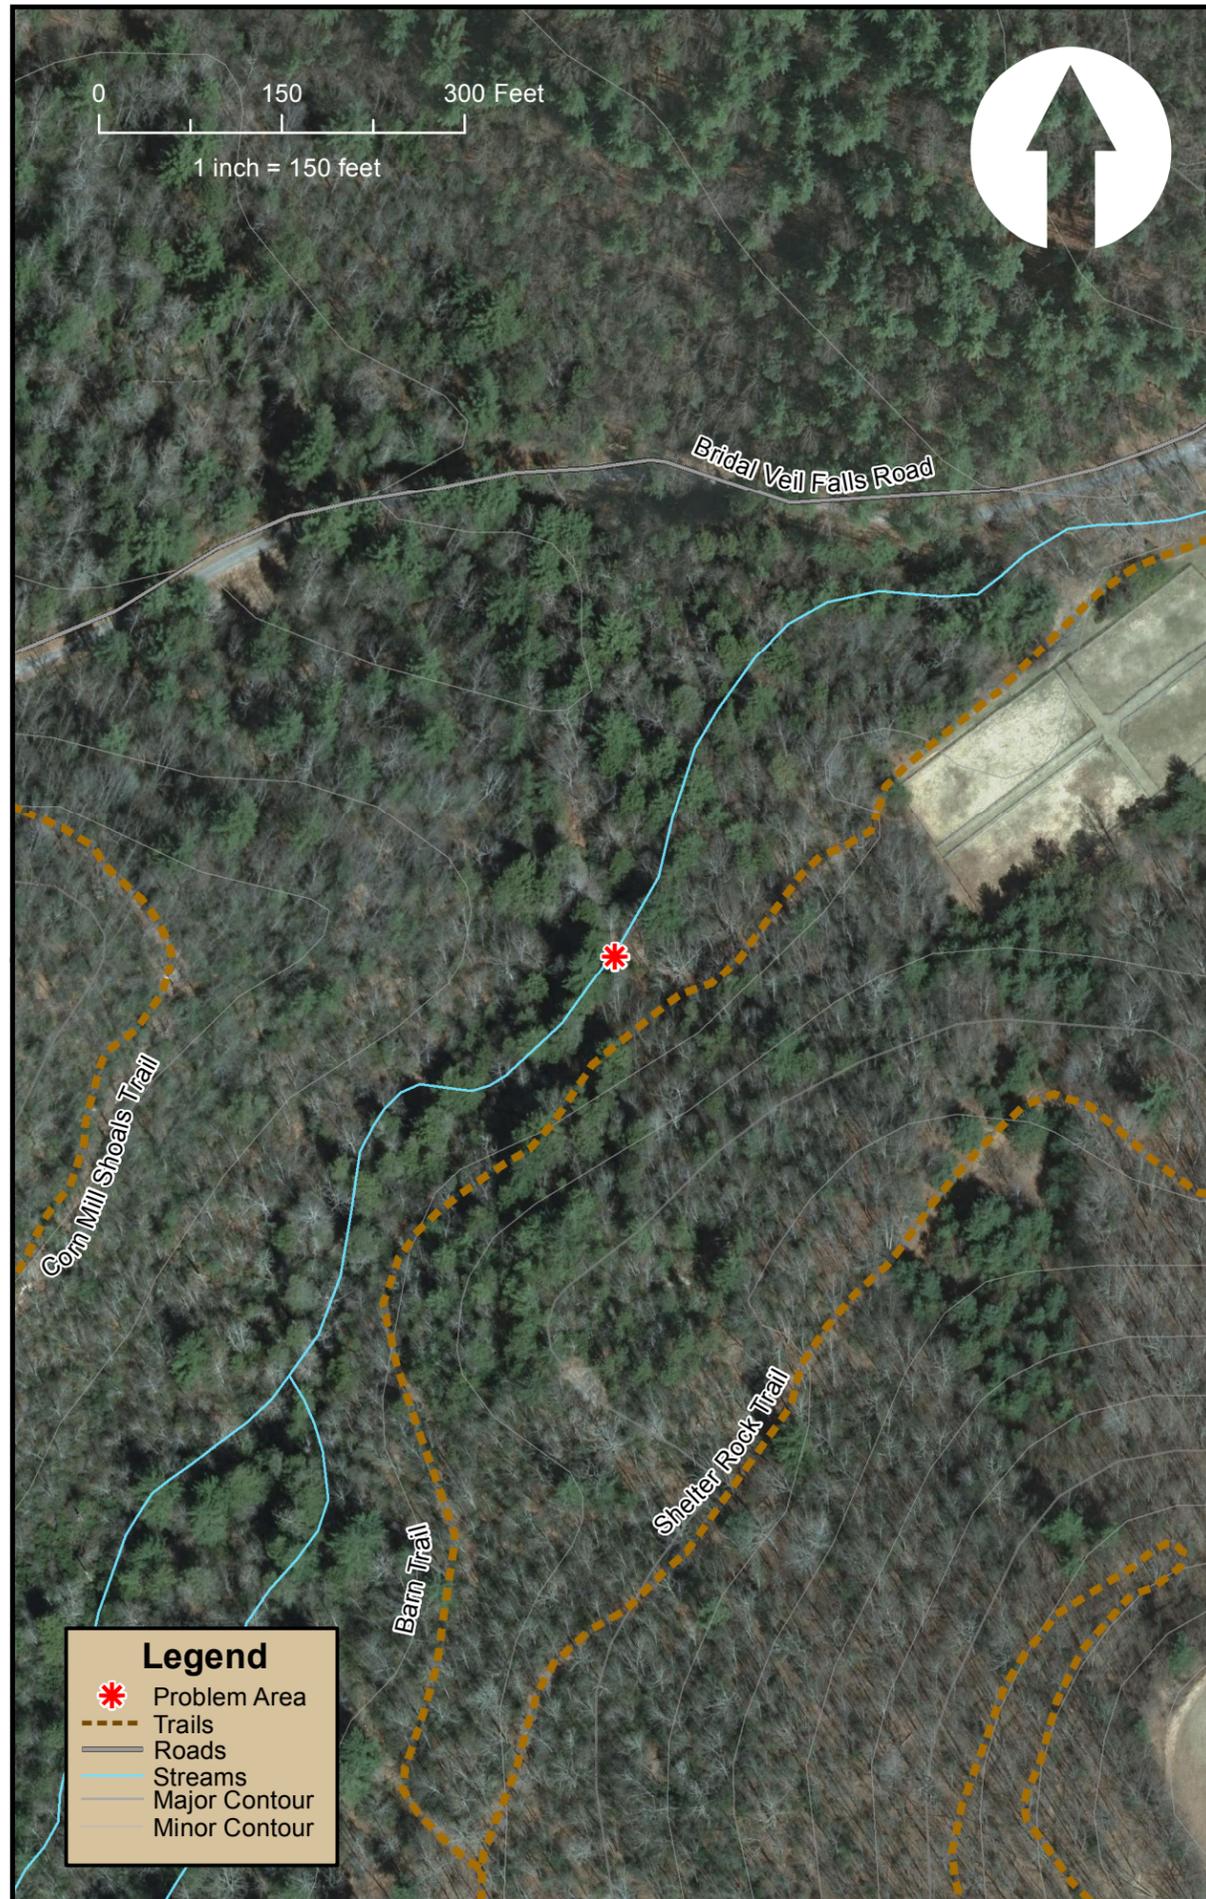
Area of Concern – Site: P16

Unvegetated stream banks and fine sediment in stream at horse watering area.

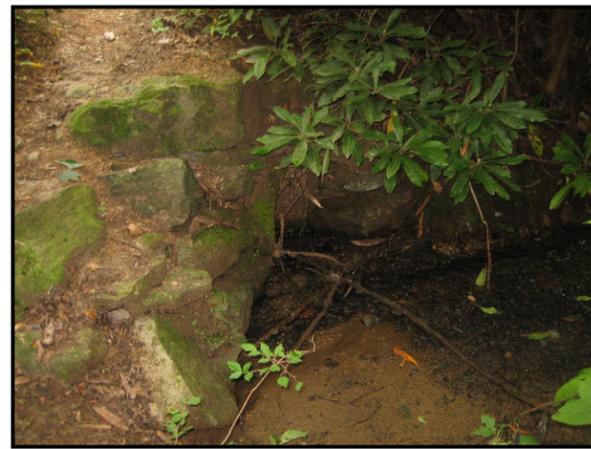
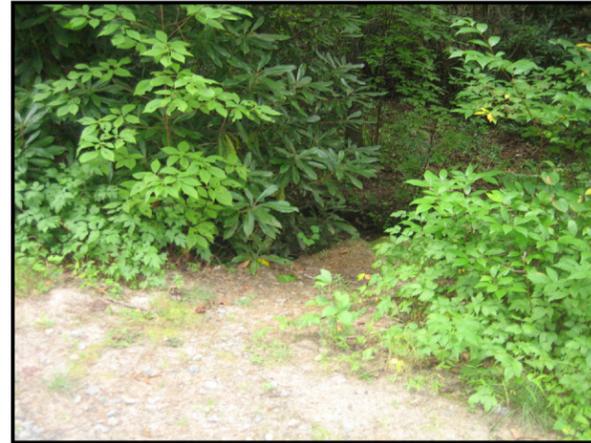
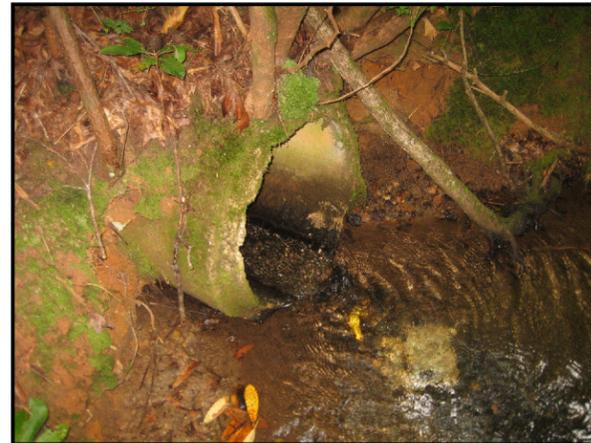
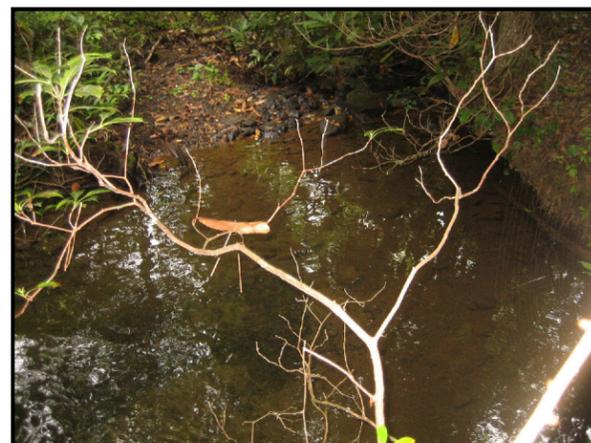
Area of Concern – Site: P18

Map Grid Location: F10 Site visit date/ team): 8/17/15/ JZ Drainage Area (Sq. Mi.): 0.15
 Name & Location: Fawn Lake outlet at Conservation Road

Comments
 Very minor bank erosion and deposition upstream and downstream of culvert, possible piping, minor erosion around culvert at downstream end.

| <input type="checkbox"/> human/ animal exclusion | <input checked="" type="checkbox"/> culvert rehabilitation/ replacement |

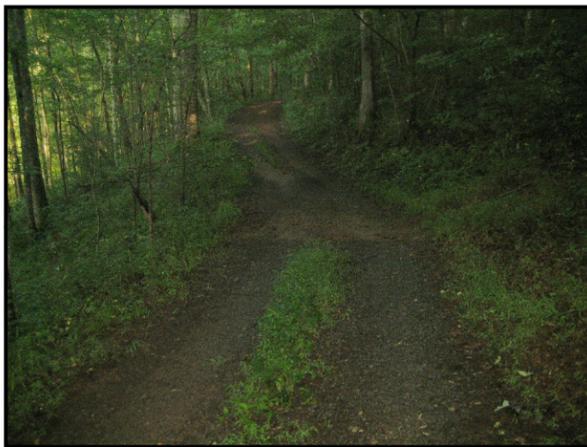
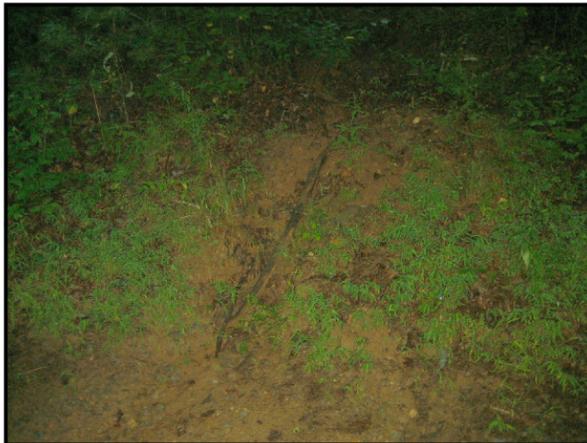
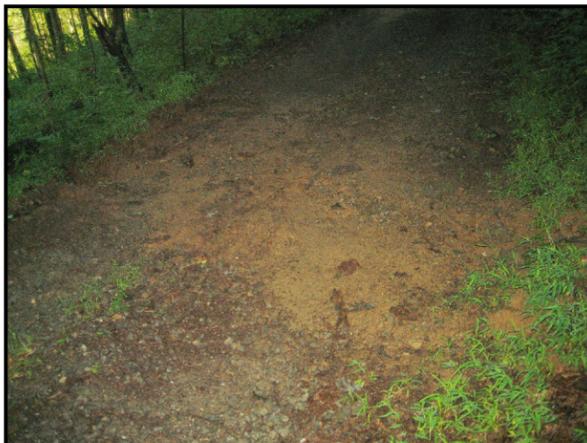
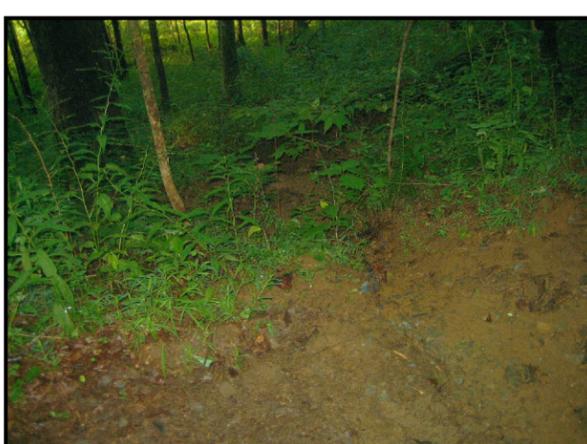
Area of Concern – Site: P20

Map Grid Location: F9 Site visit date/ team): 8/19/15/ JZ Drainage Area (Sq. Mi.): < 0.1
 Name & Location: Drainage across Reasonover Creek Trail

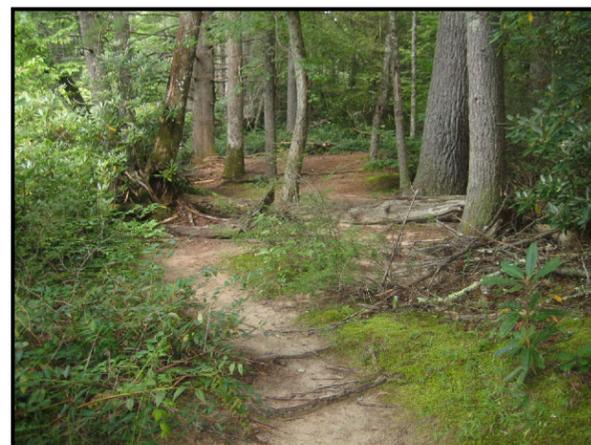
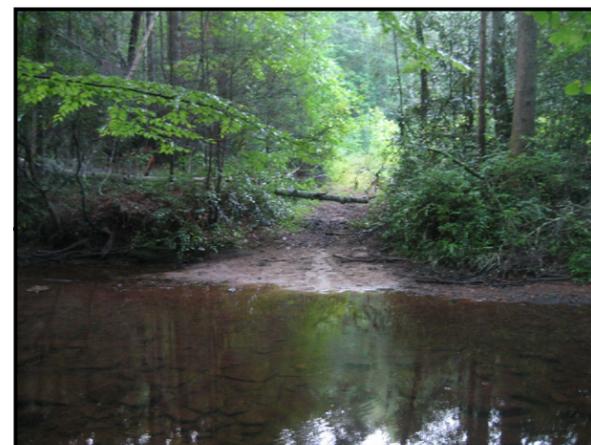
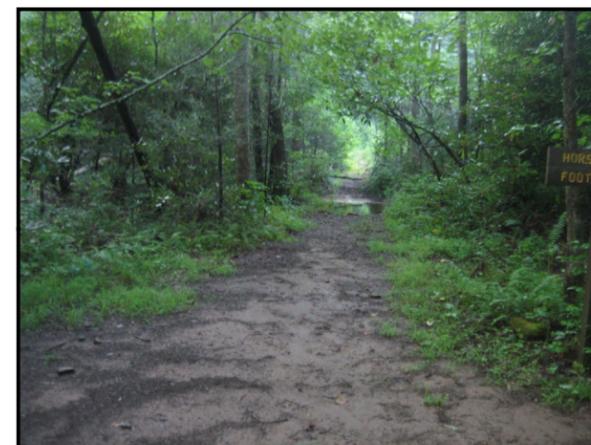
Area of Concern – Site: P21

Map Grid Location: F10 Site visit date/ team): 8/19/15/ JZ Drainage Area (Sq. Mi.): 3.27
 Name & Location: Reasonover Creek at Reasonover Creek Trail

Fine sediment entering creek as result of trail crossing. Potentially improve to harden crossing.

| <input checked="" type="checkbox"/> human/ animal exclusion | <input type="checkbox"/> culvert rehabilitation/ replacement |

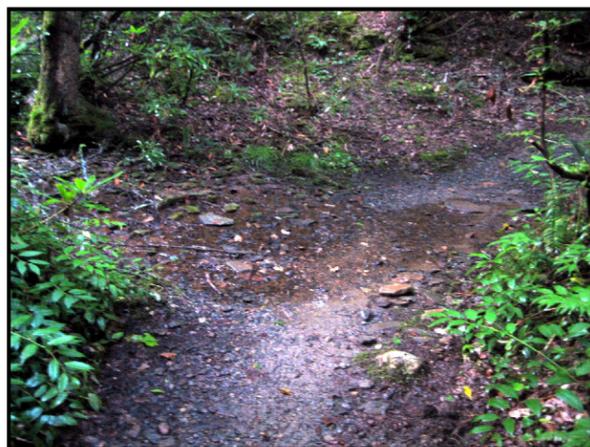
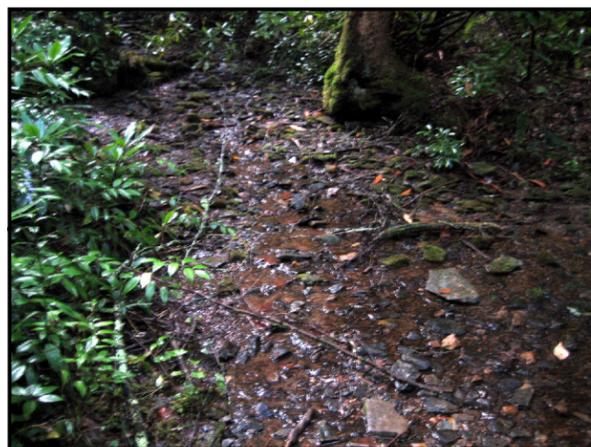
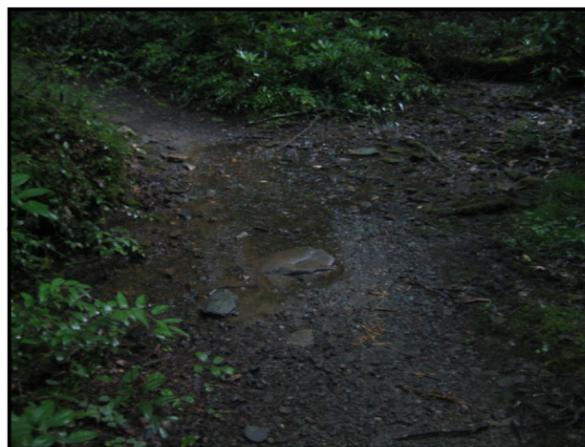
Area of Concern – Site: P22

Map Grid Location: F10 Site visit date/ team): 8/19/15/ JZ Drainage Area (Sq. Mi.): < 0.1
 Name & Location: Tributary at Reasonover Creek Trail

Tributary over widened and unvegetated at trail crossing.

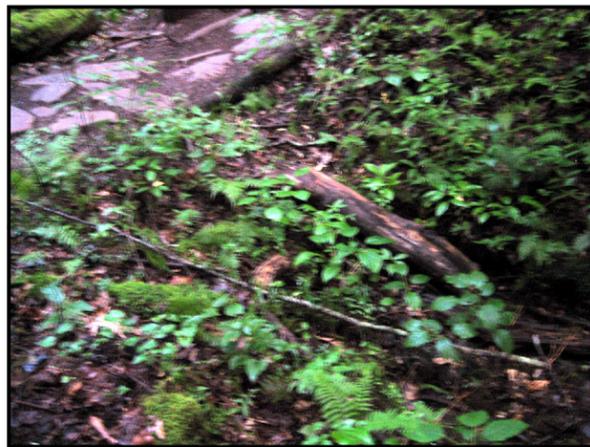
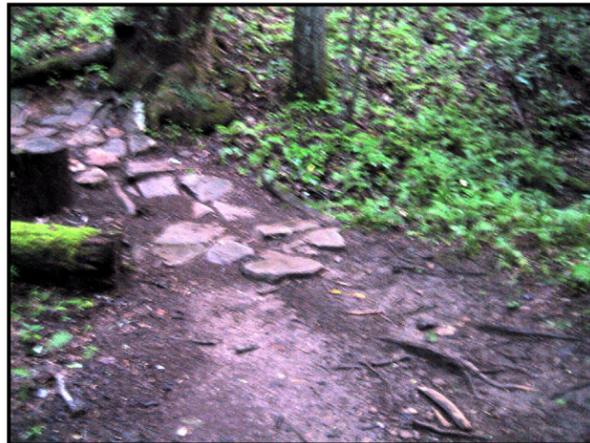
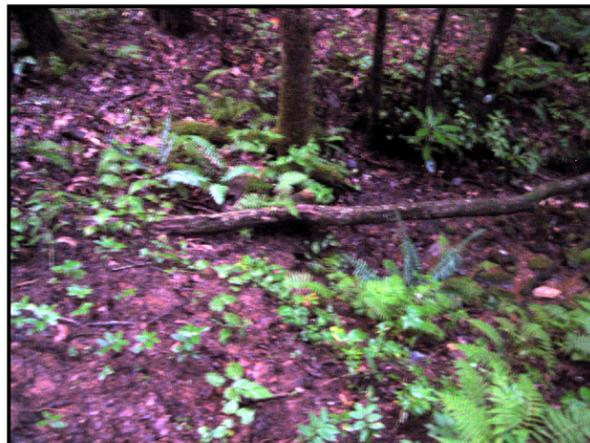
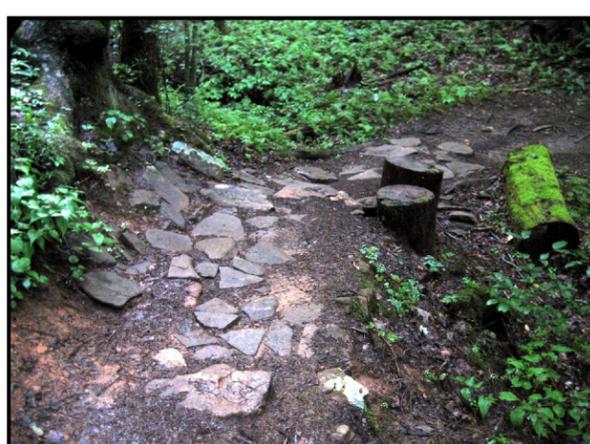
Area of Concern – Site: P23

Map Grid Location: F10 Site visit date/ team): 8/19/15/ JZ Drainage Area (Sq. Mi.): < 0.1
 Name & Location: Tributary at Reasonover Creek Trail

- 1. Culvert (diameter/material/length):** 12"/ CPP
- | | |

| <input checked="" type="checkbox"/> clogged | <input type="checkbox"/> aquatic organism passage/ perched |

| <input type="checkbox"/> human/ animal exclusion | <input checked="" type="checkbox"/> culvert rehabilitation/ replacement |
| <input checked="" type="checkbox"/> maintenance | <input type="checkbox"/> bridge replacement/improvement |

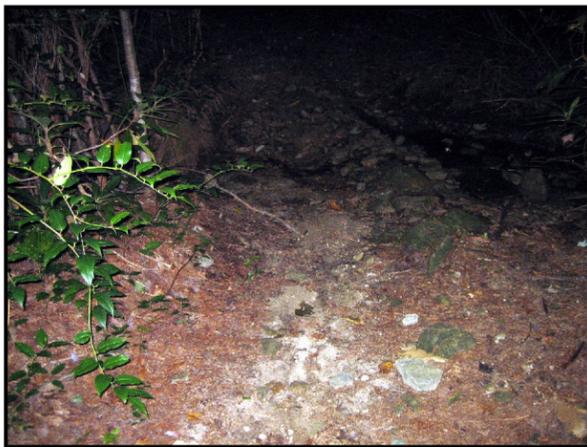
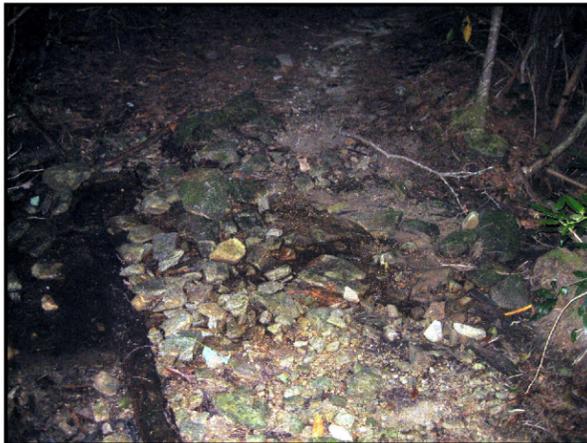
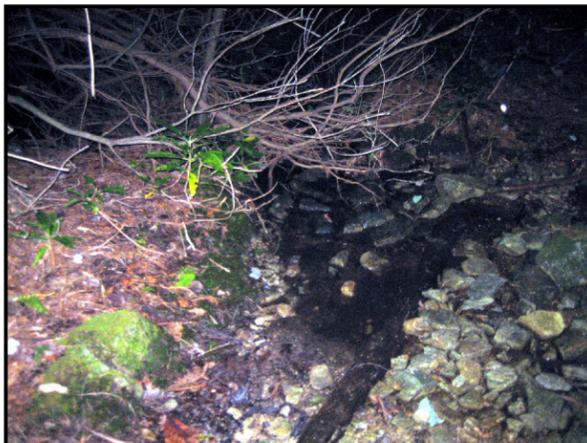
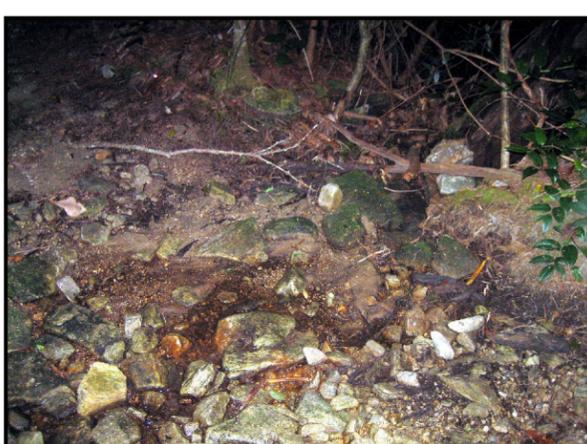
Area of Concern – Site: P25

Map Grid Location: J8 Site visit date/ team): 8/30/15/ JZ Drainage Area (Sq. Mi.): < 0.1
 Name & Location: Tributary to Briery Fork Creek at Joanna Road

<input checked="" type="checkbox"/> stormwater input	<input checked="" type="checkbox"/> sediment input
<input type="checkbox"/> bridge	<input type="checkbox"/> utilities
<input checked="" type="checkbox"/> unstable trail crossing	<input type="checkbox"/> erosion
<input type="checkbox"/> safety hazard	<input checked="" type="checkbox"/> human impact (hiking/biking)
<input type="checkbox"/> missing vegetation	<input type="checkbox"/> equine/dog impacts

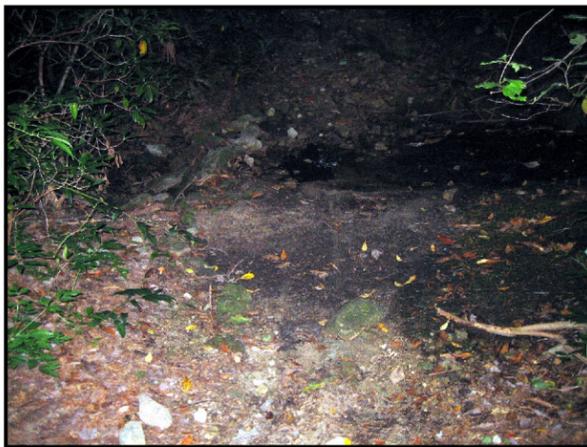
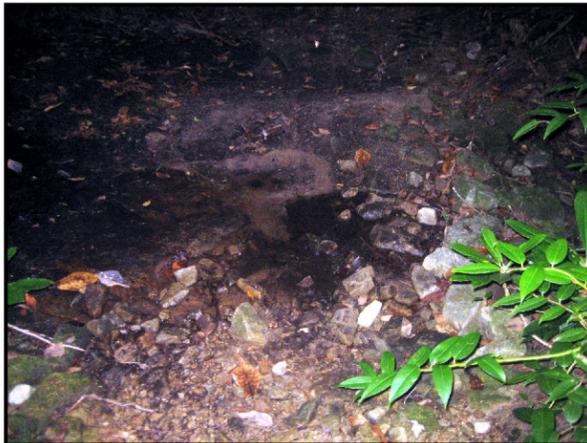
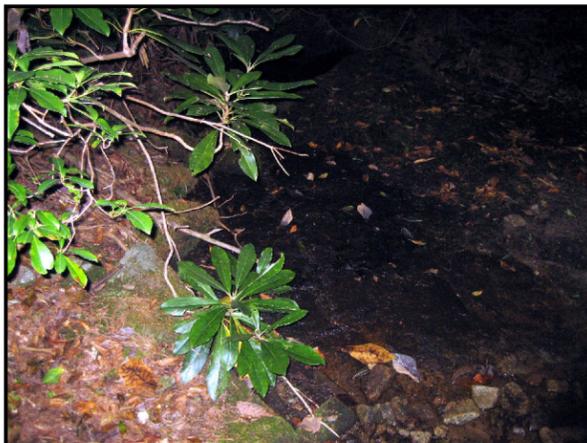
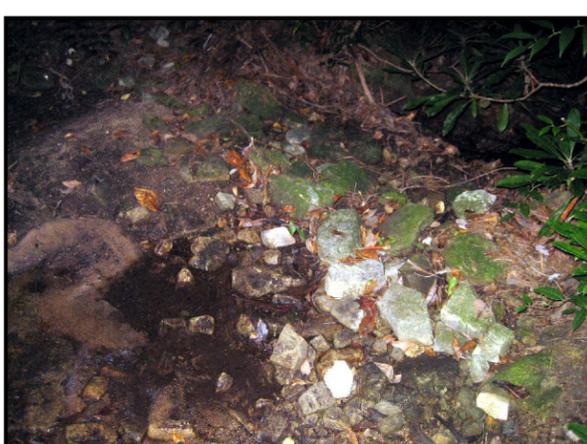
Area of Concern – Site: P26

Map Grid Location: J8 Site visit date/ team): 8/30/15/ JZ Drainage Area (Sq. Mi.): < 0.1
 Name & Location: Tributary to Briery Fork Creek at Joanna Road

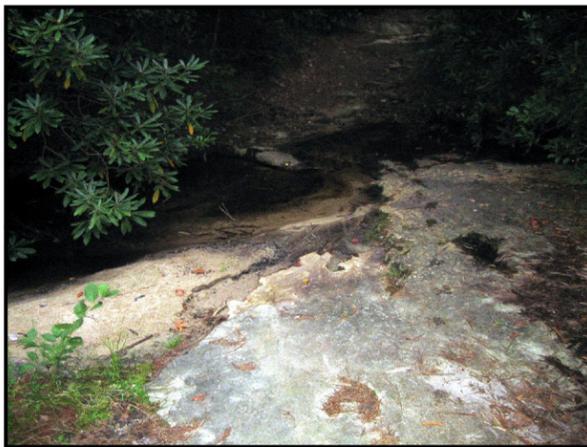
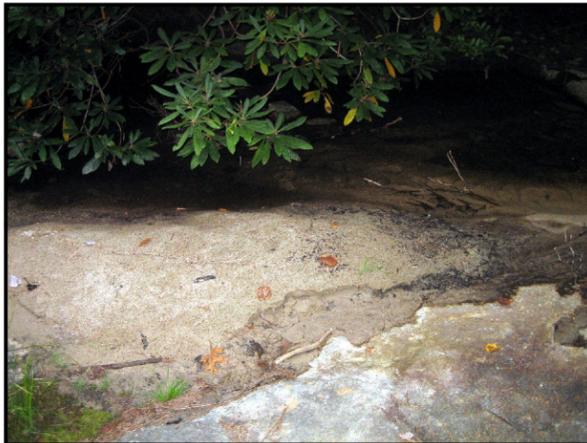
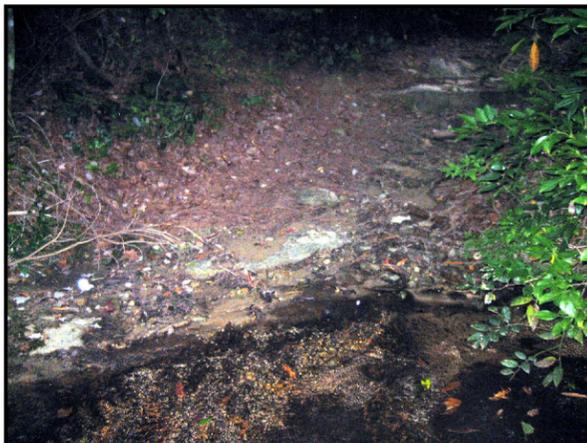
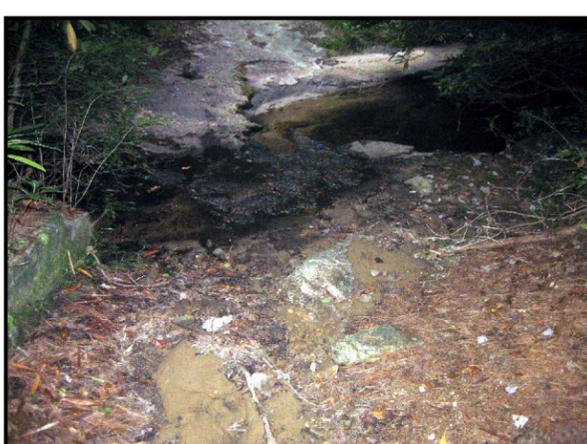
Area of Concern – Site: P27

Map Grid Location: I7 Site visit date/ team): 8/30/15/ JZ Drainage Area (Sq. Mi.): 0.42
 Name & Location: Tributary at Grassy Meadow Trail

1. **Culvert (diameter/material/length):** _____
 clogged aquatic organism passage/ perched
 crushed erosion (upstream/ downstream)
 lack of natural bed piping
 safety hazard overtopping
2. **Trail/ Road Impact (trail/ road name):** Grassy Meadow Trail
 stormwater input sediment input
 bridge utilities
 unstable trail crossing erosion
 safety hazard human impact (hiking/biking)
 missing vegetation equine/ dog impacts
3. **Upland/ Stormwater**
 nonpoint source pollution upland erosion
 pollutant point source unvegetated upland area
4. **Lake/Pond/ Reservoir (reservoir name):** _____
 erosion lack of vegetation
 equine impact human impact (hiking/biking)
 safety hazard water quality (temperature, algae, geese, fecal)
5. **Other Problem Area(s)** (list contributing factors)

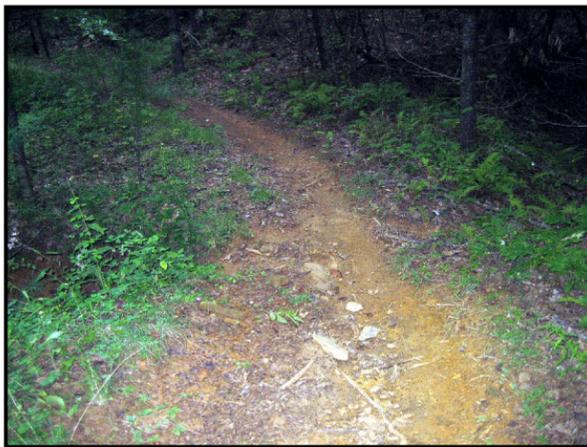
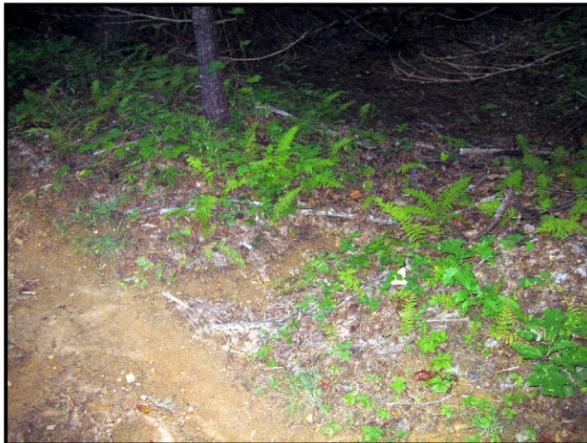
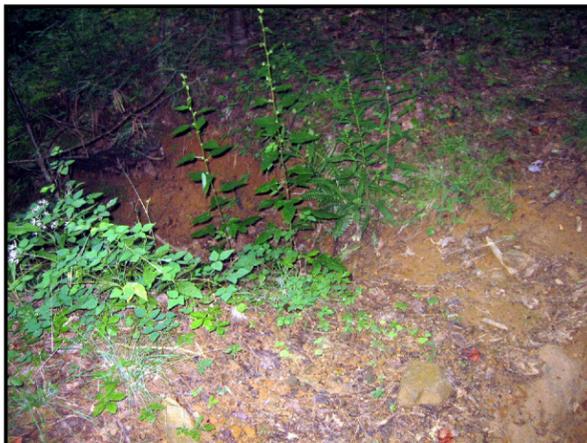
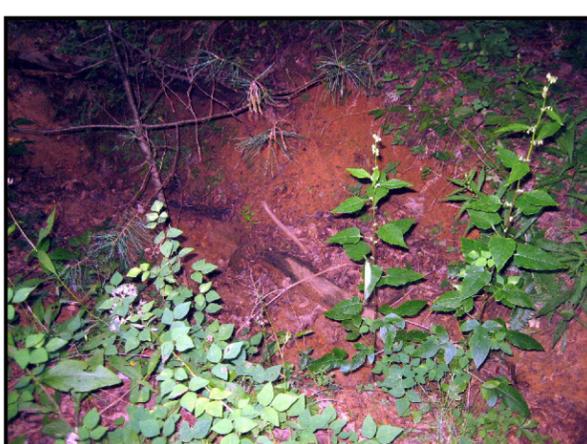
Area of Concern – Site: P29

Comments
 Trail serves as source of sediment. Eroding banks and head cut in channel downstream of trail are sediment source and may threaten trail.

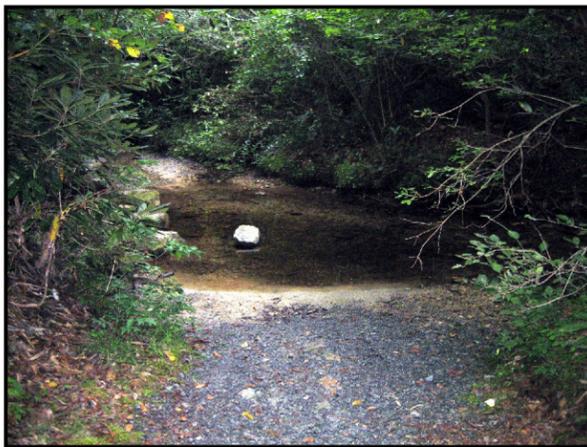
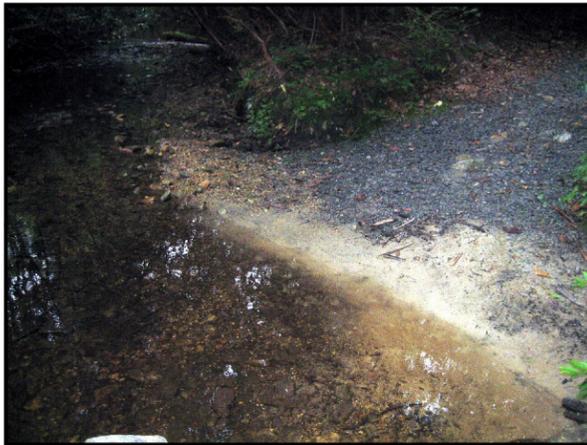
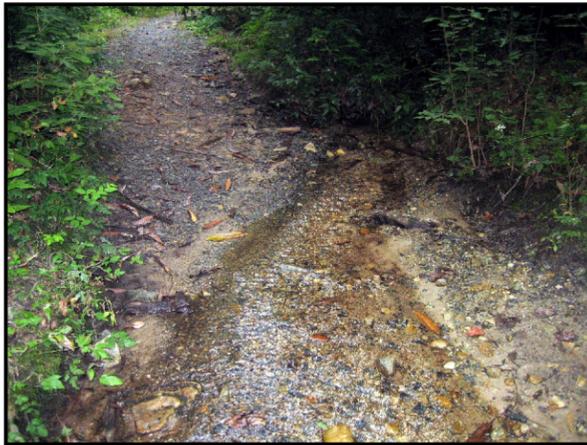
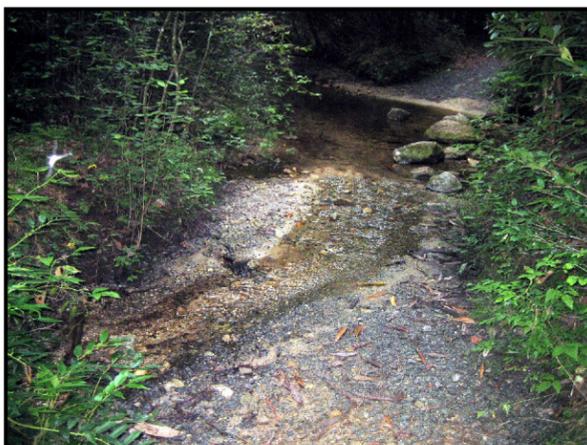
Area of Concern – Site: P30

Comments
 At trail crossing, creek is over widened with fine sediment input. A small tributary coincides with the trail.

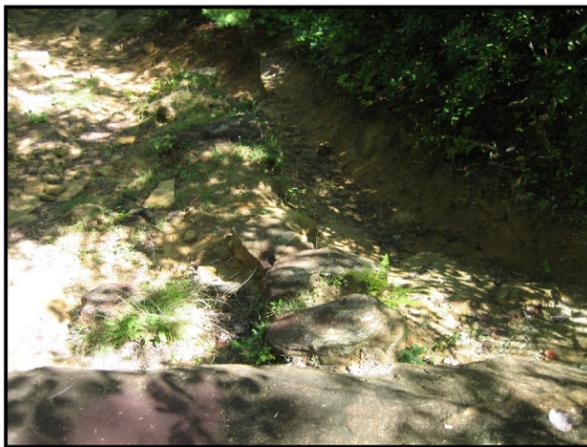
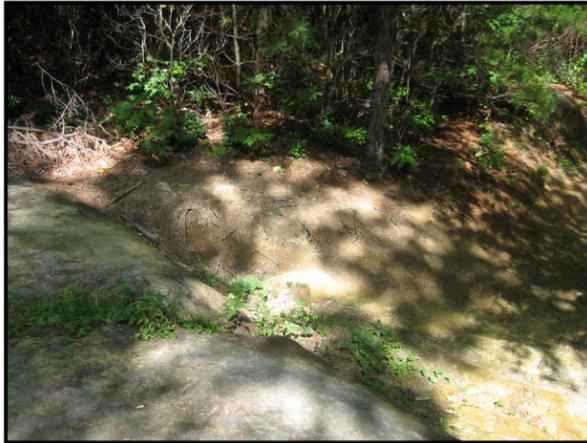
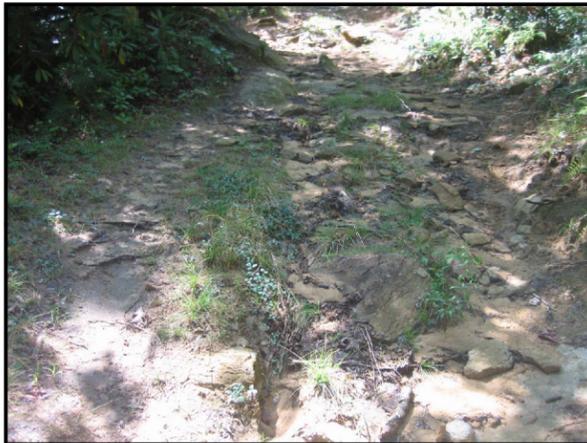
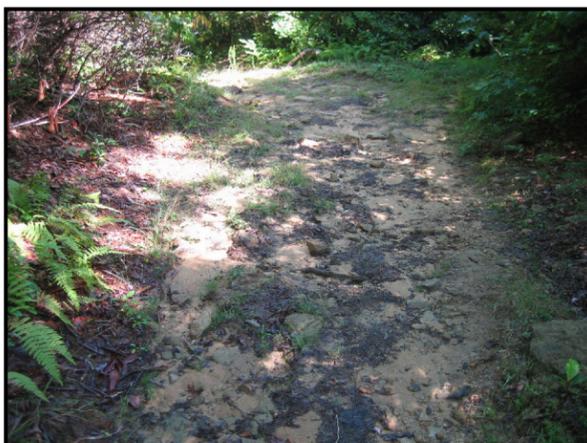
Area of Concern – Site: P32

Upland sediment source on eroding, over widened trail. Trail serves as stormwater drainage to receiving water.

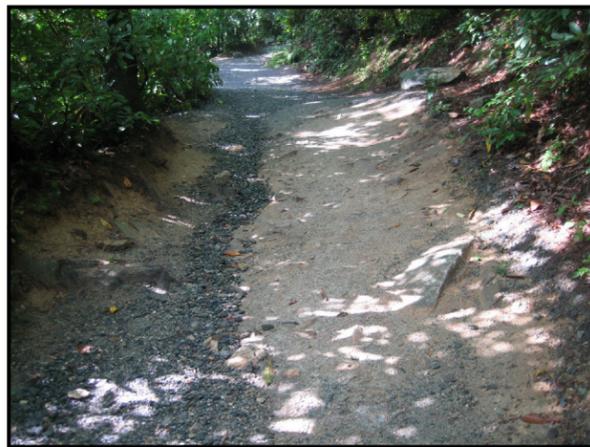
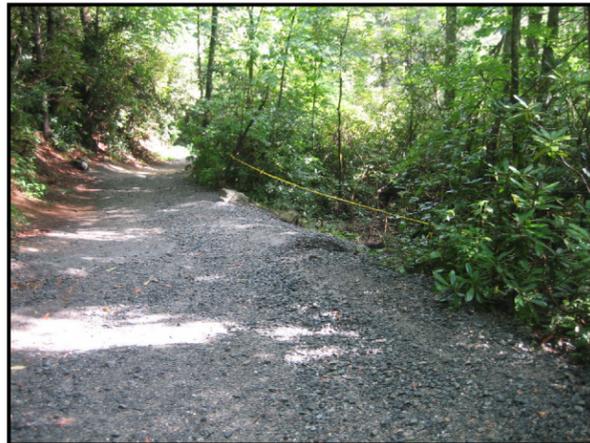
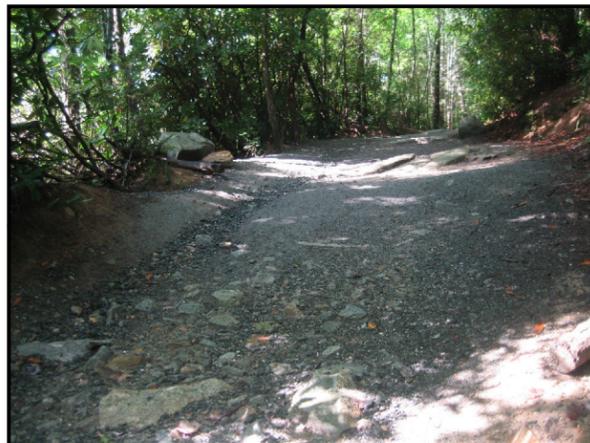
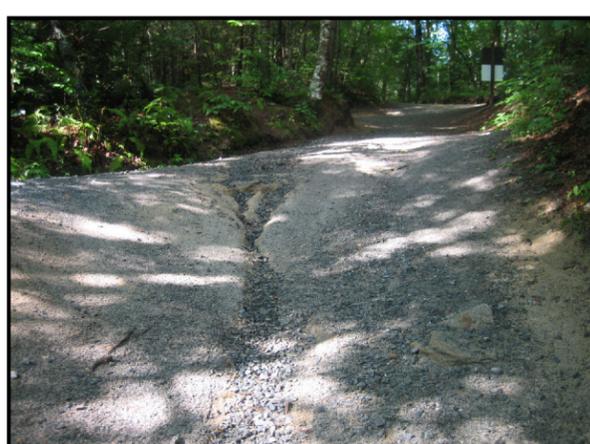
Area of Concern – Site: P34

Comments
 Trail is wide, steep and eroding along several hundred feet. Heavily used trail could be rerouted or stabilized in place with BMPs.
