Water Resources Restoration Master Plan

DuPont State Recreational Forest
North Carolina

Prepared for:
North Carolina Forest Service

November 9, 2015

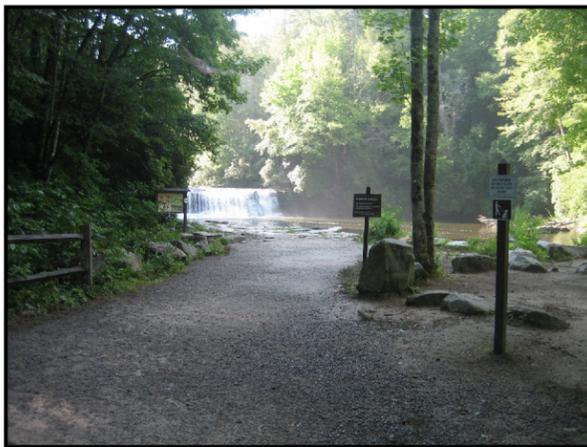
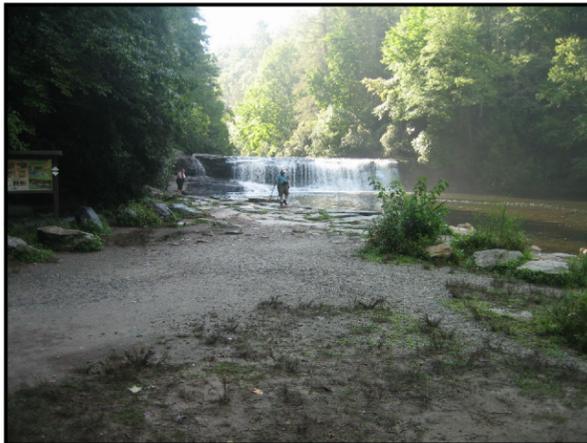
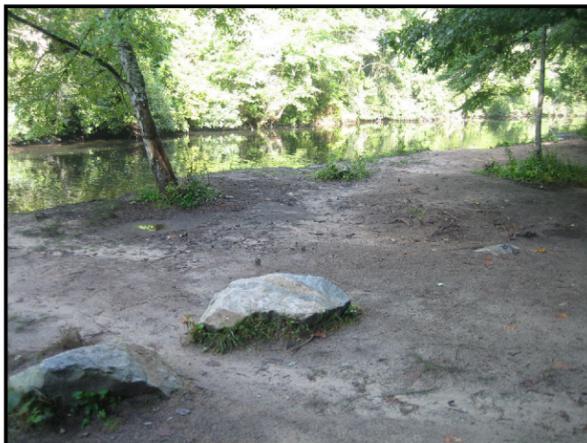
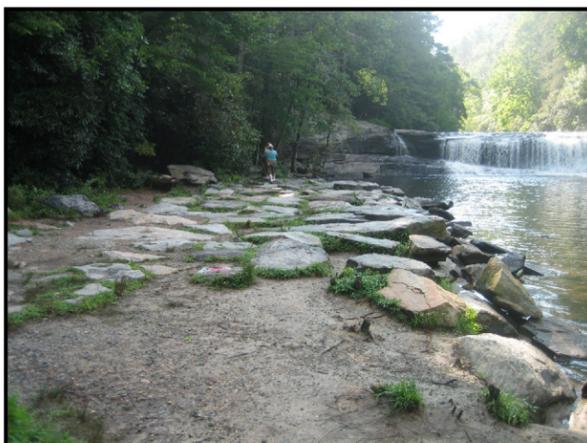
Area of Concern – Site: P35

Barc areas along viewing area below Hooker Falls.

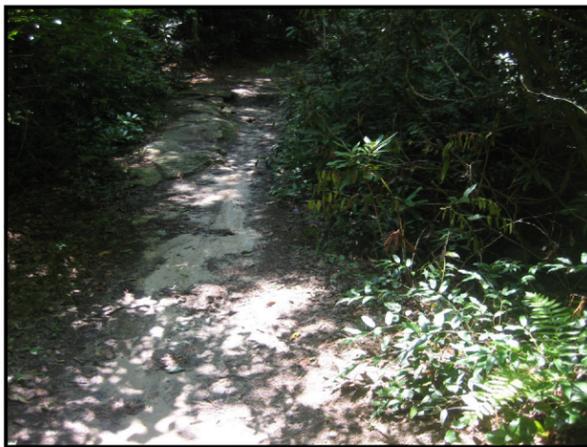
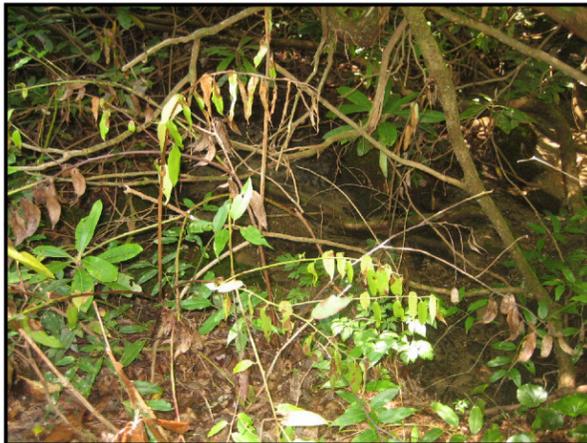
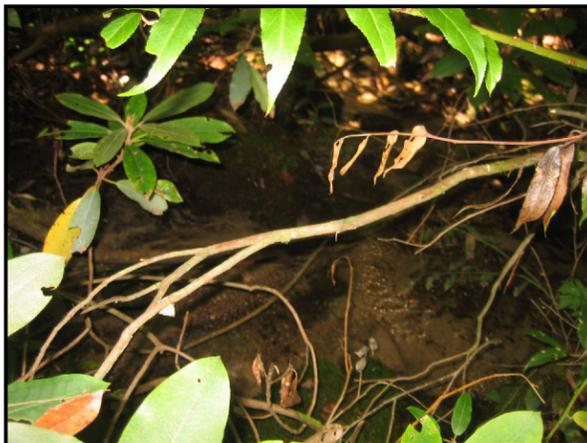
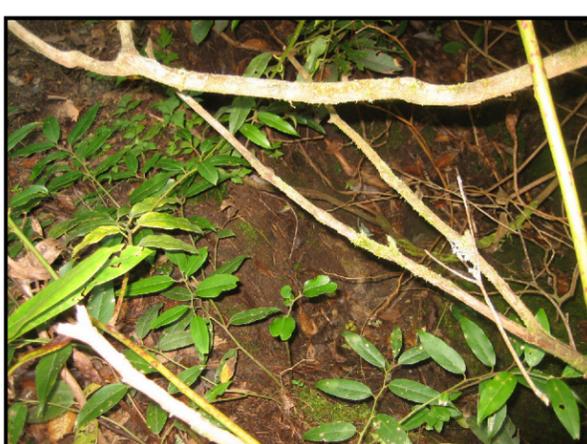
Intersection of multiple trails result in sediment source to small drainage. Channel drops off steeply downstream of trail, and future head-cut may threaten trail.

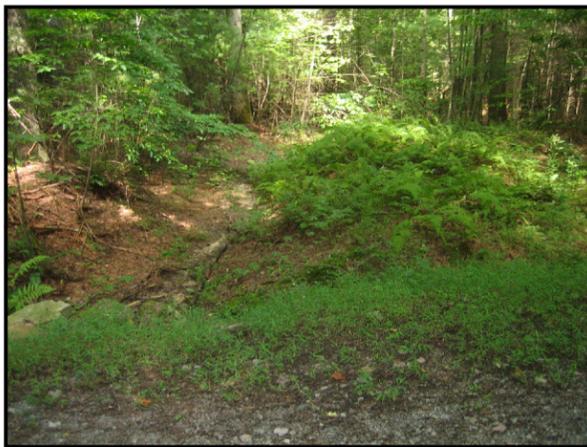
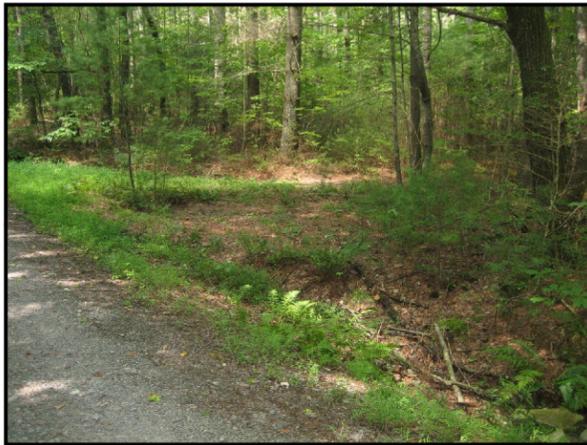
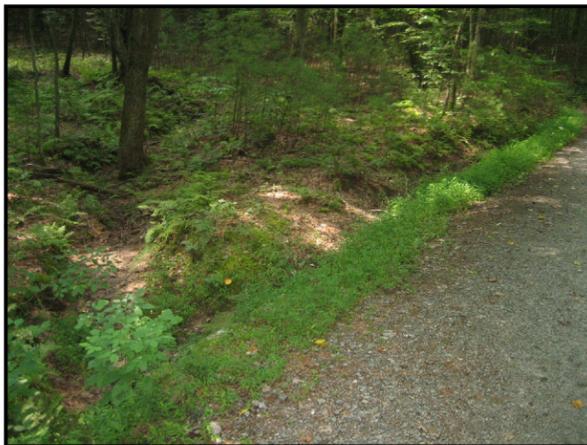
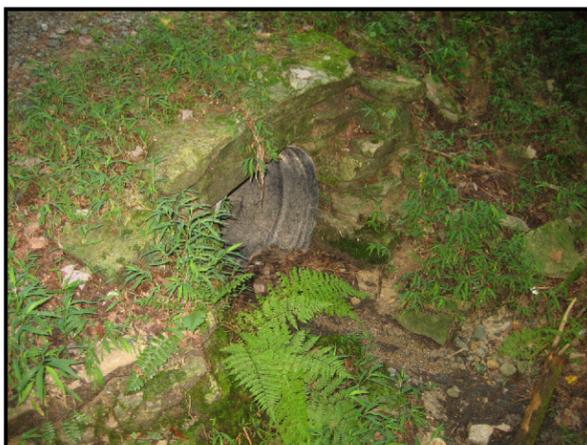
Area of Concern – Site: P37

Comments
 Hardened trail crossing, though trail still serves as sediment source. Minor bank erosion in channel just downstream of crossing.

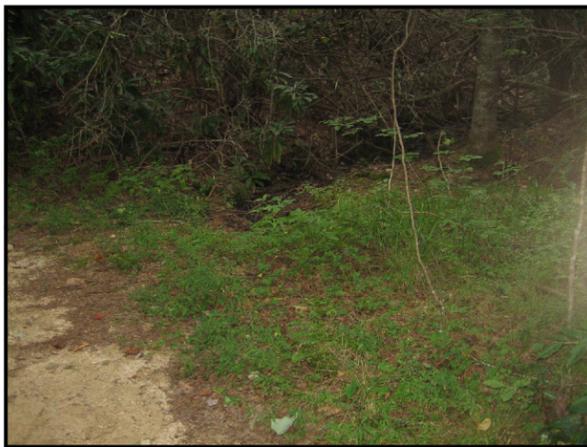
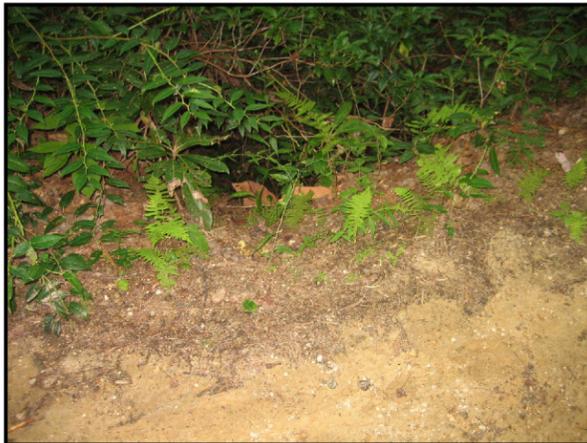
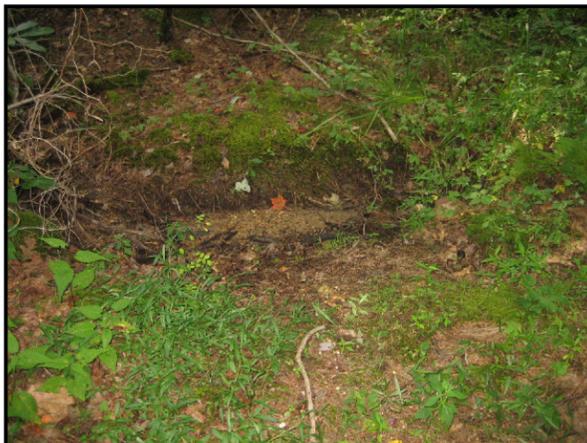
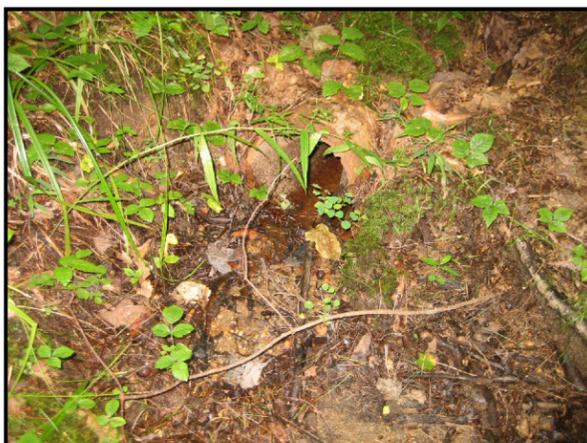
Area of Concern – Site: P39

Trampled banks and sediment input to stream at signed horse watering area. Despite "Dead End Trail" sign, watering area also appears to be used as stream crossing.

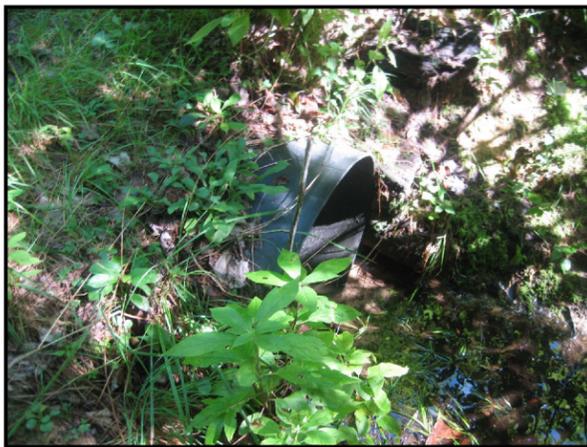
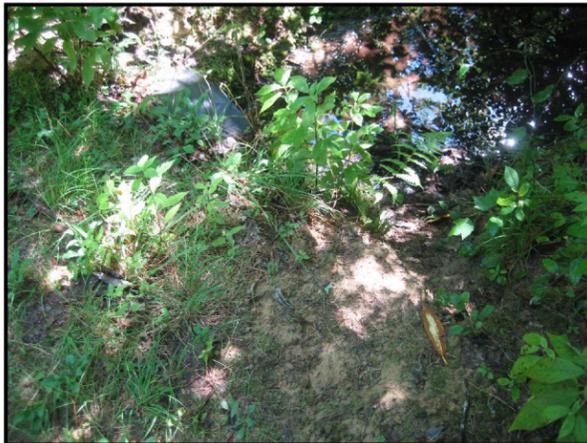
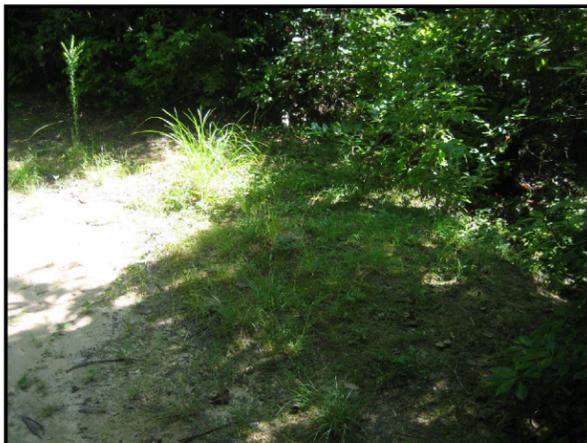
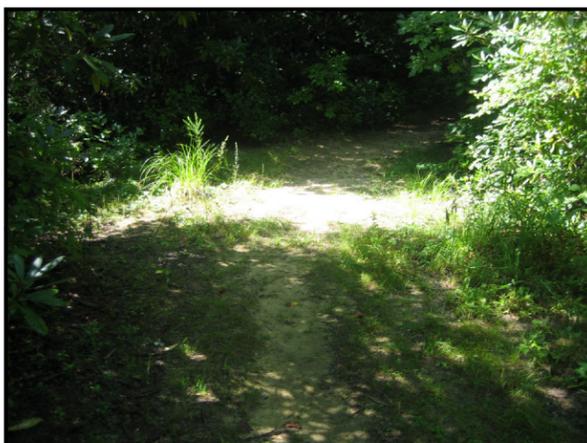
Area of Concern – Site: P47

No problems with culvert. However, trail in vicinity is over widened and lacking vegetation.

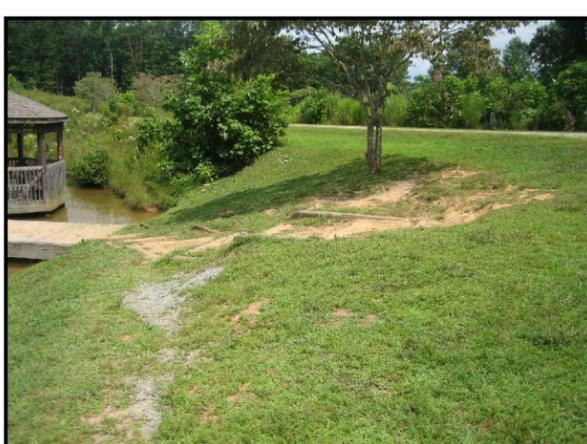
Area of Concern – Site: P48

Comments
 Shoreline of lake unvegetated and partially eroding at human access area; vegetation could be improved between lake and Fawn Lake Road.

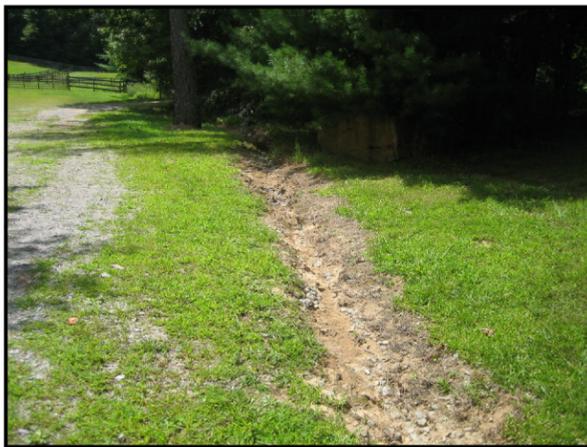
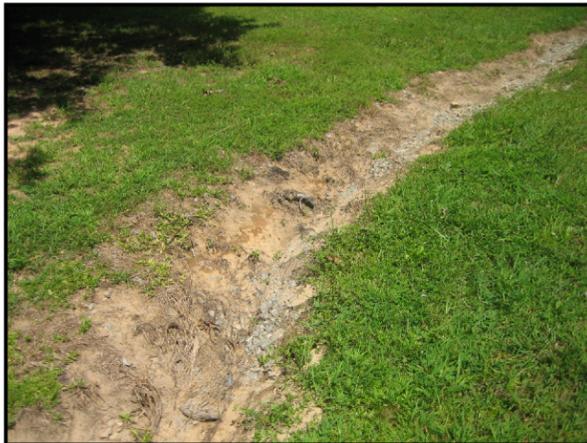
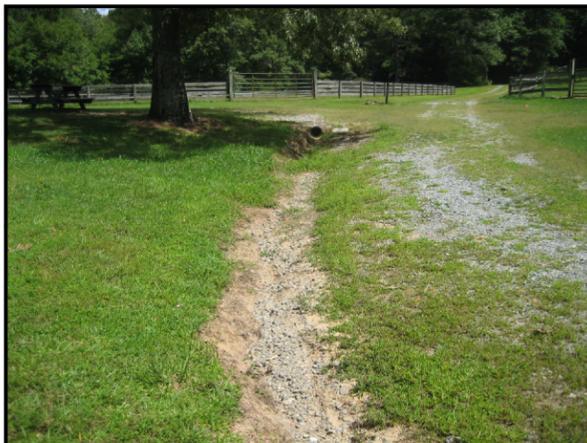
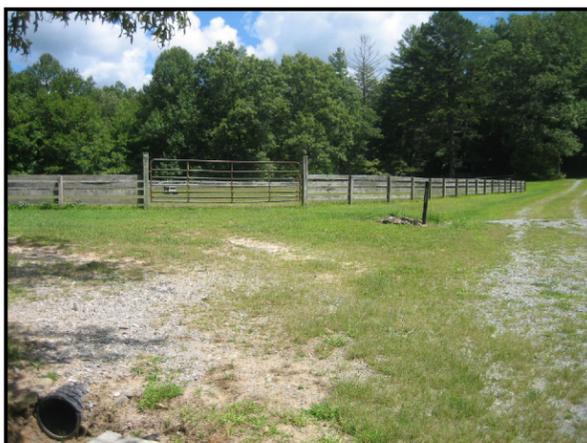
Area of Concern – Site: P51

1. **Culvert (diameter/material/length):** 12"/ CPP
 - clogged
 - aquatic organism passage/ perched
 - crushed
 - erosion (upstream/ downstream)
 - lack of natural bed
 - piping
 - safety hazard
 - overtopping
2. **Trail/ Road Impact (trail/ road name):** _____
 - stormwater input
 - sediment input
 - bridge
 - utilities
 - unstable trail crossing
 - erosion
 - safety hazard
 - human impact (hiking/biking)
 - missing vegetation
 - equine/ dog impacts
3. **Upland/ Stormwater**
 - nonpoint source pollution
 - upland erosion
 - pollutant point source
 - unvegetated upland area
4. **Lake/Pond/ Reservoir (reservoir name):** _____
 - erosion
 - lack of vegetation
 - equine impact
 - human impact (hiking/biking)
 - safety hazard
 - water quality (temperature, algae, geese, fecal)
5. **Other Problem Area(s)** (list contributing factors)
 Unstable stormwater ditch.
