Area of Concern – Site: P32

Map Grid Location: G7 Site visit date/ team): 8/31/15/ JZ Drainage Area (Sq. Mi.): -
Name & Location: Oak Tree Trail

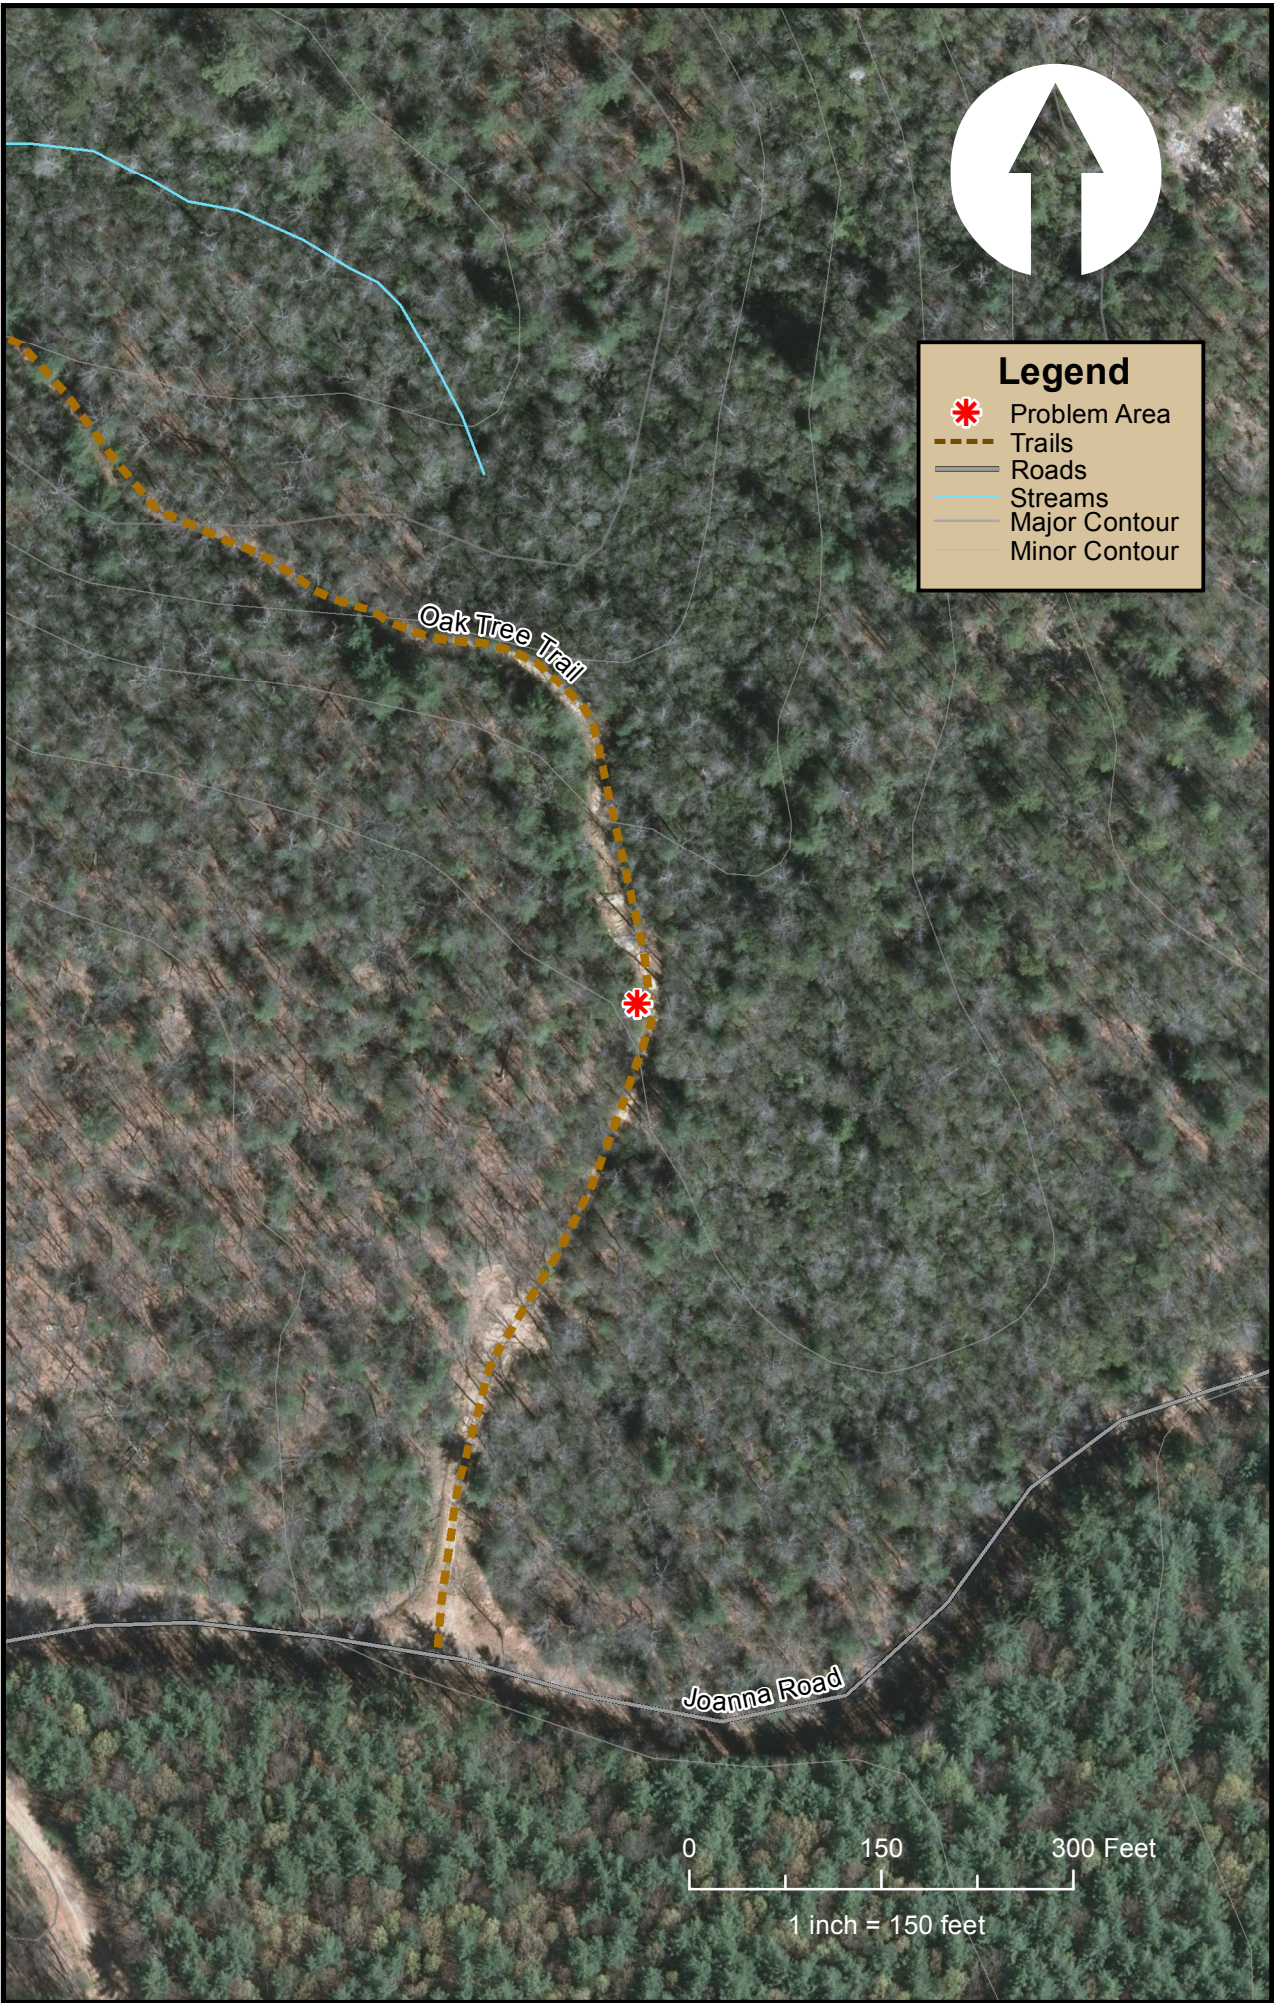
☒ sediment input

☒ erosion

☒ human impact (hiking/biking)

☒ missing vegetation

☒ nonpoint source pollution

☒ upland erosion
