Area of Concern – Site: P37

Map Grid Location: H6 Site visit date/ team): 8/26/15/ JZ Drainage Area (Sq. Mi.): < 0.1
Name & Location: Tributary at Sandy Trail

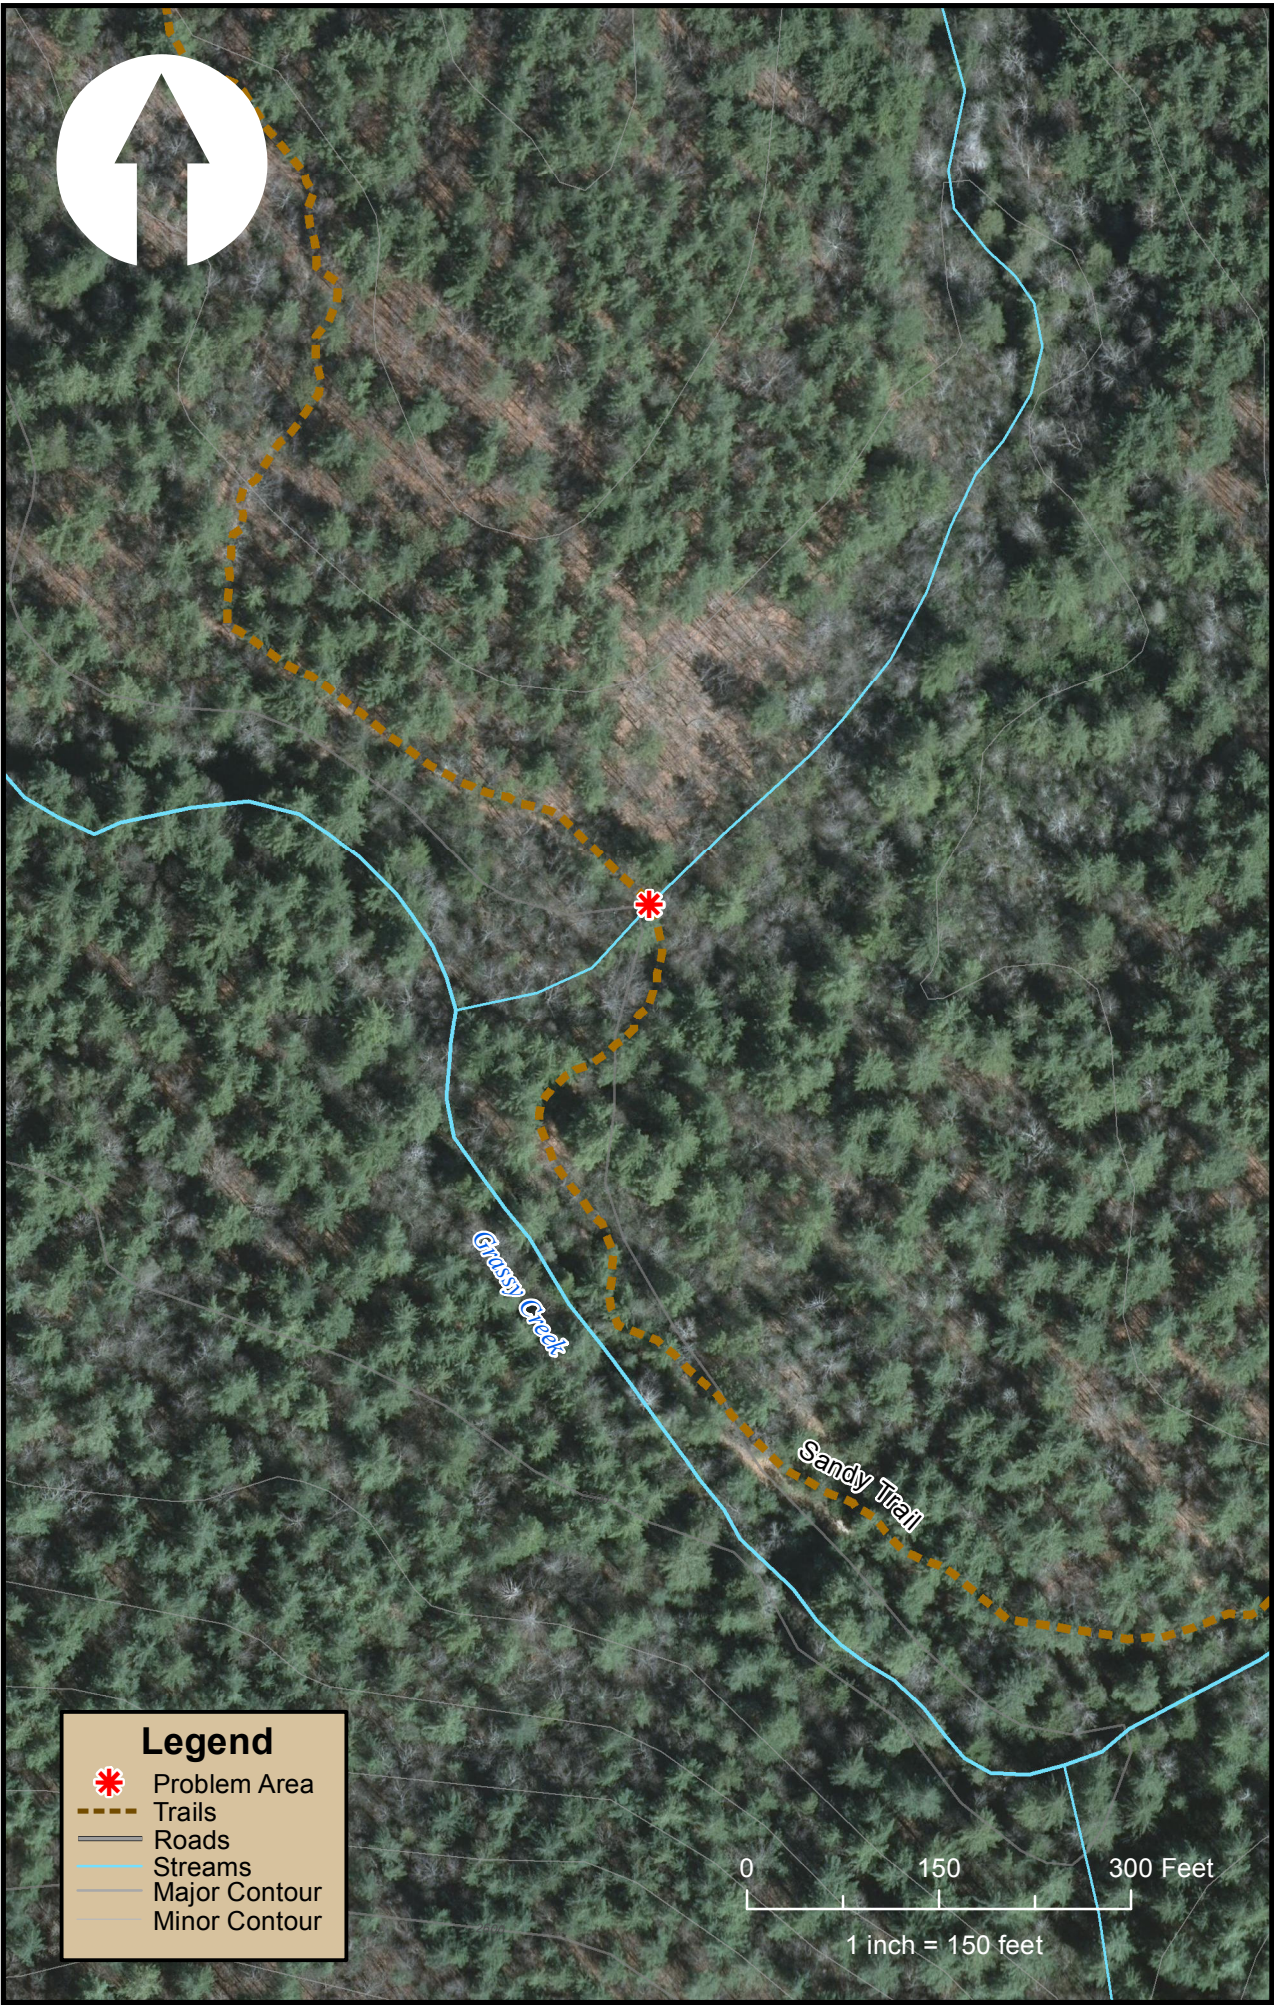
Comments
Hardened trail crossing, though trail still serves as sediment source. Minor bank erosion in channel just downstream of crossing.

- Potential Solutions**
☒relocate trail/close trail/road ☒trail/road crossing improvement
☒vegetation/ shoreline planting ☐mechanical grading
☐stormwater treatment ☐animal watering
☐human/ animal exclusion ☐culvert rehabilitation/ replacement
☐signs ☐culvert daylighting
☐maintenance ☐bridge replacement/improvement
