Area of Concern – Site: P39

Map Grid Location: H4 Site visit date/ team): 8/26/15/ JZ Drainage Area (Sq. Mi.): < 0.1
 Name & Location: Horse watering along Tarklin Branch Road

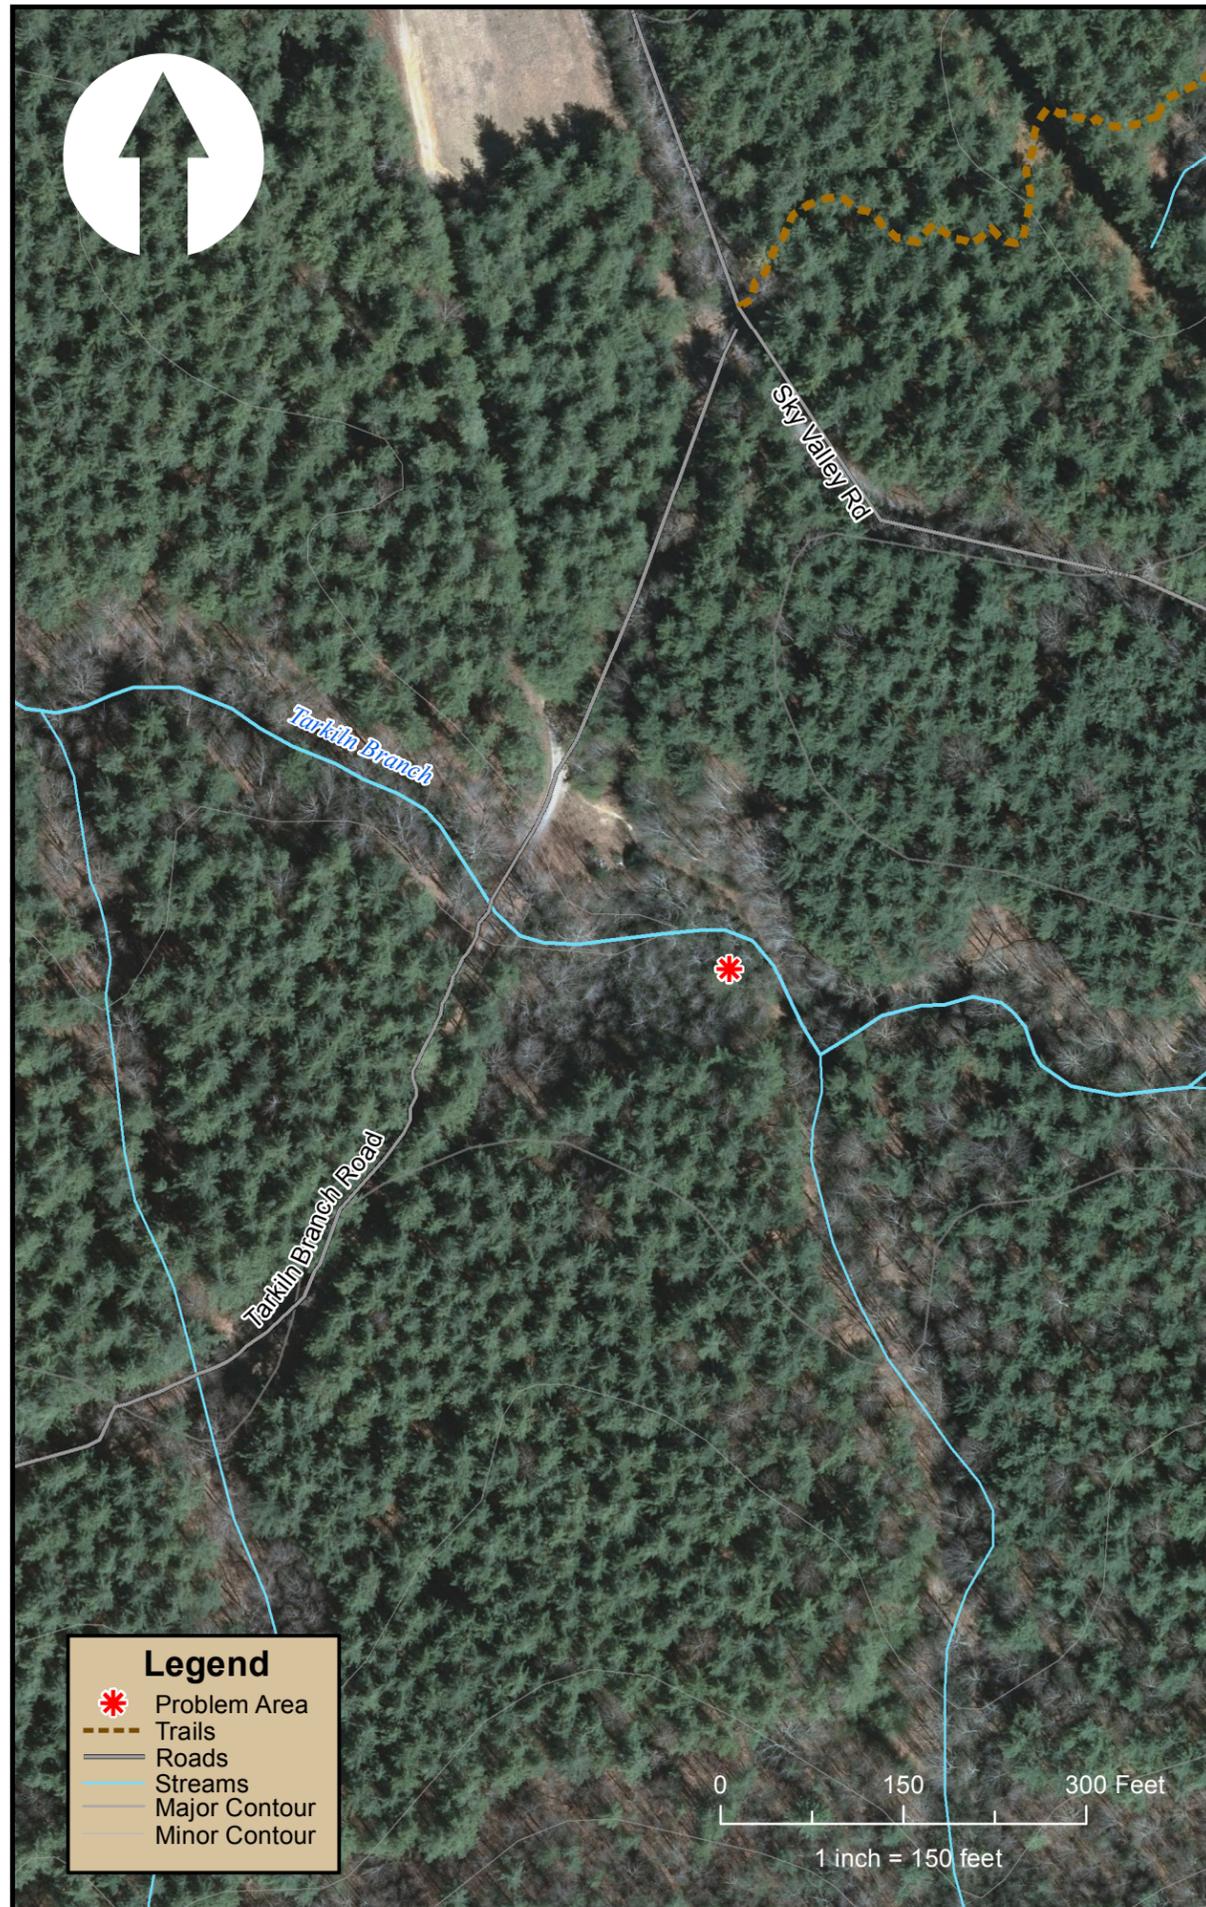
Trampled banks and sediment input to stream at signed horse watering area. Despite "Dead End Trail" sign, watering area also appears to be used as stream crossing.

| <input checked="" type="checkbox"/> relocate trail/close trail/road | <input type="checkbox"/> trail/road crossing improvement |
| <input checked="" type="checkbox"/> vegetation/ shoreline planting | <input type="checkbox"/> mechanical grading |
| <input type="checkbox"/> stormwater treatment | <input checked="" type="checkbox"/> animal watering |
| <input checked="" type="checkbox"/> human/ animal exclusion | <input type="checkbox"/> culvert rehabilitation/ replacement |
| <input checked="" type="checkbox"/> signs | <input type="checkbox"/> culvert daylighting |
