Area of Concern – Site: P40

Map Grid Location: H3 Site visit date/ team): 8/26/15/ JZ Drainage Area (Sq. Mi.): < 0.1  
Name & Location: Shoal Creek Tributary at Shoal Creek Trail

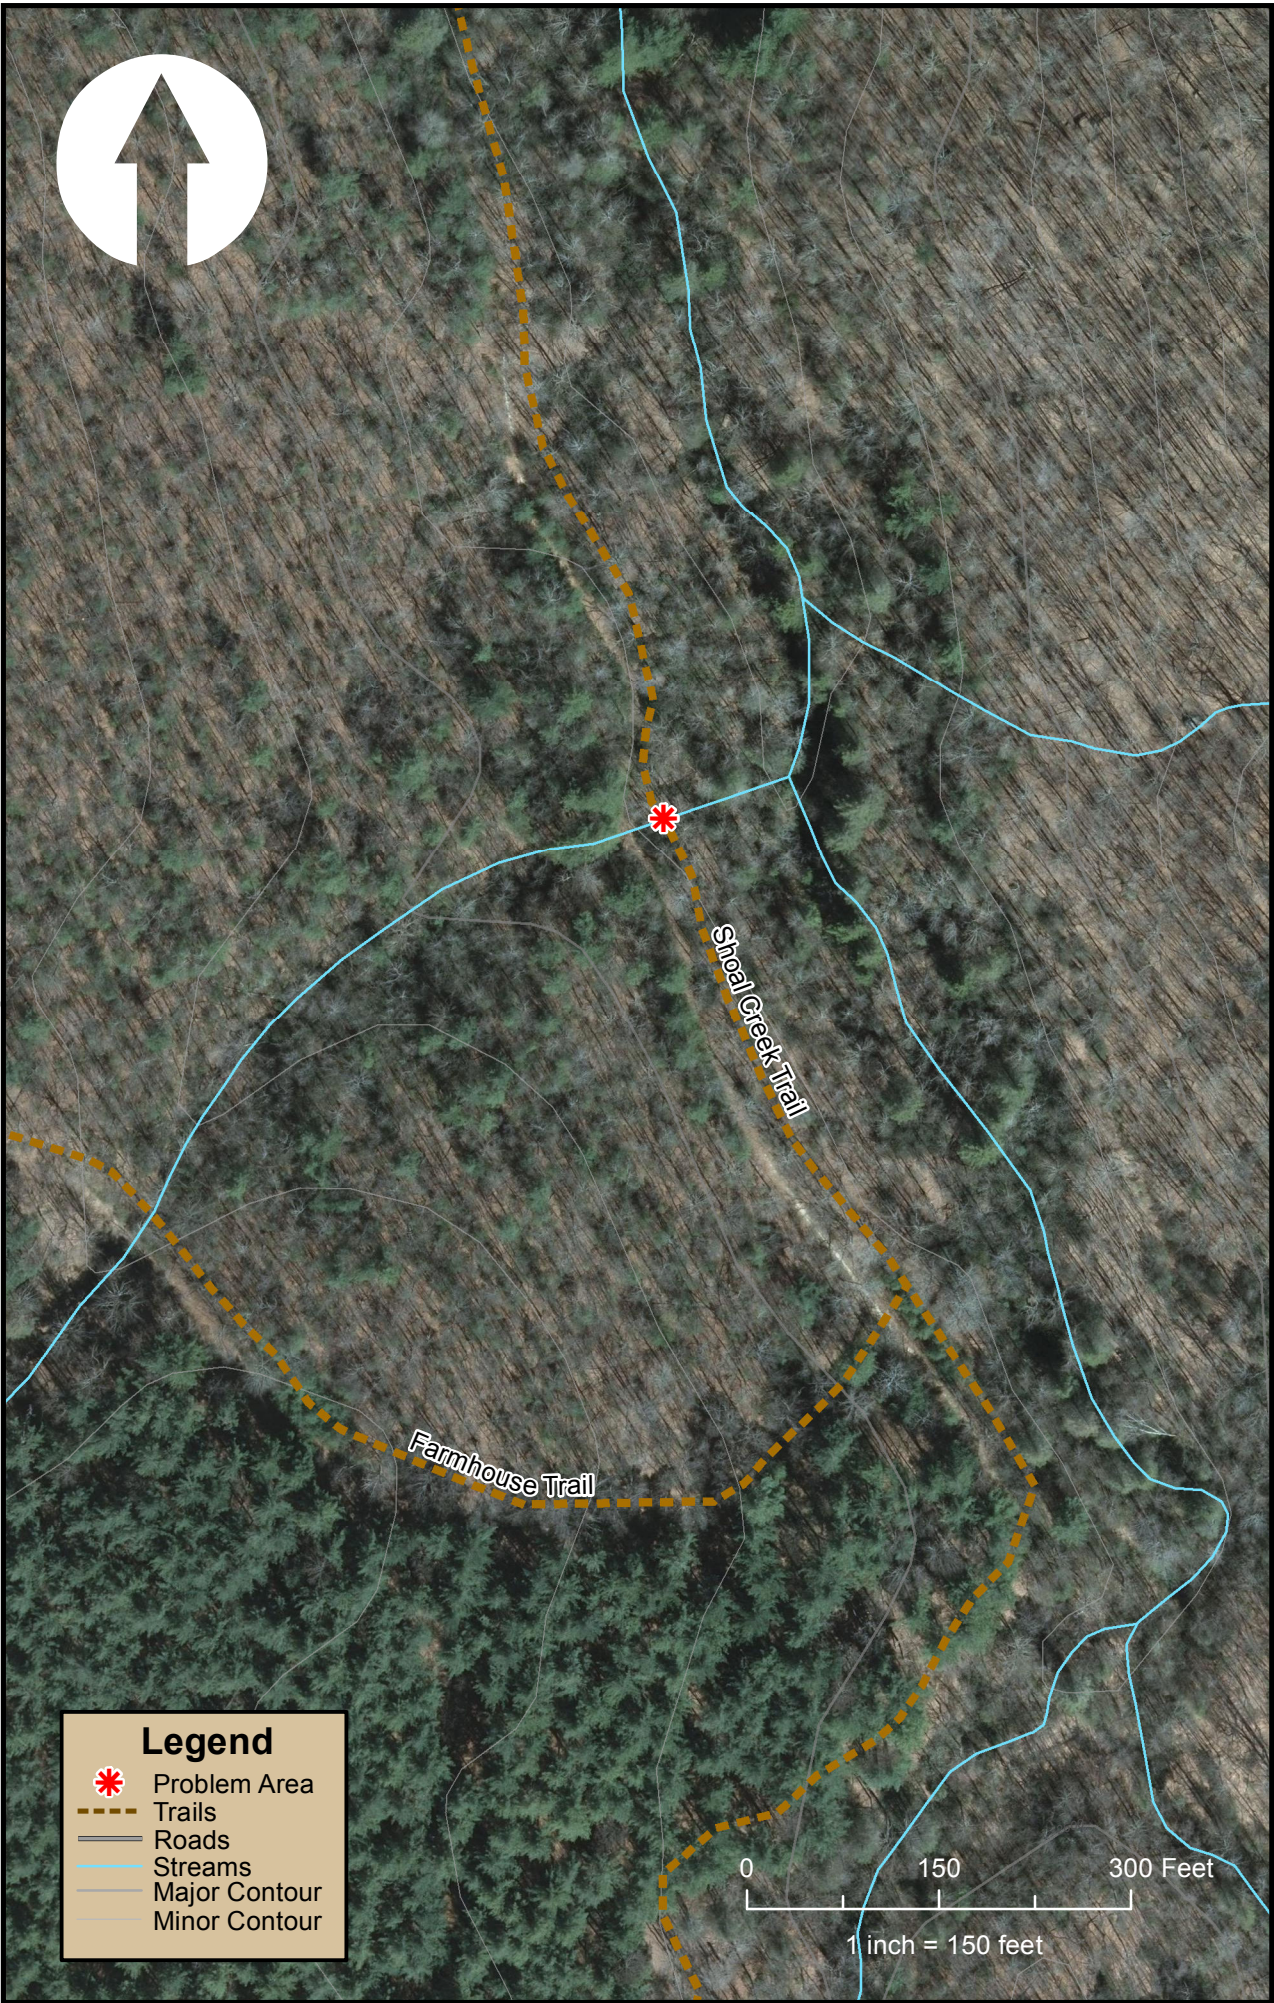
1. Culvert (diameter/material/length): 10”/ iron

☒erosion (upstream/ downstream)

☒missing vegetation

Comments  
Culvert appears to be in good condition. Bare areas in vicinity could benefit from vegetation.
