Area of Concern – Site: P50

Map Grid Location: E8 Site visit date/ team): 8/30/15/ JZ Drainage Area (Sq. Mi.): < 0.1
 Name & Location: Tributary at Cedar Rock Trail

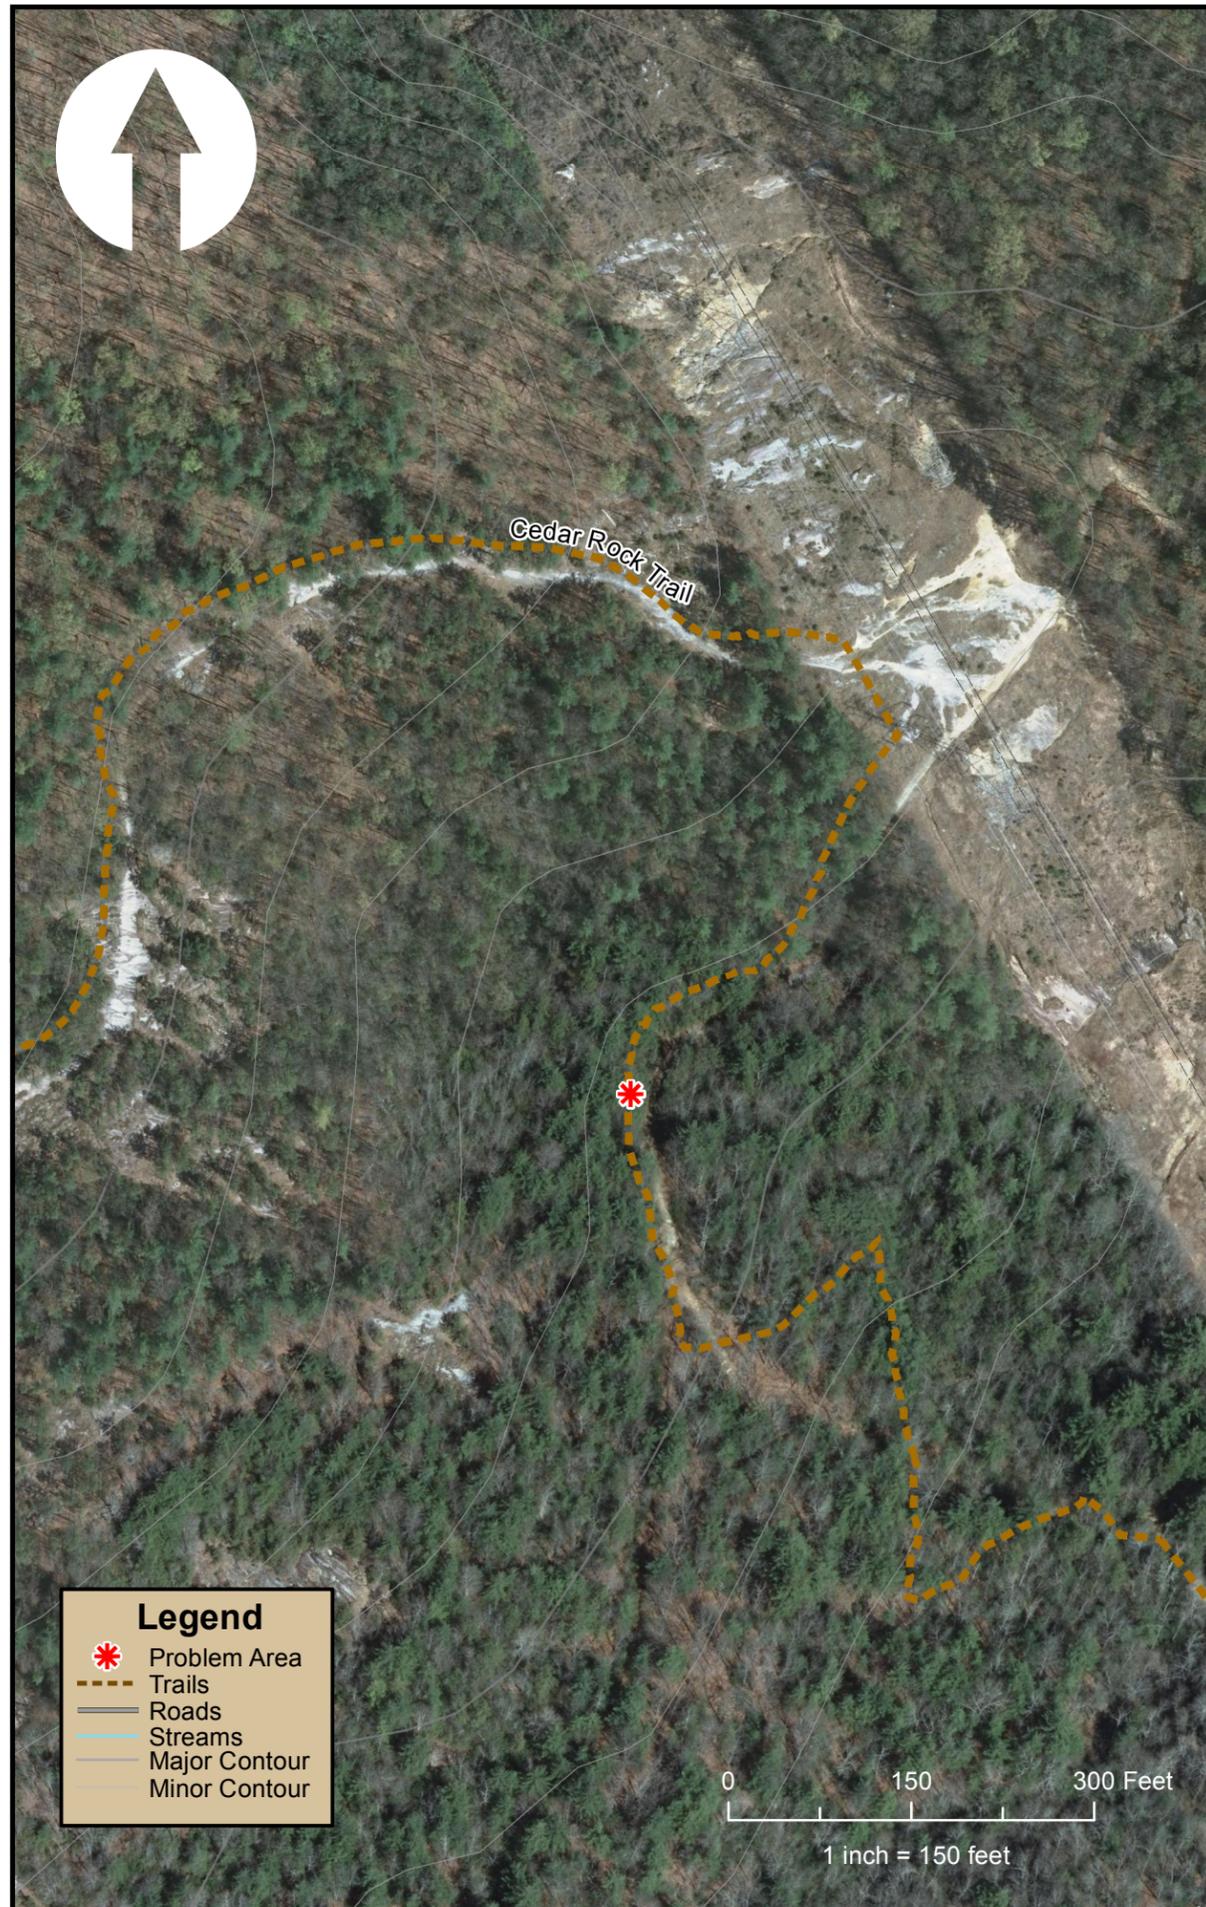
1. **Culvert (diameter/material/length):** _____
 clogged aquatic organism passage/ perched
 crushed erosion (upstream/ downstream)
 lack of natural bed piping
 safety hazard overtopping
2. **Trail/ Road Impact (trail/ road name):** Cedar Rock Trail
 stormwater input sediment input
 bridge utilities
 unstable trail crossing erosion
 safety hazard human impact (hiking/biking)
 missing vegetation equine/dog impacts
3. **Upland/ Stormwater**
 nonpoint source pollution upland erosion
 pollutant point source unvegetated upland area
4. **Lake/Pond/ Reservoir (reservoir name):** _____
 erosion lack of vegetation
 equine impact human impact (hiking/biking)
 safety hazard water quality (temperature, algae, geese, fecal)
5. **Other Problem Area(s)**(list contributing factors)

Trail crossing serves as source of fine sediment. Head-cut downstream of trail may threaten trail and/ or be safety hazard in the future. Potentially install bridge. Culvert and stabilize head-cut.

| <input checked="" type="checkbox"/> relocate trail/close trail/road | <input checked="" type="checkbox"/> trail/road crossing improvement |
