Stream Condition – Site: S01

Map Grid Location: D10 Site visit date/ team): 4/13/15 / BK, JZ Drainage Area (Sq. Mi.): 0.89  
Stream name & Location: Stream along Corn Mill Shoals Trail  
Streambed Substrate: Sand / Gravel Length (ft): +/- 235 Bankfull Width (ft): +/- 6

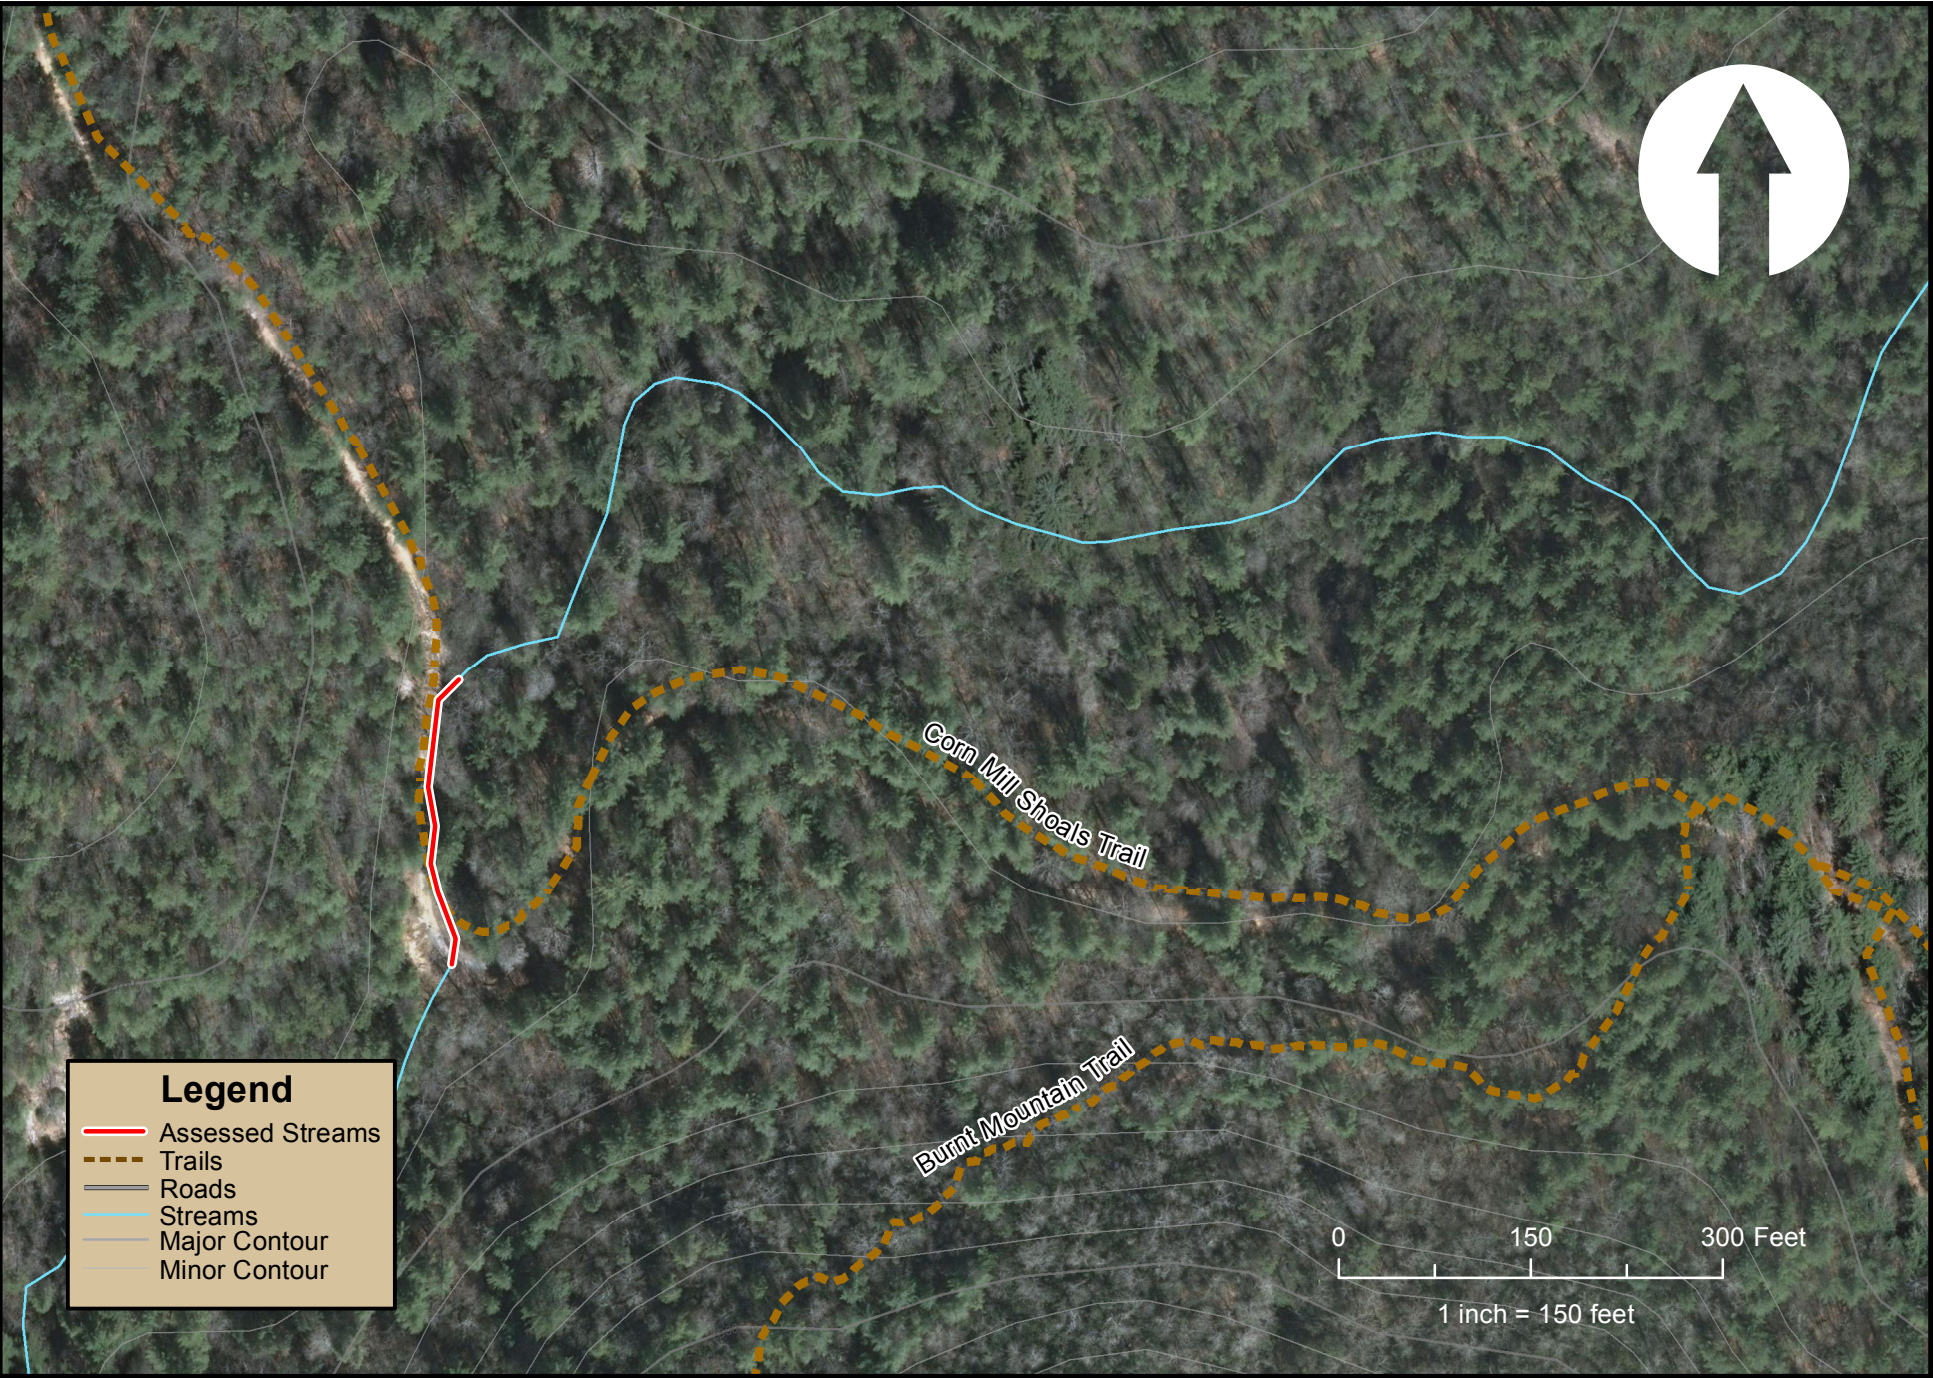
<b>1. Site and Watershed Conditions</b>	<b>2</b>
<input type="checkbox"/> stormwater input	<input checked="" type="checkbox"/> sediment input
<input type="checkbox"/> trampled banks	<input type="checkbox"/> equine/dog impacts
<input checked="" type="checkbox"/> trail crossing	<input checked="" type="checkbox"/> trail in buffer
<input checked="" type="checkbox"/> bridge/culvert/armoring	<input type="checkbox"/> utilities
<b>2. Channel Morphology and Condition</b>	<b>3</b>
<input type="checkbox"/> overwide	<input type="checkbox"/> incised
<input type="checkbox"/> straightened	<input type="checkbox"/> eroding banks
<input type="checkbox"/> head-cutting	<input type="checkbox"/> lack of bedform diversity
<input type="checkbox"/> high bed scour	<input checked="" type="checkbox"/> excessive sediment deposition
<b>3. Floodplain Morphology</b>	<b>3</b>
<input type="checkbox"/> incised channel	<input type="checkbox"/> entrenched channel

<input checked="" type="checkbox"/> floodplain fill/ levees	<input type="checkbox"/> irregular/ obstructed floodplain
<b>4. Vegetation</b>	<b>3</b>
<input checked="" type="checkbox"/> narrow buffer width	<input type="checkbox"/> invasive plants (banks/floodplain)
<input type="checkbox"/> poor overstory/tree cover	<input type="checkbox"/> bare areas/mineral soil (banks/floodplain)
<b>5. Habitat</b>	<b>3</b>
<input type="checkbox"/> lack of woody debris	<input type="checkbox"/> poor water quality (turbid, algae, temperature)
<input checked="" type="checkbox"/> lack of diverse bedform/ flow	<input type="checkbox"/> lack of fine roots, leaf packs, coarse substrate
<b>Score (of 20) and Rating</b> (Poor 0-7; Fair 8-12; Good 13-17; Excellent 18-20)	<b>14</b>

**Comments**  
See also P07; Corn Mill Shoals Trail in buffer, providing sediment/ stormwater source.

<b>Potential Solutions</b>	
<input checked="" type="checkbox"/> relocate/close trail	<input checked="" type="checkbox"/> trail crossing improvement
<input checked="" type="checkbox"/> vegetation planting	<input type="checkbox"/> mechanical grading
<input type="checkbox"/> in-stream structures	<input type="checkbox"/> watershed improvements
<input type="checkbox"/> preservation/ exclusion	<input type="checkbox"/> culvert rehabilitation/ replacement
<input type="checkbox"/> maintenance	<input type="checkbox"/> signs
