Stream Condition – Site: S03

Map Grid Location: E10 Site visit date/ team): 8/31/15 / JZ Drainage Area (Sq. Mi.): < 0.1

Stream name & Location: Tributary along Corn Mill Shoals Trail

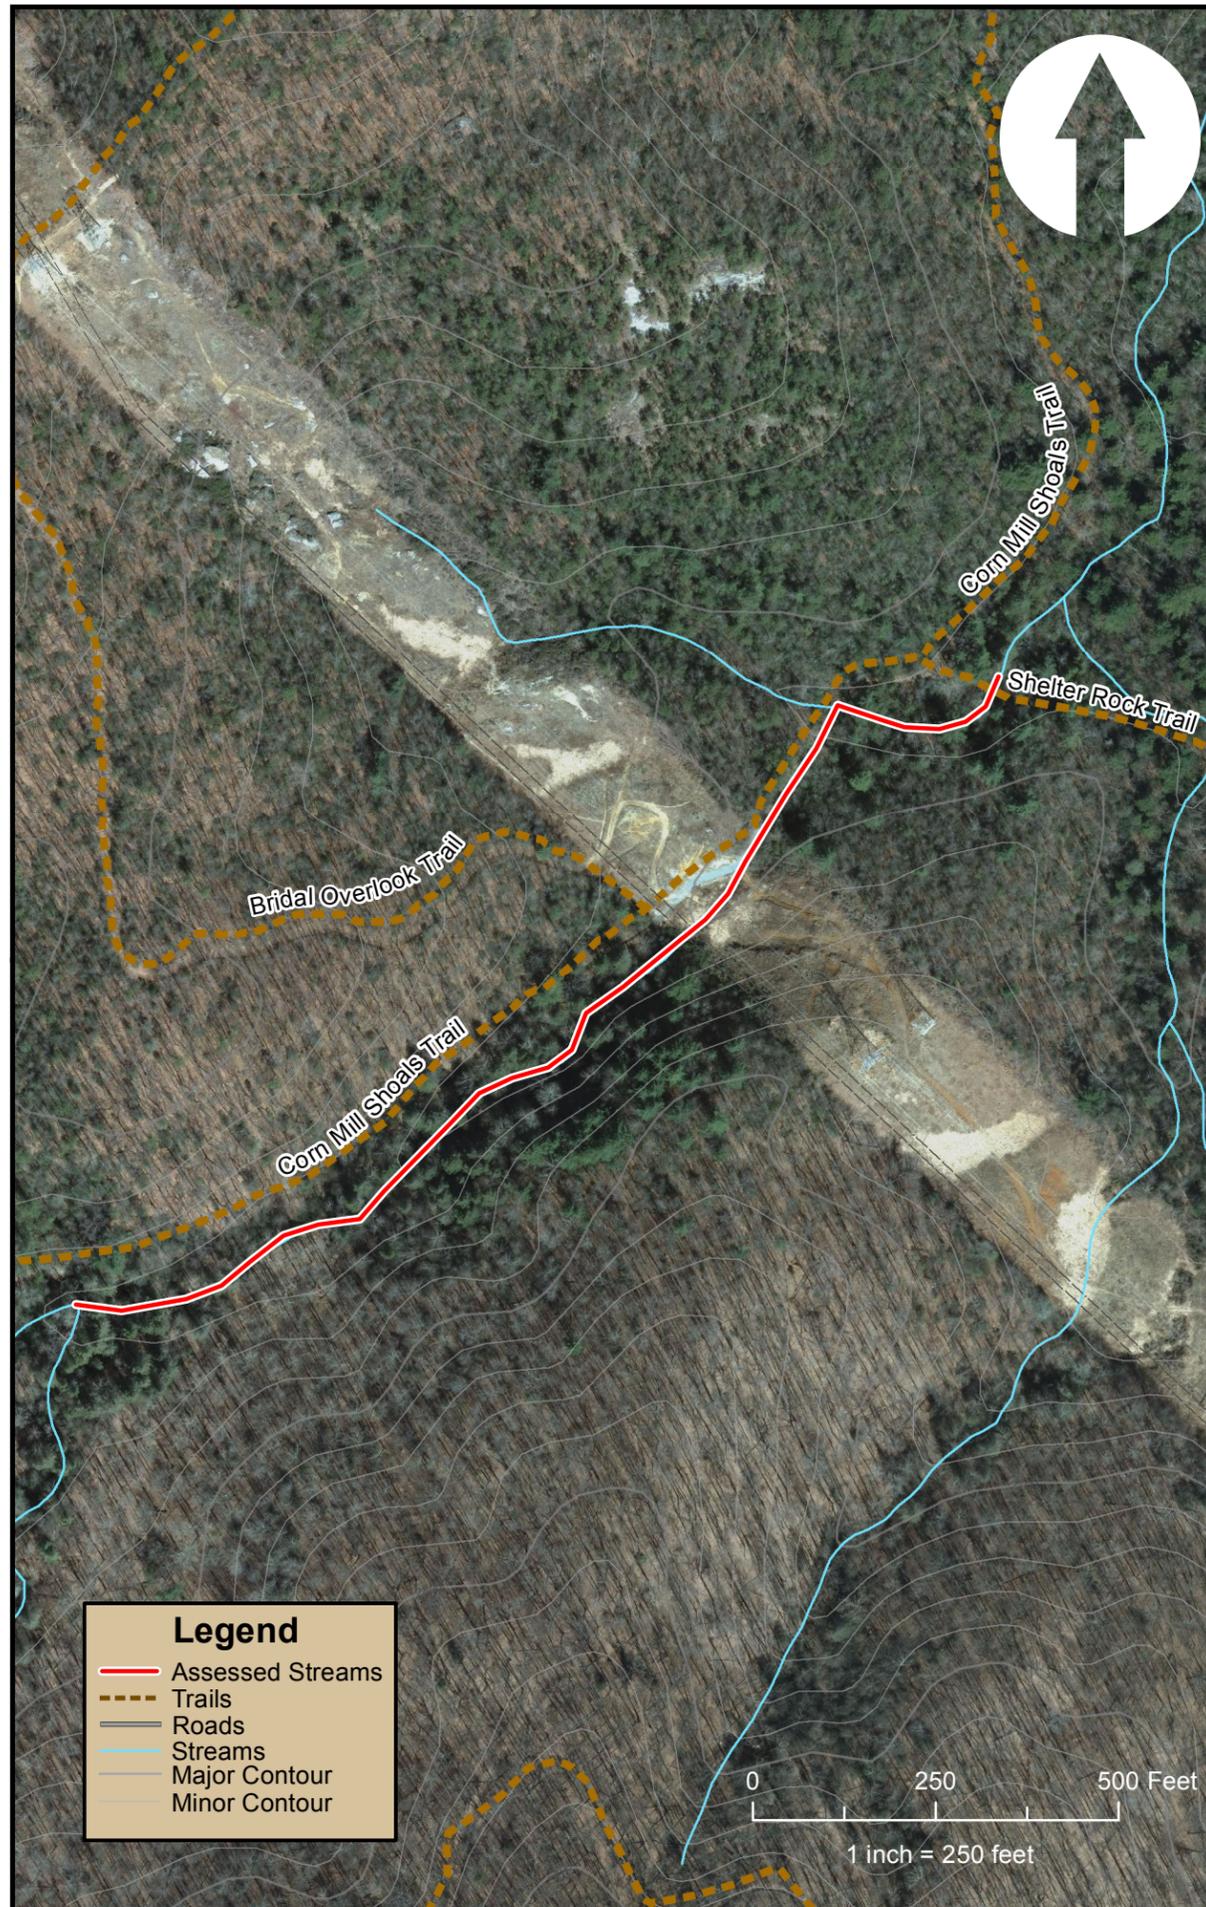
Streambed Substrate: sand, gravel Length (ft): +/-1665 Bankfull Width (ft): +/- 8

1. Site and Watershed Conditions	2
<input checked="" type="checkbox"/> stormwater input <input type="checkbox"/> trampled banks <input type="checkbox"/> trail crossing <input checked="" type="checkbox"/> bridge/culvert/armoring	<input checked="" type="checkbox"/> sediment input <input type="checkbox"/> equine/dog impacts <input checked="" type="checkbox"/> trail in buffer <input checked="" type="checkbox"/> utilities

2. Channel Morphology and Condition	3
<input type="checkbox"/> overwide <input type="checkbox"/> straightened <input type="checkbox"/> head-cutting <input type="checkbox"/> high bed scour	<input type="checkbox"/> incised <input type="checkbox"/> eroding banks <input type="checkbox"/> lack of bedform diversity <input checked="" type="checkbox"/> excessive sediment deposition

3. Floodplain Morphology	3
<input type="checkbox"/> incised channel <input type="checkbox"/> floodplain fill/ levees	<input checked="" type="checkbox"/> entrenched channel <input type="checkbox"/> irregular/ obstructed floodplain

4. Vegetation	3
<input checked="" type="checkbox"/> narrow buffer width <input type="checkbox"/> poor overstory/tree cover	<input type="checkbox"/> invasive plants (banks/floodplain) <input checked="" type="checkbox"/> bare areas/mineral soil (banks/floodplain)

| <input type="checkbox"/> preservation/ exclusion | <input type="checkbox"/> culvert rehabilitation/ replacement |
