Stream Condition – Site: S04

Stream name & Location: Tributary along Barn Trail

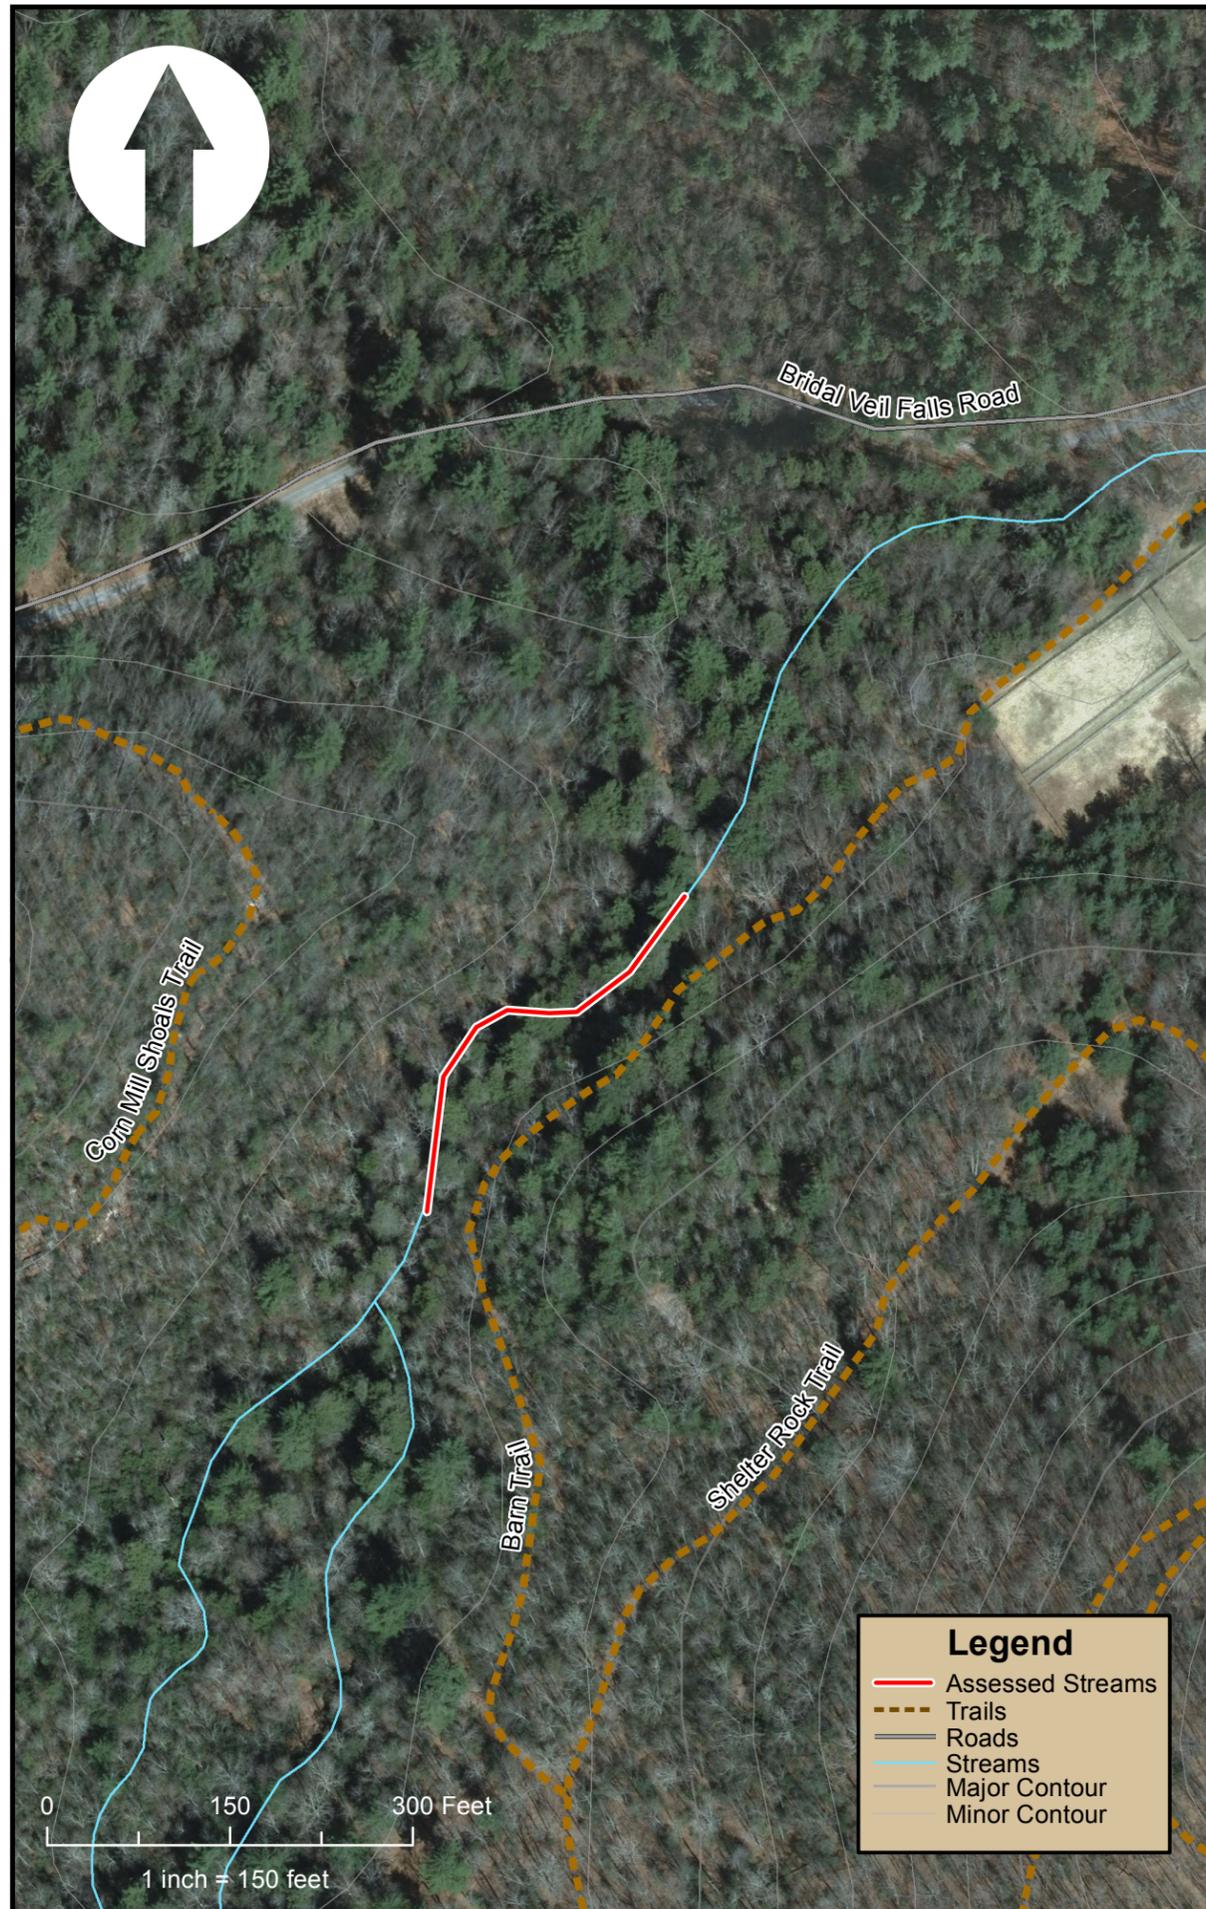
1. Site and Watershed Conditions	2
<input type="checkbox"/> stormwater input <input type="checkbox"/> trampled banks <input type="checkbox"/> trail crossing <input type="checkbox"/> bridge/culvert/armoring	<input checked="" type="checkbox"/> sediment input <input type="checkbox"/> equine/dog impacts <input checked="" type="checkbox"/> trail in buffer <input type="checkbox"/> utilities

2. Channel Morphology and Condition	3
<input type="checkbox"/> overwide <input type="checkbox"/> straightened <input type="checkbox"/> head-cutting <input type="checkbox"/> high bed scour	<input type="checkbox"/> incised <input checked="" type="checkbox"/> eroding banks <input type="checkbox"/> lack of bedform diversity <input checked="" type="checkbox"/> excessive sediment deposition

3. Floodplain Morphology	3
<input type="checkbox"/> incised channel <input type="checkbox"/> floodplain fill/ levees	<input checked="" type="checkbox"/> entrenched channel <input type="checkbox"/> irregular/ obstructed floodplain

4. Vegetation	3
<input type="checkbox"/> narrow buffer width <input type="checkbox"/> poor overstory/tree cover	<input type="checkbox"/> invasive plants (banks/floodplain) <input checked="" type="checkbox"/> bare areas/mineral soil (banks/floodplain)

| <input checked="" type="checkbox"/> preservation/ exclusion | <input type="checkbox"/> culvert rehabilitation/ replacement |
