Stream Condition – Site: S14

Map Grid Location: H2 Site visit date/ team): 8/26/15 / JZ Drainage Area (Sq. Mi.): < 0.1

Stream name & Location: Tributary along Rifle Trail

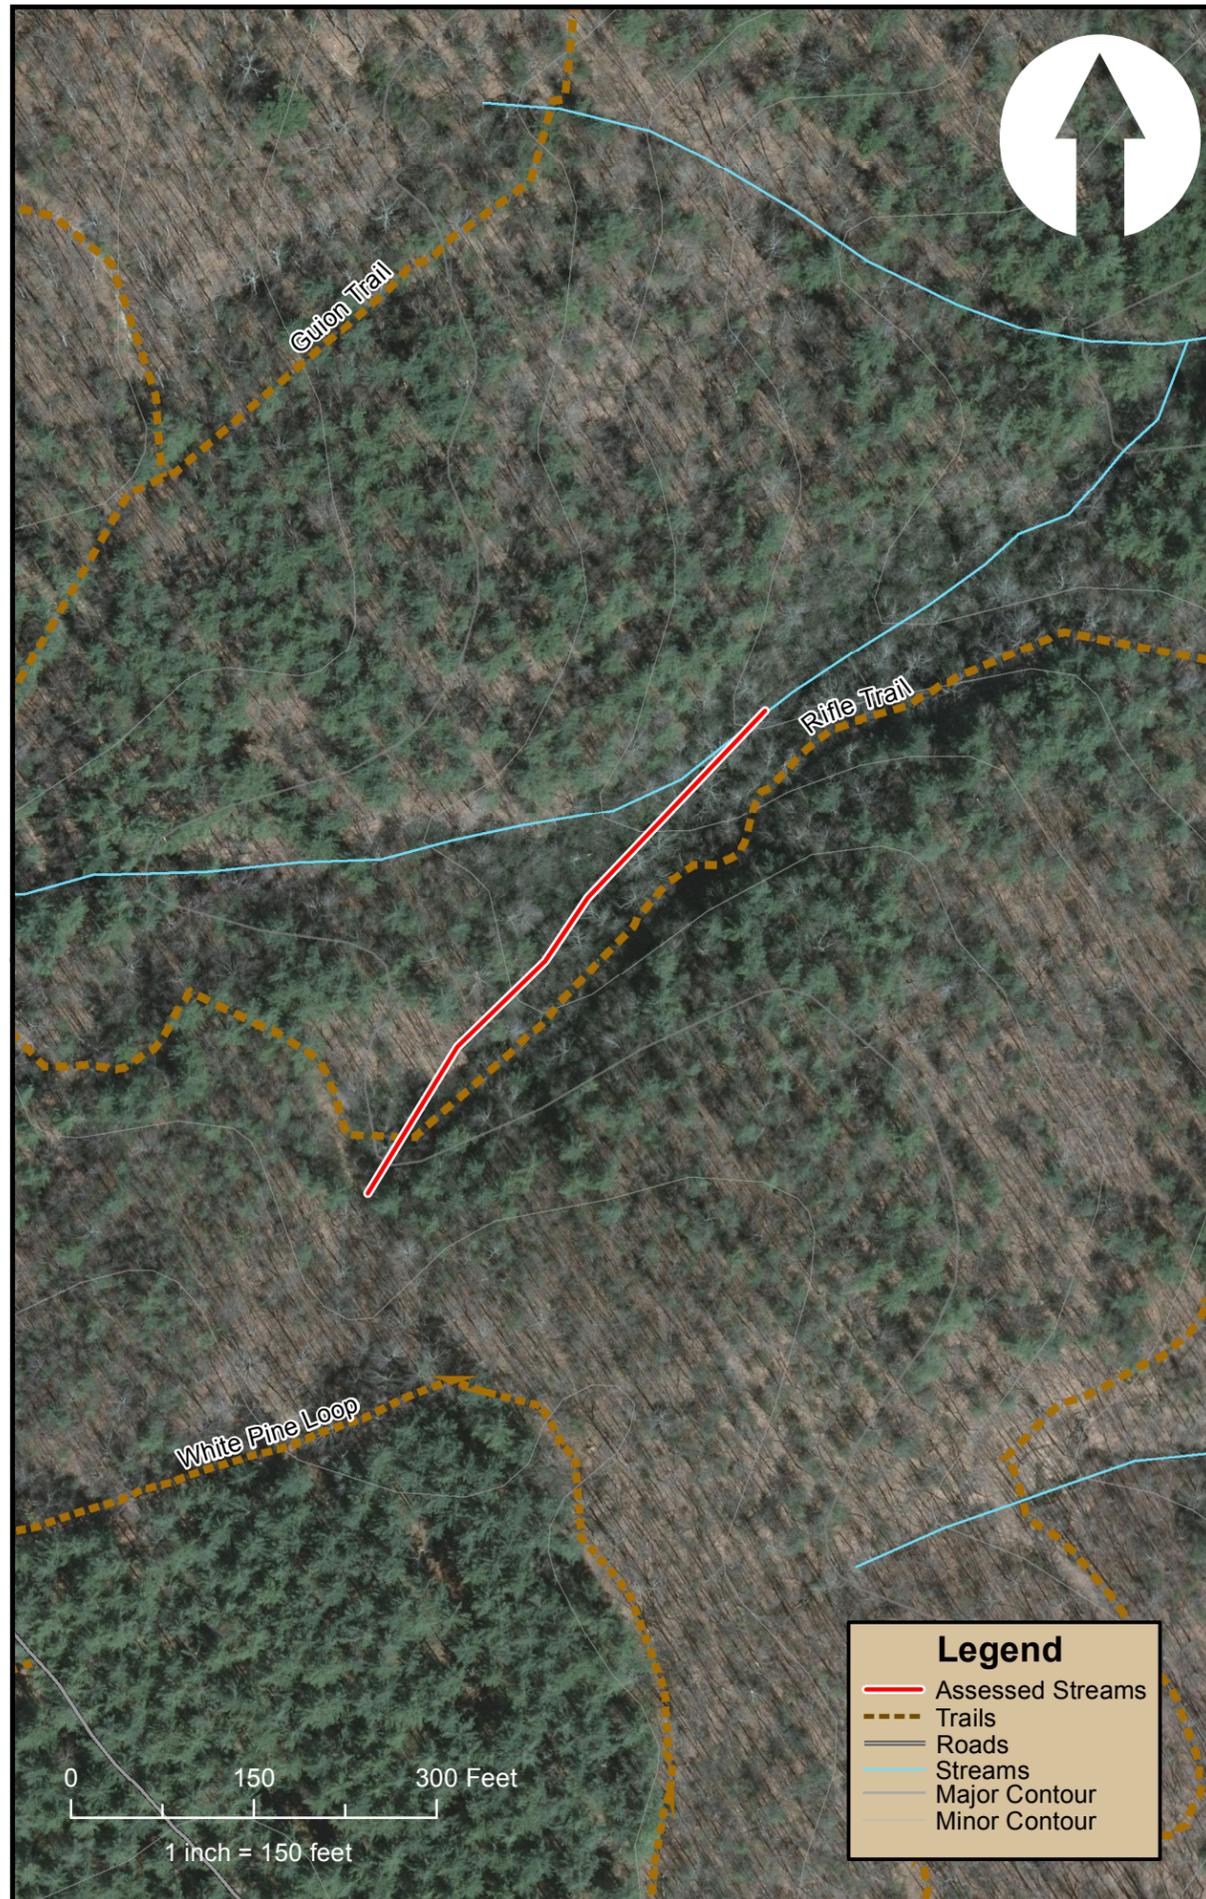
1. Site and Watershed Conditions	1
<input checked="" type="checkbox"/> stormwater input <input type="checkbox"/> trampled banks <input checked="" type="checkbox"/> trail crossing <input type="checkbox"/> bridge/culvert/armoring	<input checked="" type="checkbox"/> sediment input <input type="checkbox"/> equine/dog impacts <input checked="" type="checkbox"/> trail in buffer <input type="checkbox"/> utilities

2. Channel Morphology and Condition	2
<input type="checkbox"/> overwide <input type="checkbox"/> straightened <input type="checkbox"/> head-cutting <input type="checkbox"/> high bed scour	<input type="checkbox"/> incised <input type="checkbox"/> eroding banks <input checked="" type="checkbox"/> lack of bedform diversity <input checked="" type="checkbox"/> excessive sediment deposition

3. Floodplain Morphology	1
<input checked="" type="checkbox"/> incised channel <input checked="" type="checkbox"/> floodplain fill/ levees	<input checked="" type="checkbox"/> entrenched channel <input type="checkbox"/> irregular/ obstructed floodplain

4. Vegetation	2
<input checked="" type="checkbox"/> narrow buffer width <input type="checkbox"/> poor overstory/tree cover	<input type="checkbox"/> invasive plants (banks/floodplain) <input checked="" type="checkbox"/> bare areas/mineral soil (banks/floodplain)

| <input checked="" type="checkbox"/> preservation/ exclusion | <input type="checkbox"/> culvert rehabilitation/ replacement |
