Area of Concern – Site: P17

Map Grid Location: F9 Site visit date/ team): 8/31/15/ JZ Drainage Area (Sq. Mi.): < 0.1  
Name & Location: Airstrip Trail below airstrip

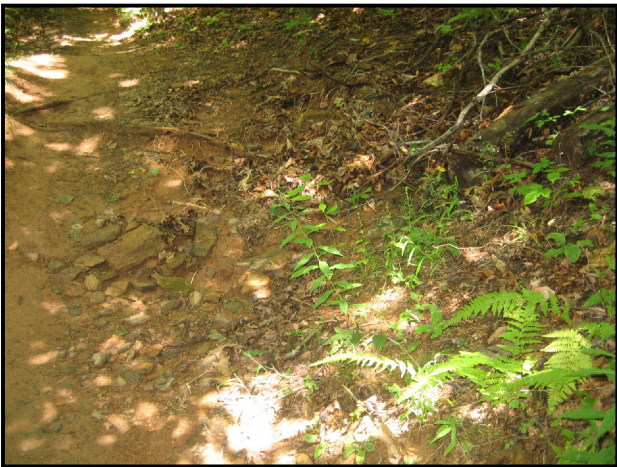
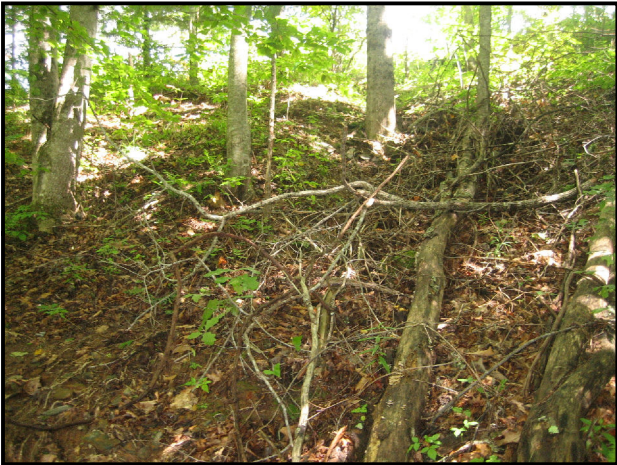
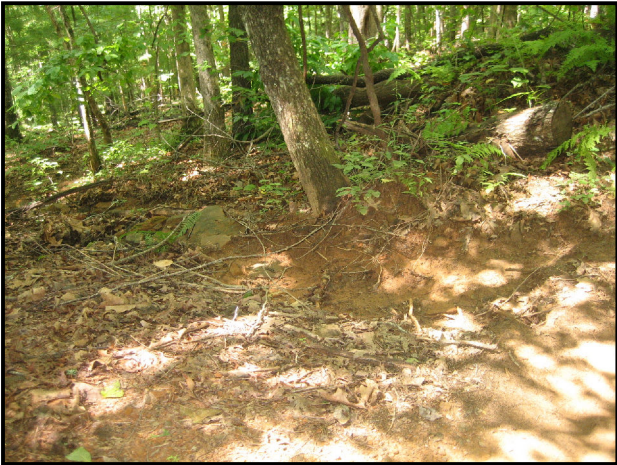
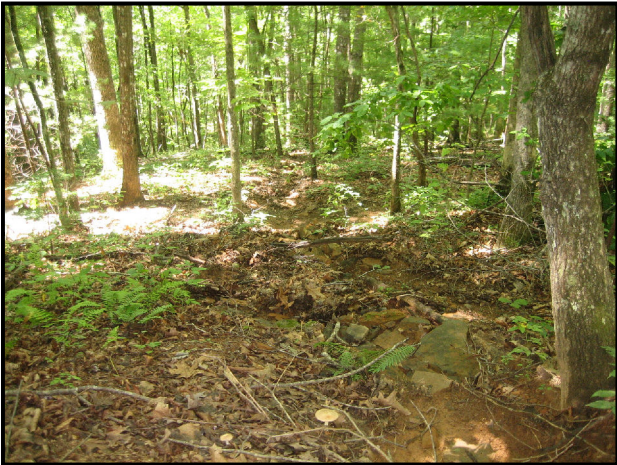
3. **Upland/ Stormwater**  
☒ nonpoint source pollution ☒ upland erosion  
☐ pollutant point source ☒ unvegetated upland area
4. **Lake/Pond/ Reservoir (reservoir name):** \_\_\_\_\_  
☐ erosion ☐ lack of vegetation  
☐ equine impact ☐ human impact (hiking/biking)  
☐ safety hazard ☐ water quality (temperature, algae, geese, fecal)

5. **Other Problem Area(s)** (list contributing factors)  
Impervious surface (airstrip) contributing runoff.

**Comments**  
Airstrip Trail is in good condition. However, runoff from impervious airstrip has formed gully crossing Airstrip Trail in multiple locations. Potential solution includes treating stormwater at its source.

| <input type="checkbox"/> relocate trail/close trail/road | <input checked="" type="checkbox"/> trail/road crossing improvement |
| <input checked="" type="checkbox"/> stormwater treatment | <input type="checkbox"/> animal watering |
