Stream Condition – Site: S10

Map Grid Location: H6 Site visit date/ team): 8/26/15 / JZ Drainage Area (Sq. Mi.): 4.35

Stream name & Location: Grassy Creek along Sandy Trail

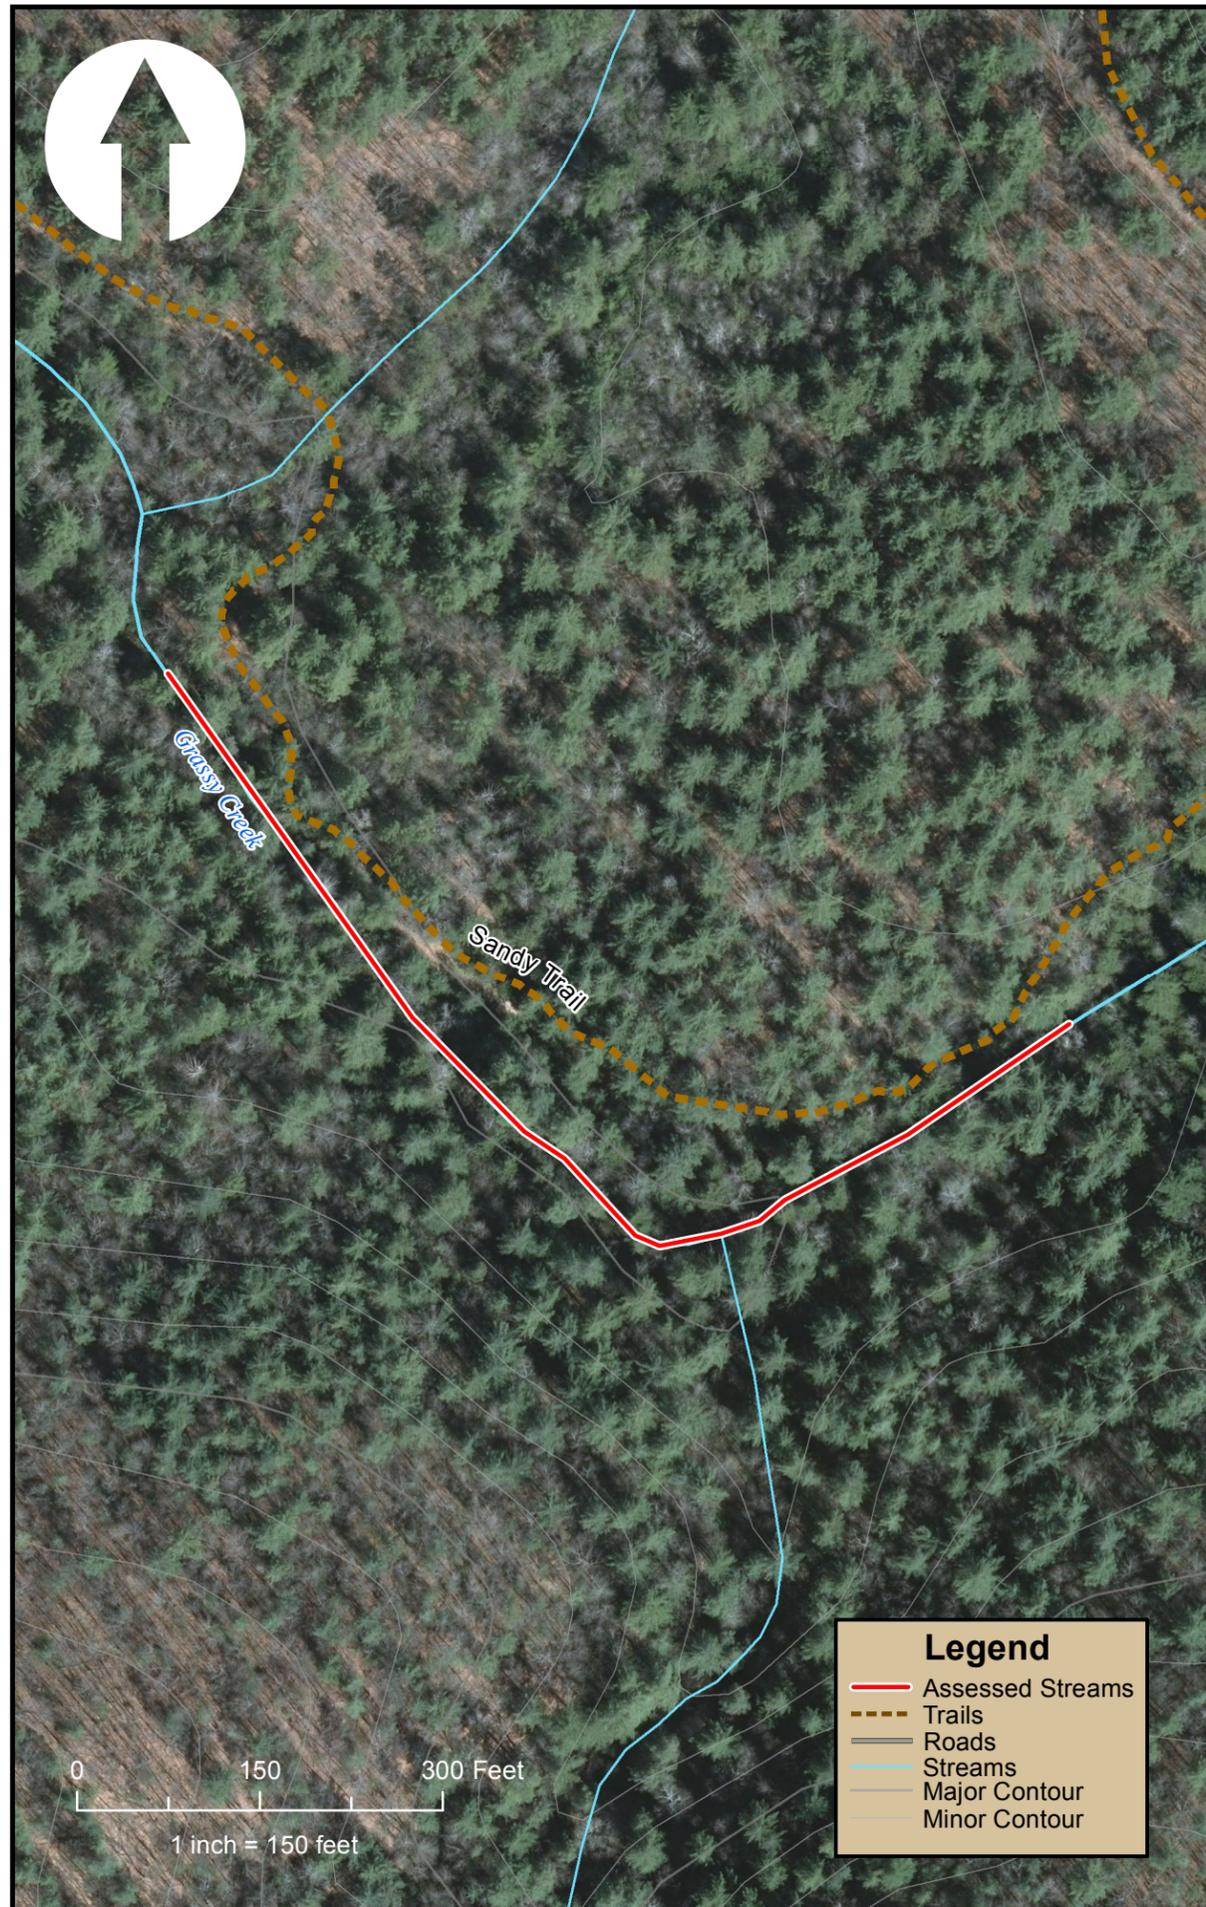
Streambed Substrate: sand, cobble Length (ft): +/-1015 Bankfull Width (ft): +/- 25

1. Site and Watershed Conditions	3
<input type="checkbox"/> stormwater input <input type="checkbox"/> trampled banks <input type="checkbox"/> trail crossing <input type="checkbox"/> bridge/culvert/armoring	<input type="checkbox"/> sediment input <input type="checkbox"/> equine/dog impacts <input checked="" type="checkbox"/> trail in buffer <input type="checkbox"/> utilities

2. Channel Morphology and Condition	3
<input type="checkbox"/> overwide <input type="checkbox"/> straightened <input type="checkbox"/> head-cutting <input type="checkbox"/> high bed scour	<input type="checkbox"/> incised <input checked="" type="checkbox"/> eroding banks <input type="checkbox"/> lack of bedform diversity <input checked="" type="checkbox"/> excessive sediment deposition

3. Floodplain Morphology	2
<input checked="" type="checkbox"/> incised channel <input checked="" type="checkbox"/> floodplain fill/ levees	<input type="checkbox"/> entrenched channel <input type="checkbox"/> irregular/ obstructed floodplain

4. Vegetation	2
<input checked="" type="checkbox"/> narrow buffer width <input type="checkbox"/> poor overstory/tree cover	<input type="checkbox"/> invasive plants (banks/floodplain) <input checked="" type="checkbox"/> bare areas/mineral soil (banks/floodplain)

| <input type="checkbox"/> preservation/ exclusion | <input type="checkbox"/> culvert rehabilitation/ replacement |
